File #: EMS-8-1415-2

Date of Inspection: August 14, 2015
Commissioned by: Randy Pauly
Address: 1655 Memory Lane, Arroyo Grande. CA 93420
e-mail: rfpauly@aol.com
Phone: 805.748.9202

Vessel Name	“Black Hole”
Designer of Vessel:	Don Radon - Radon Boats
Model Year:	1979
CA. State Registration #:	CF-7721 GM
Registration Tags:	2015 Tags - #K-024986

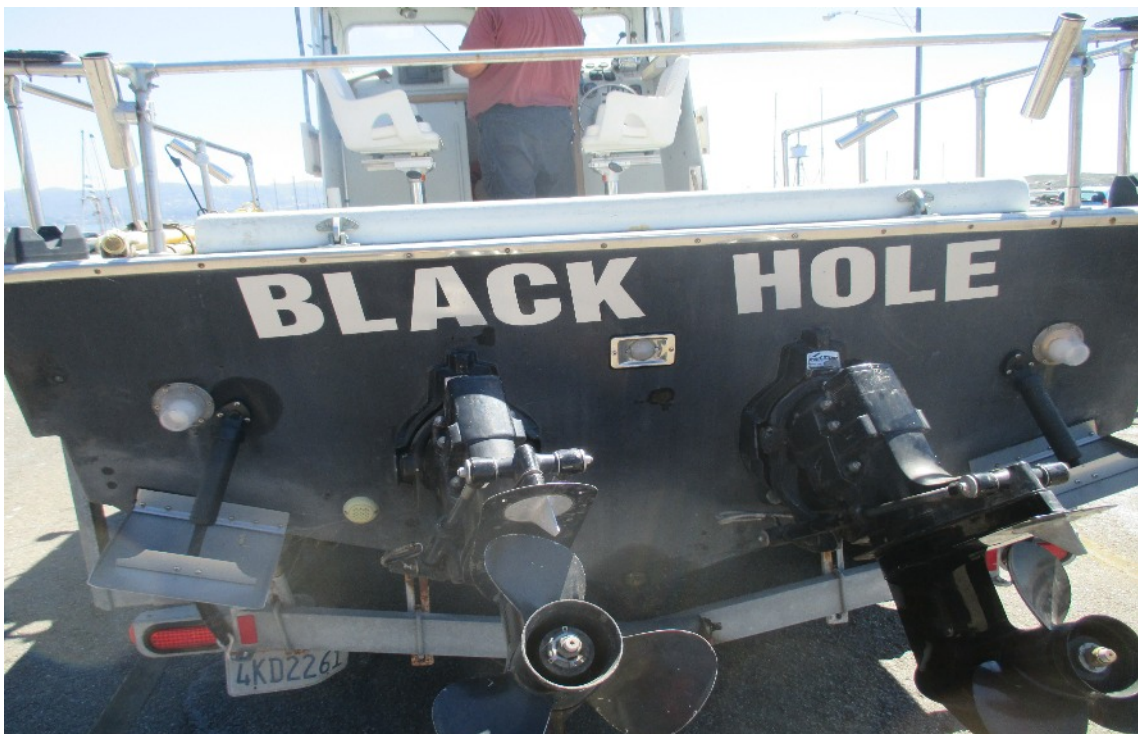
- Helm: The helm station has wheel steering. Engine ignition and dash panel includes temperature gauge, oil pressure gauge, volt meter, trim gauges, fuel gauge and engine hour meters (Port meter reads 1009-hrs - Starboard engine meter reads 988-hrs.). NOTE: Unknown if meters are accurate.
- Steering: Steering is free moving.
- Propellers: Propellers check secure and in good order (13-1/2 RH 21) and secured to shaft with castellated nut, cotter pin and lock nut.
- Shaft System: MerCruiser 'alpha' - Outdrive unit.
- Bellows: Good condition.
- Trim Tabs: Yes. Secure and free of visible fluid leakage.
