Cleaning and Lubing Anti Reverse Bearings and ARB Performance

I just returned from a long range trip on the RRlll and have been cleaning my fishing reels. As I was working on a Shimano Trinidad 40 the thought occurred to me that I should clean and lube the anti reverse bearing. In doing so, I thought I might as well try my first post on this site.

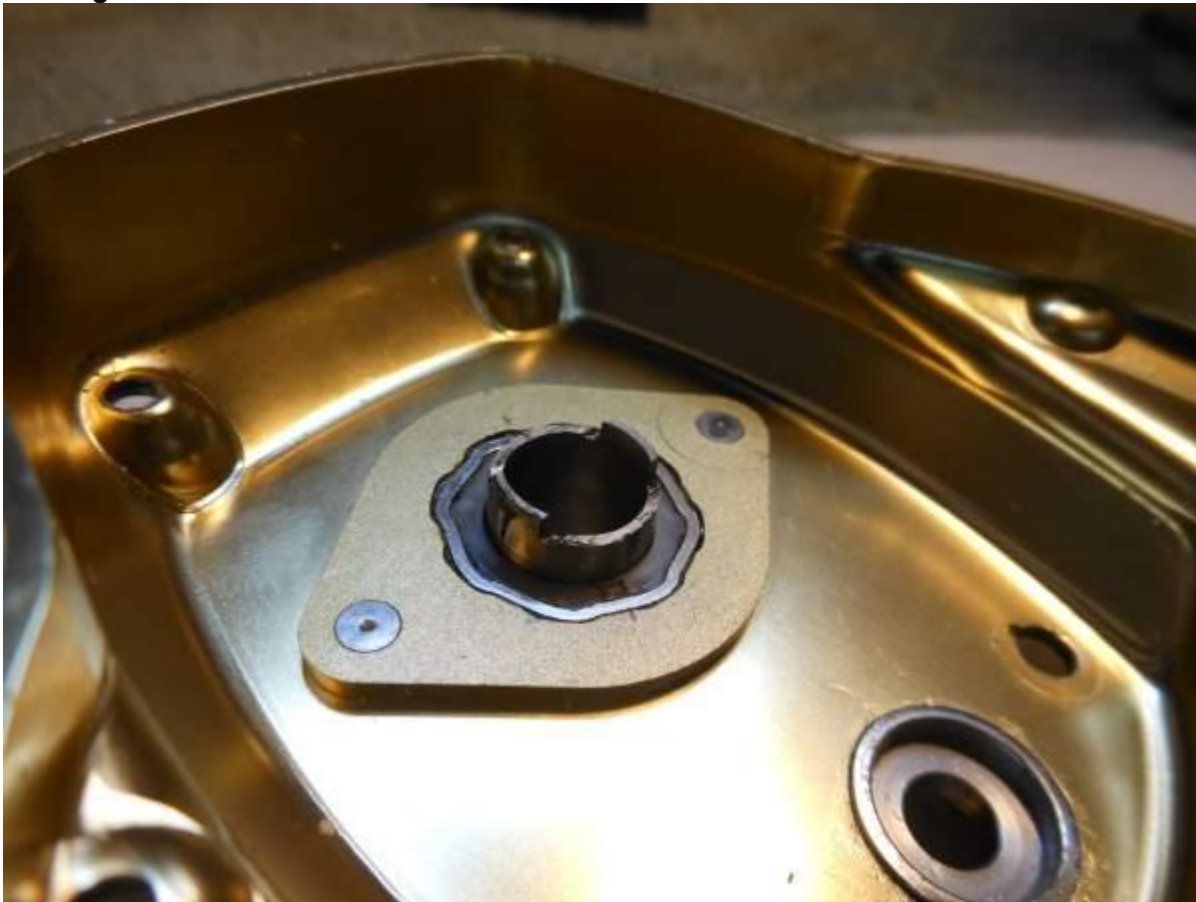
DSCN0255

Here is the right side plate that has been removed from the reel. The shaft sleeve is still inside the bearing.

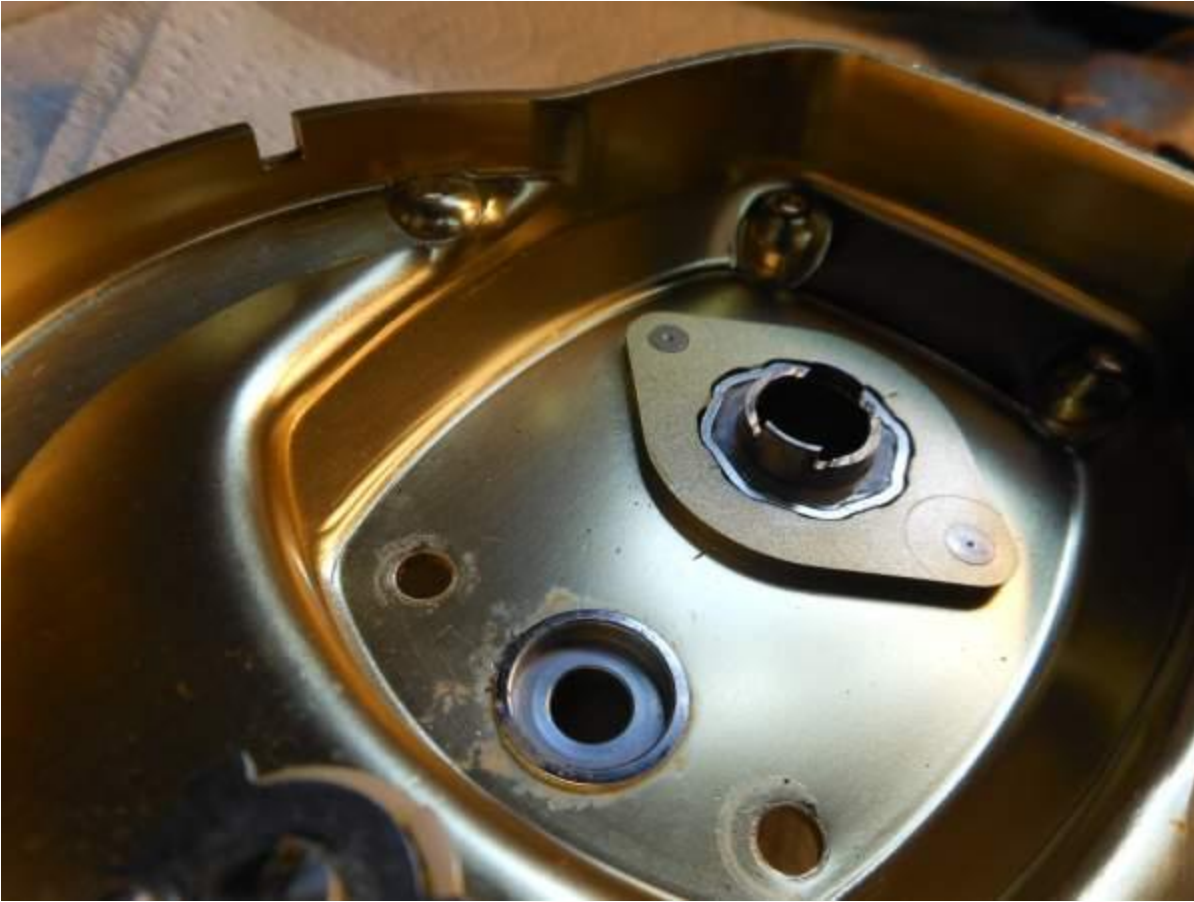
DSCN0289

With the sleeve removed you can see that the bearing is pretty dirty but doesn't appear to be damaged. Notice the two cuts in the plastic bearing cage. I use these cuts as a means to be sure I get the bearing back together properly. There are no cuts on the back side of the cage that is installed into the bearing housing. Note that I have made small marks on the side plate to indicate where the cuts are aligned.

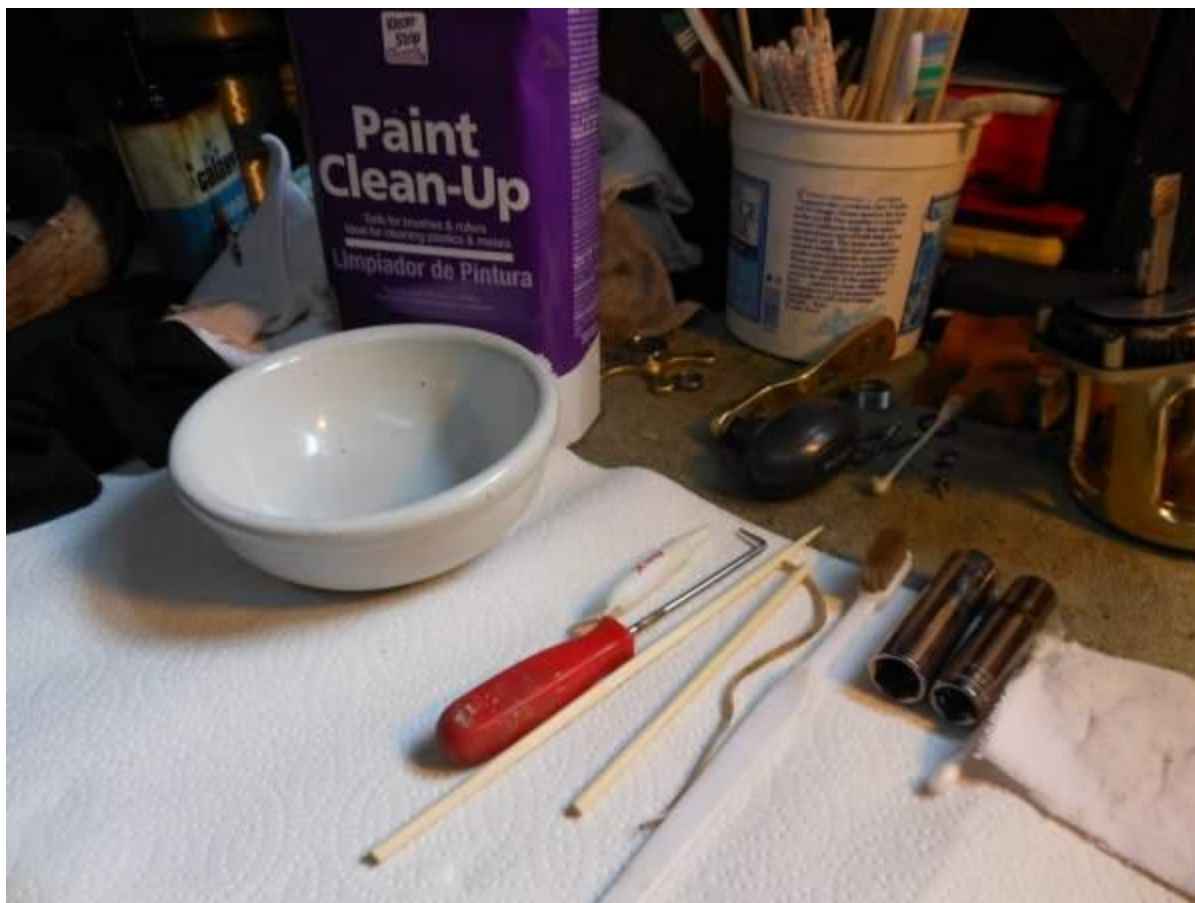
DSCN0259

I use a 10 mm socket to remove the bearing from the side plate as recommended by Alan's tutorial. This bearing was the "tightest" that I've removed. When a couple of solid taps didn't remove the bearing I took the side plate to the kitchen sink and ran hot water over it for a couple of minutes. After the plate was pretty warm the bearing came out pretty easily. Remember, sometimes it's not always the best idea to get a bigger hammer!

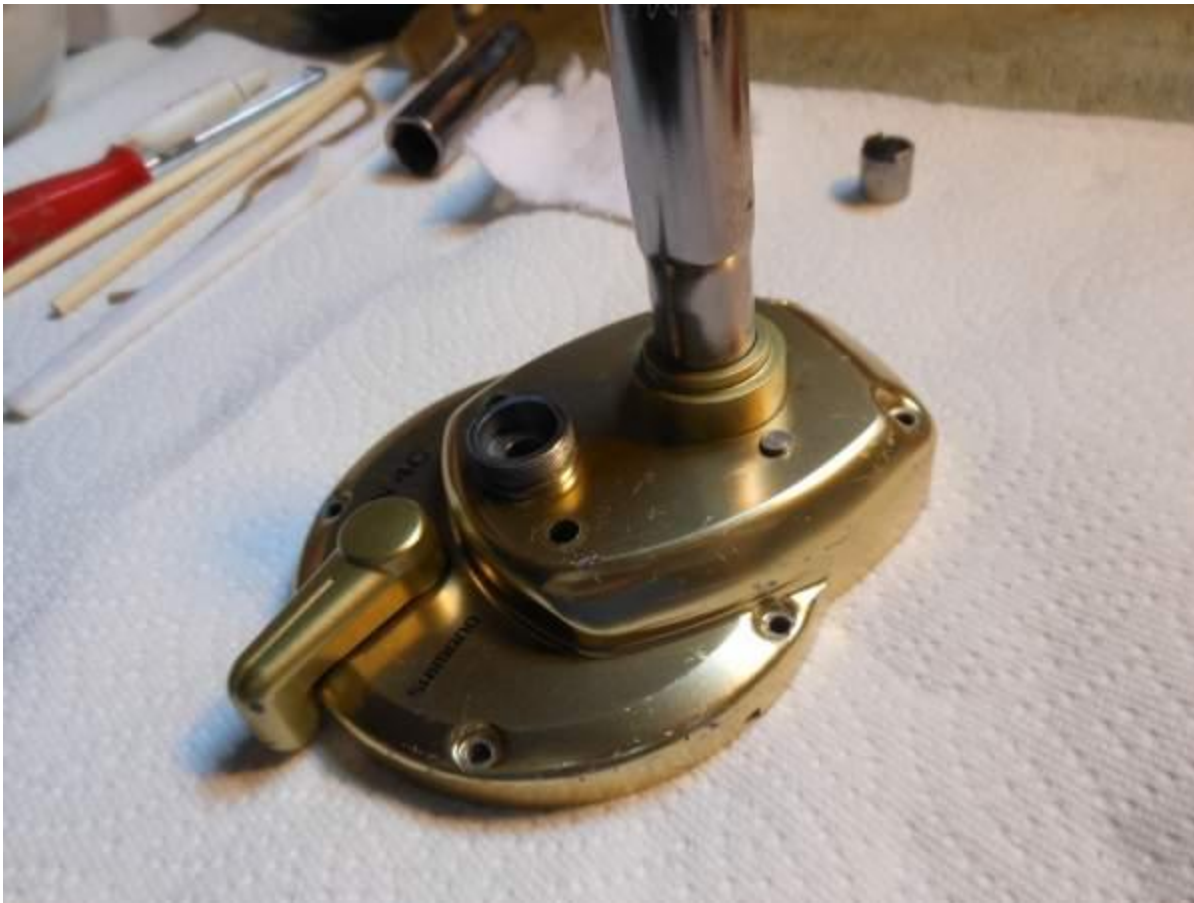
DSCN0262

In this photo you can see the bearing is almost all the way out of the plate.

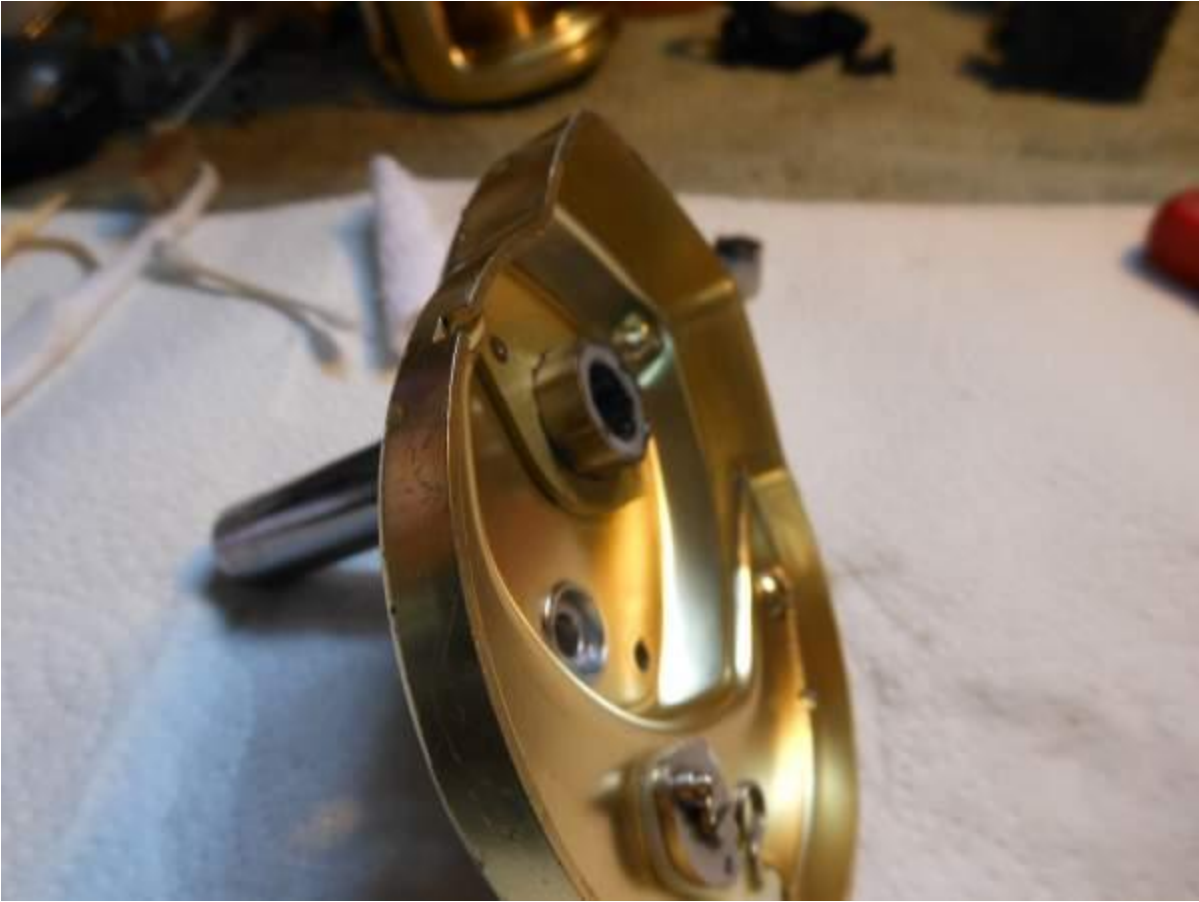
DSCN0263

The side plate recess is fairly clean, I'll clean it farther before I reinstall the bearing.

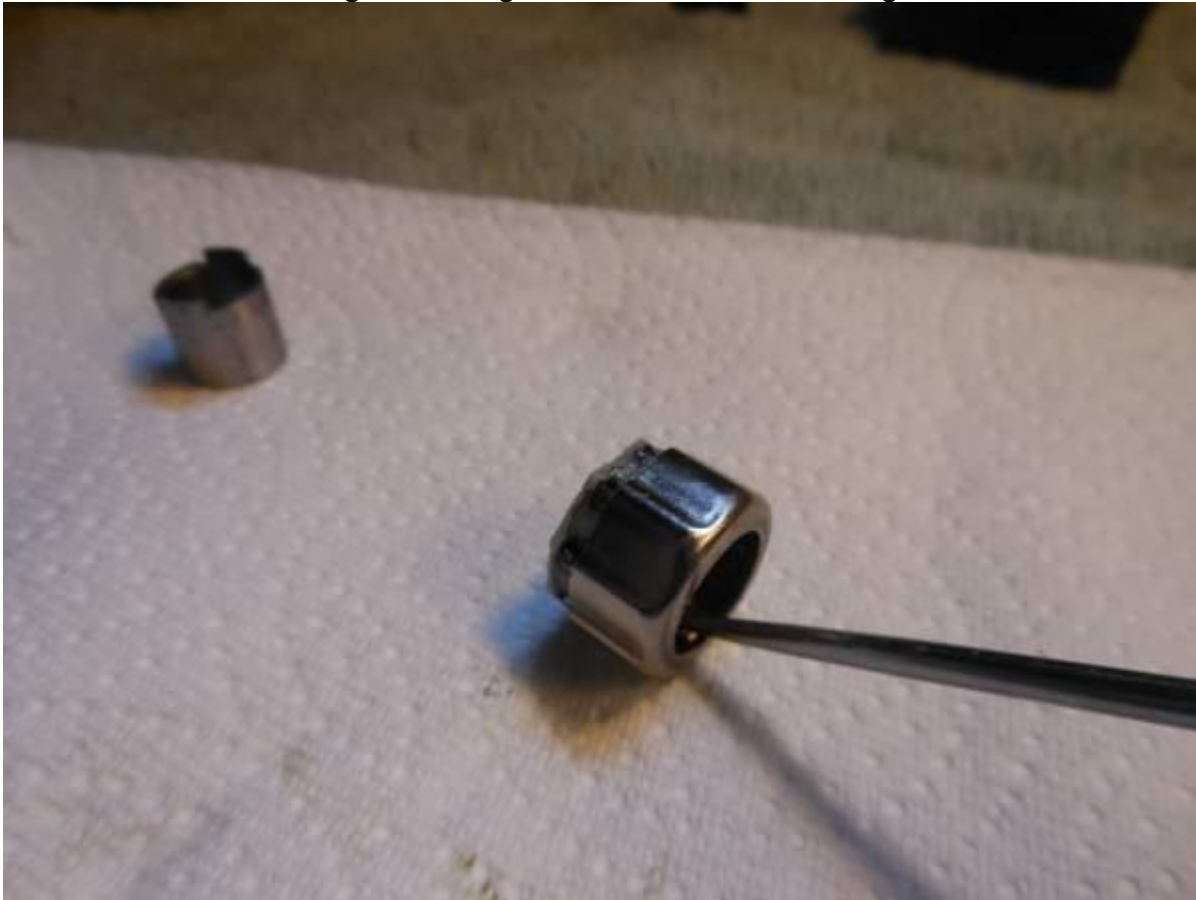
DSCN0268

The bearing housing, bearing cage and bearing rollers are dirty but, as a good thing, there is no corrosion or rust. The lubrication residue is very sticky, I believe from the incursion of grease into the bearing. It is my belief that grease along with water and salt is what causes the bearing to fail to operate properly.

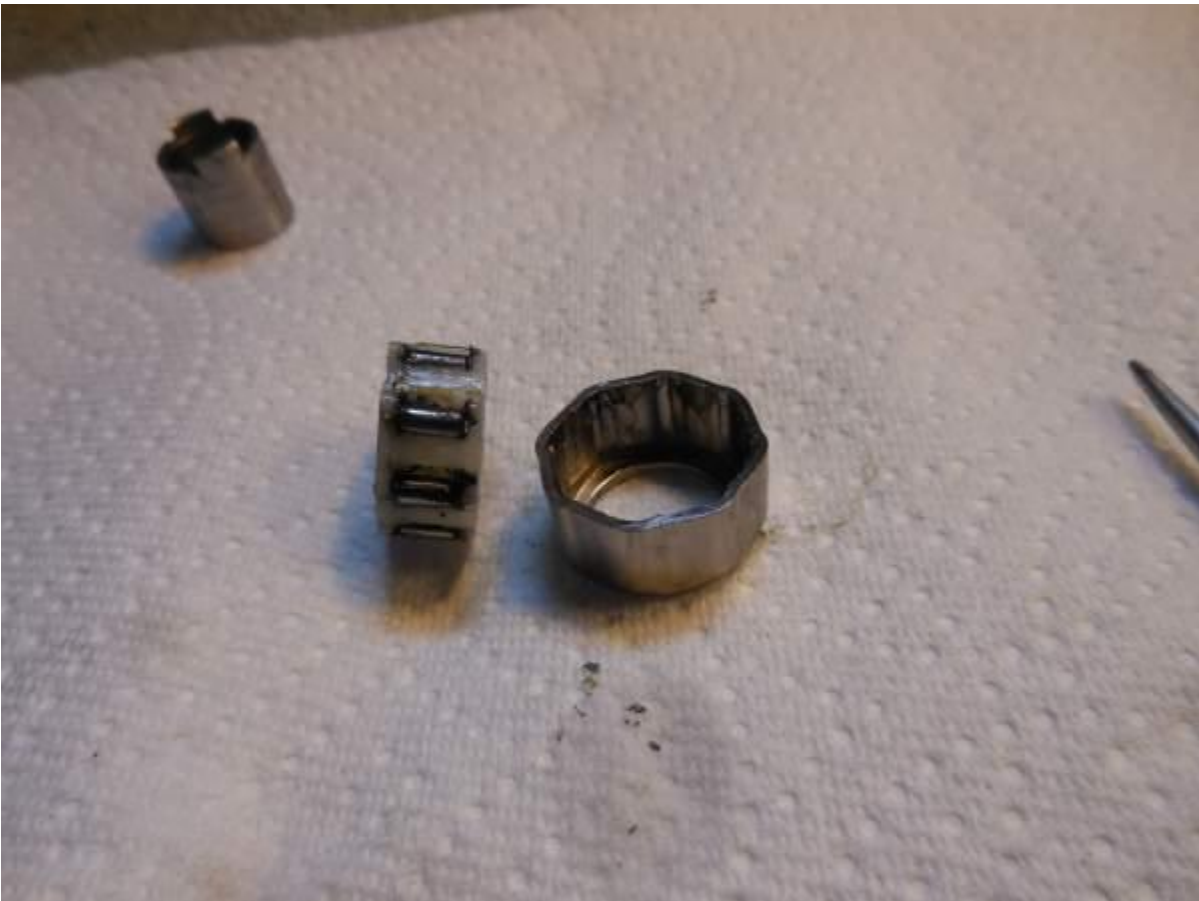
DSCN0270

The roller bearings will typically fall right out of the cage. Because of the stickiness of the lube, I had to push these out.

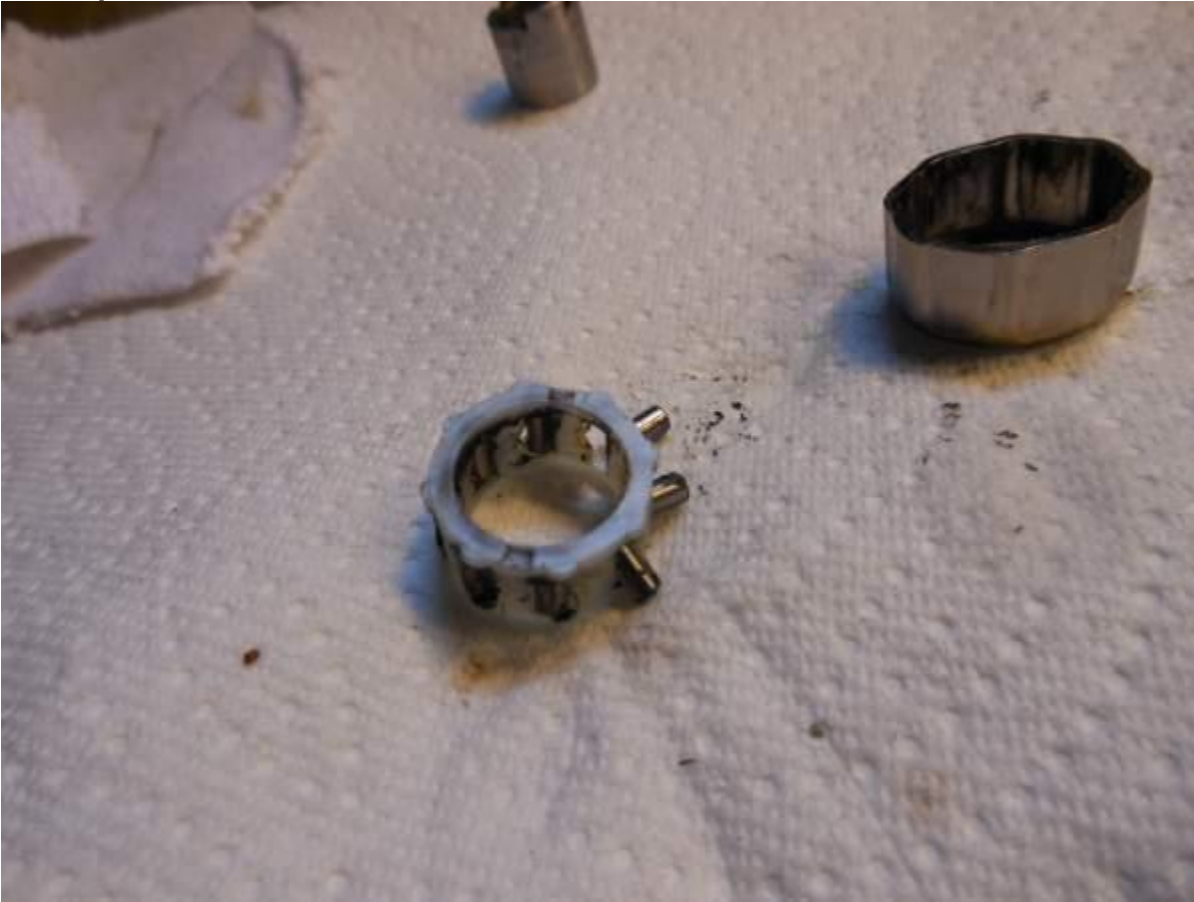
DSCN0271

Further indication the service was required, a lot of dirt. Note that there are 8 rollers. If you come up with 7 when it comes time for reassembly there will be a problem!

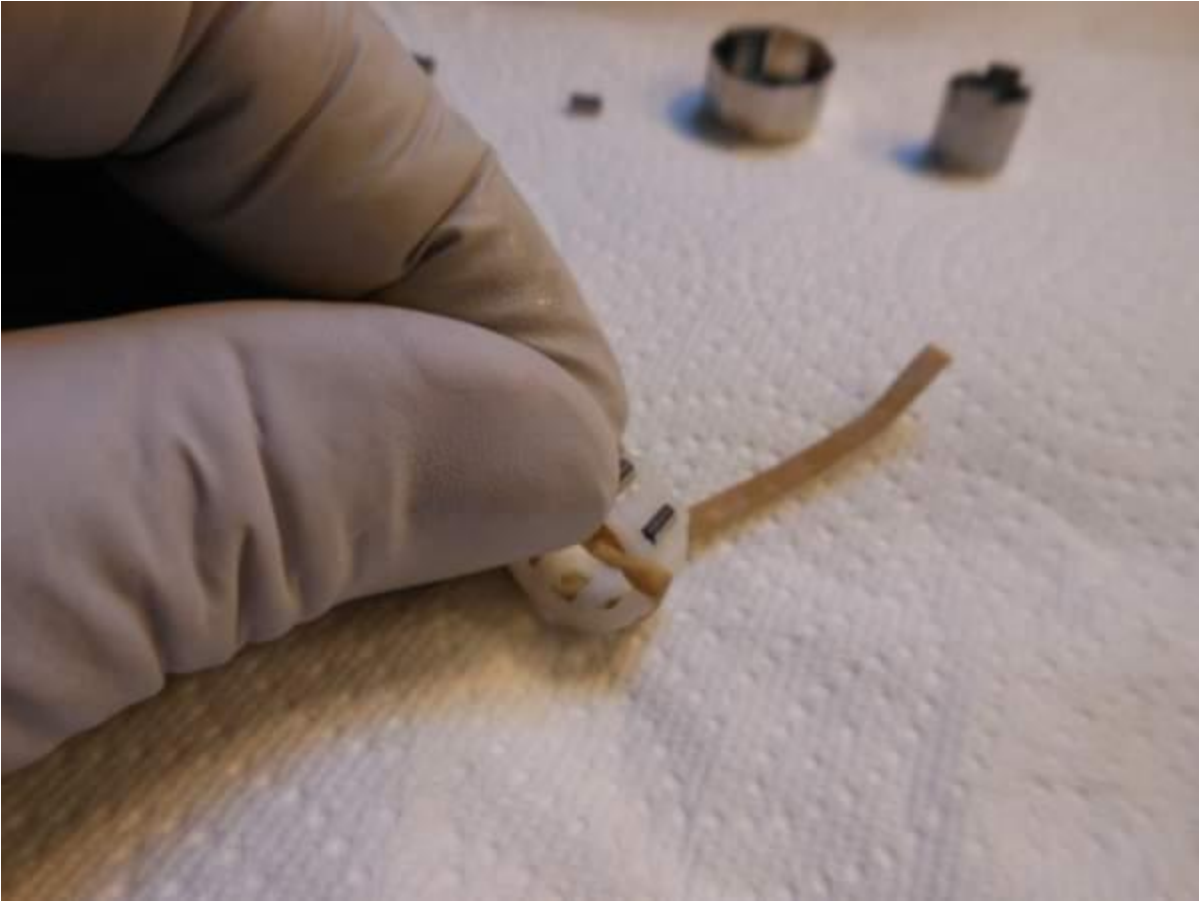
DSCN0277

Here all the rollers are reinstalled into the cage.

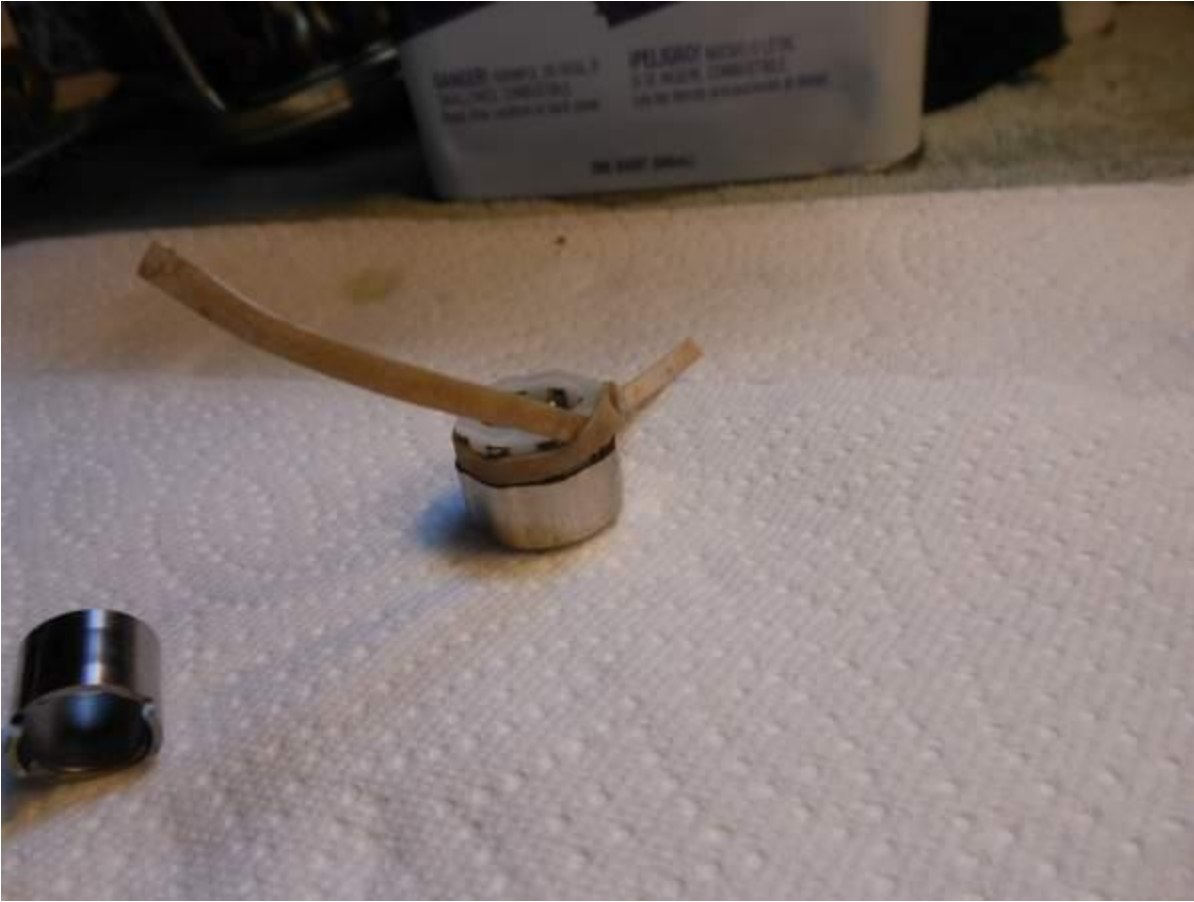
DSCN0280

The rubber band pops off..

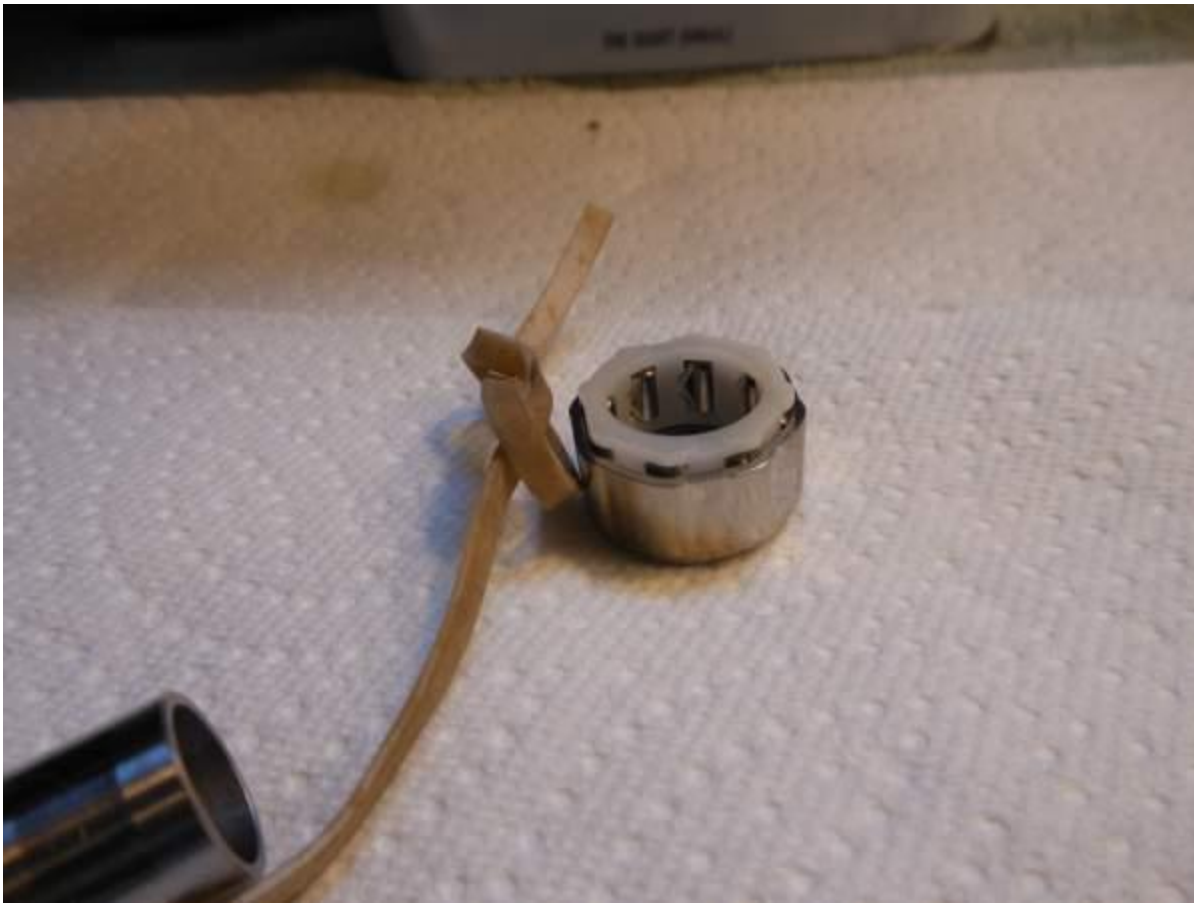
DSCN0281

You can then push the cage back into the housing. It snaps into a place with a satisfying click! Barely visible are the cut marks that I mentioned earlier, the cage is back in its original position. In this photo you can see the plastic preload springs that I believe push the bearings into the normal from the backspin lock position.

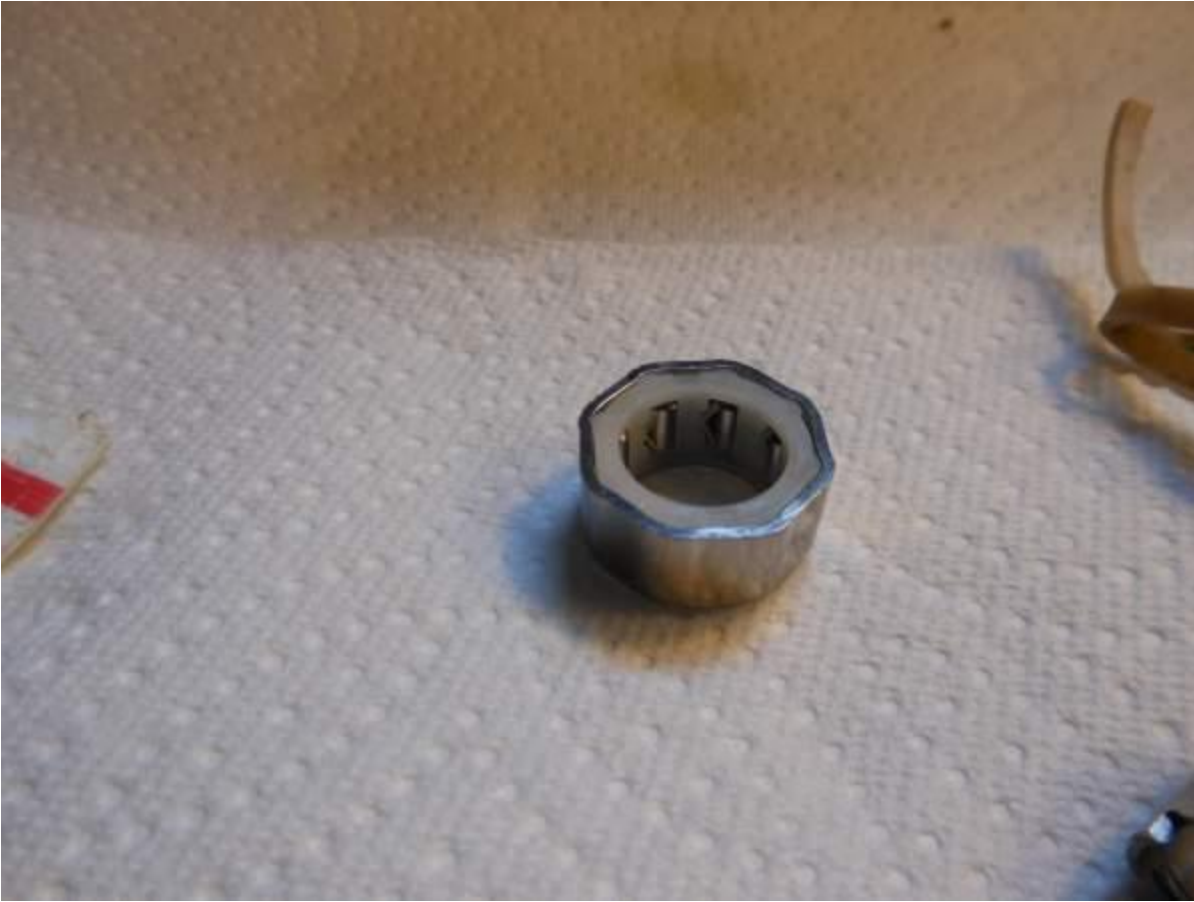
DSCN0282

After lubing with Reelx, I install the shaft sleeve and turn it to see that the bearing is working correctly. In this case it was working smoothly so we can reinstall it in the side plate.

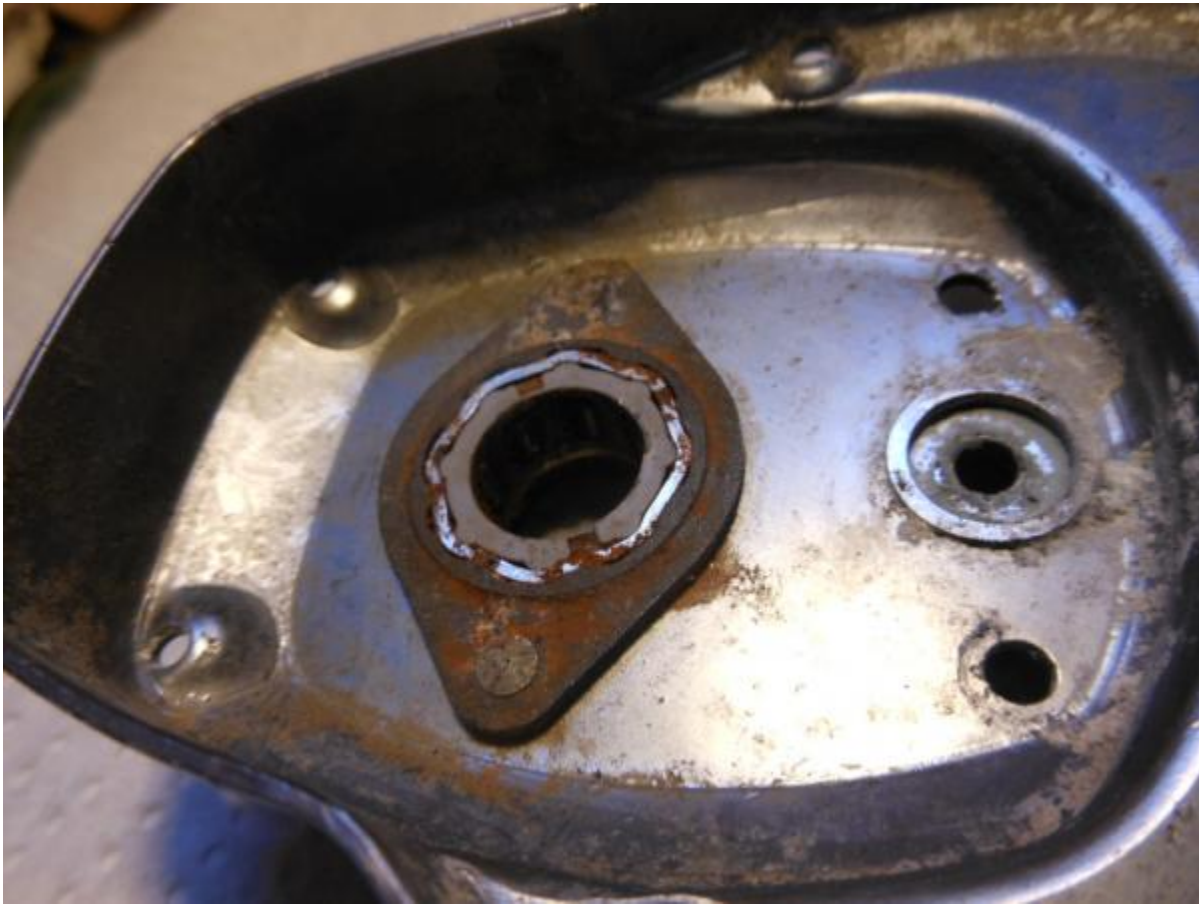
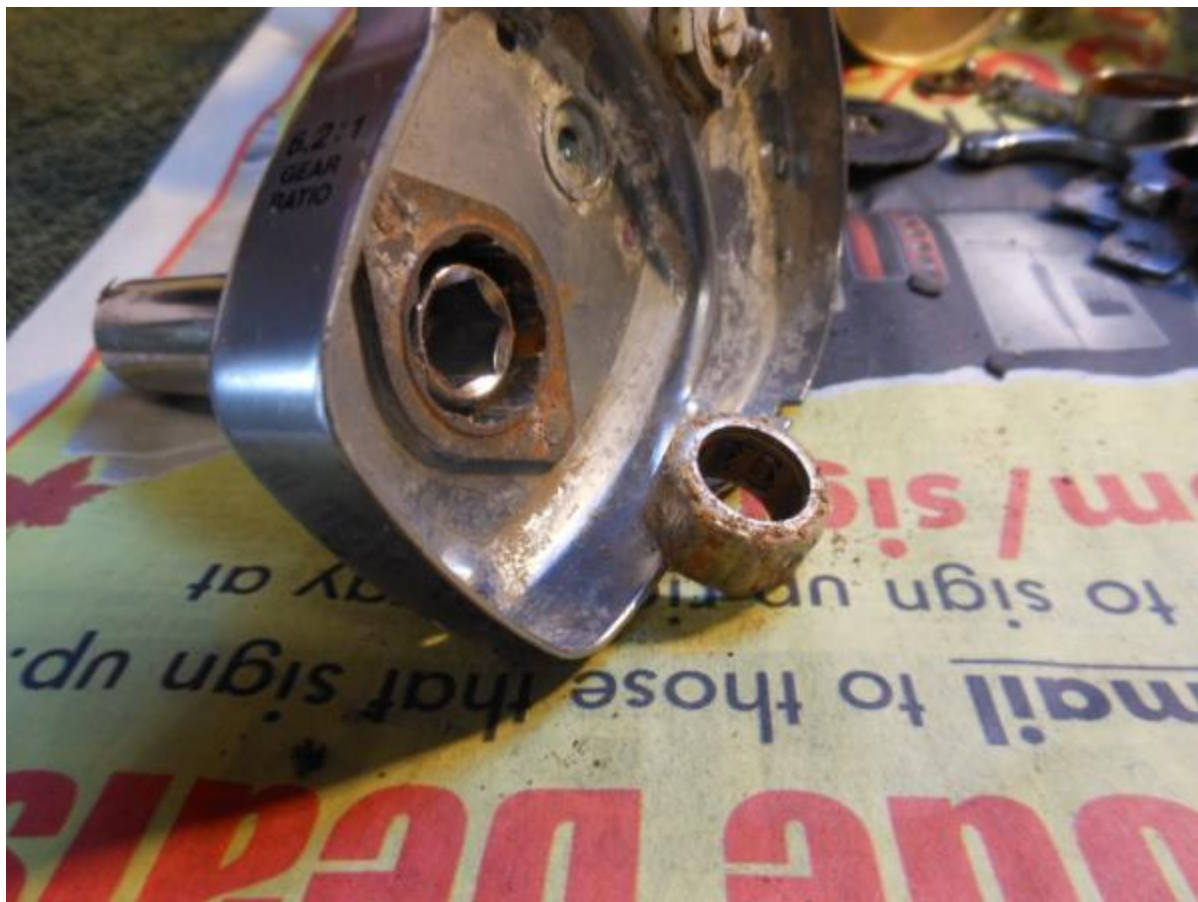
Here are a couple of new pictures I took of an anti reverse bearing that I couldn't save. I did the service noted in the post, but the interior of the outer bearing race was badly corroded where the rollers were setting. I actually used the Torium 30 reel that these pictures came from to catch a couple of nice wahoo on a recent trip after I had cleaned and reassembled it. However, I found out that under heavy drag loads that the reel anti reverse would transfer to the dog with an audible "clack". Now, I'll have to replace this one but I really don't feel too badly, as the old saying goes, "nothing ventured, nothing gained".

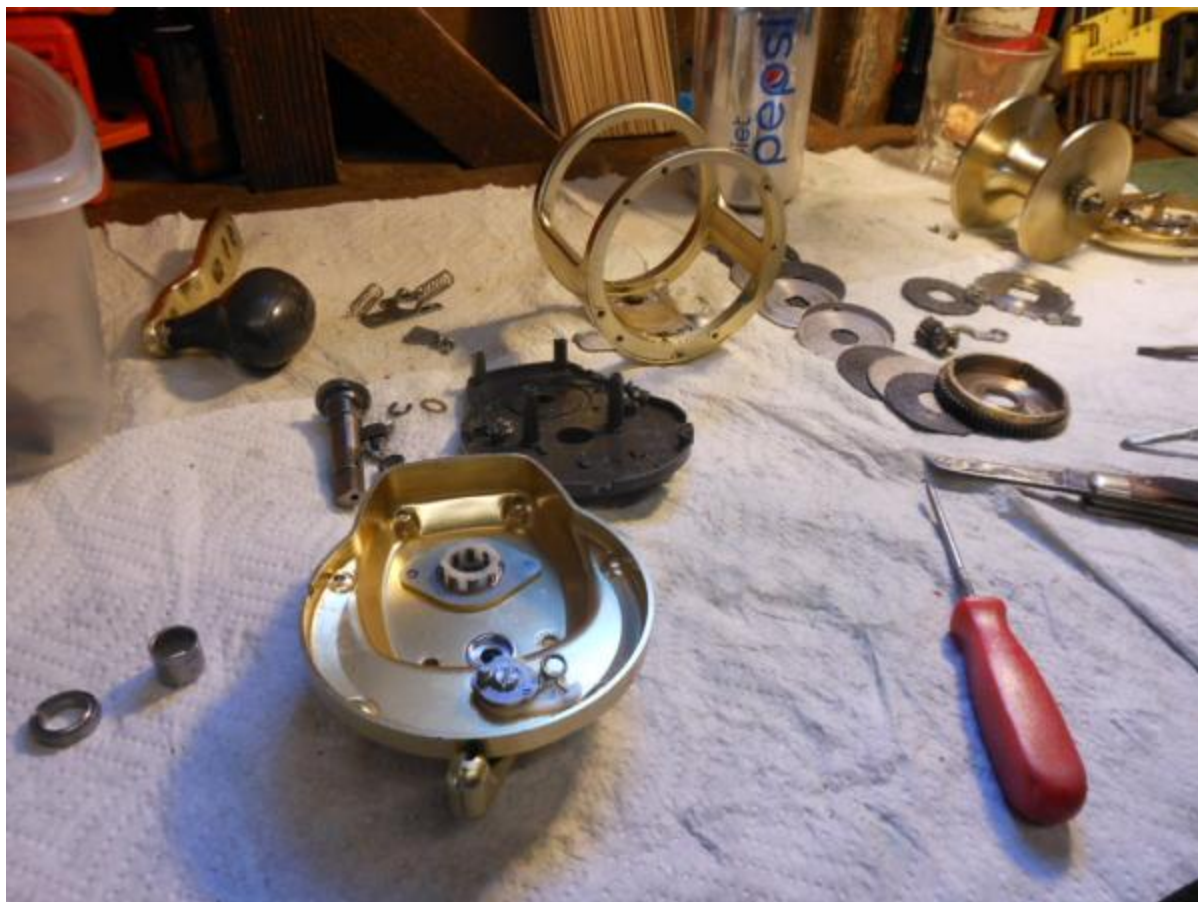
DSCN1657.JPG (224.11 KB, 1024x768 - viewed 122 times.)

Picture 1: Reel dismantled and all parts cleaned. Note no line on spool, and greased carbon fiber drag washers.

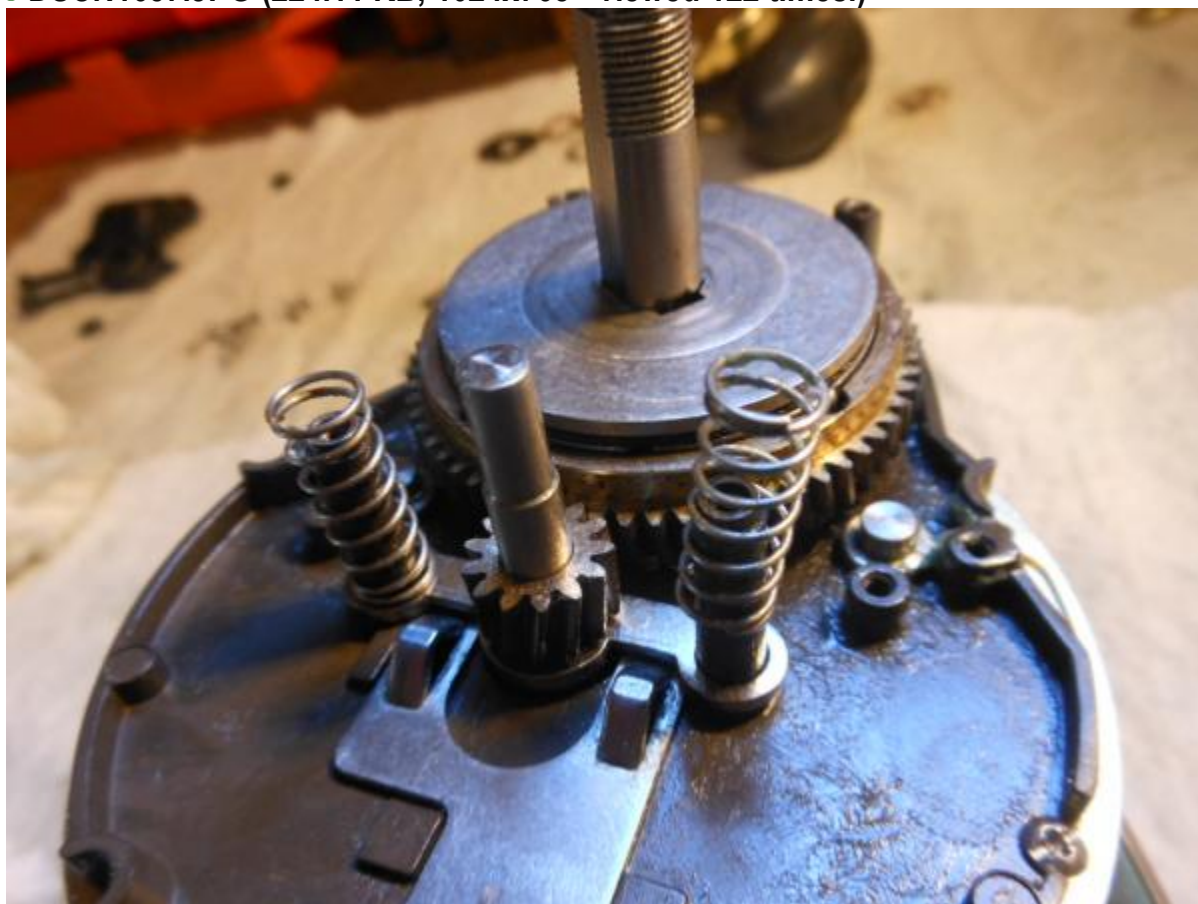
DSCN1659.JPG (225.93 KB, 1024x768 - viewed 116 times.)

Picture 2: Reel partially reassembled, no mechanical dogs on the dog posts.

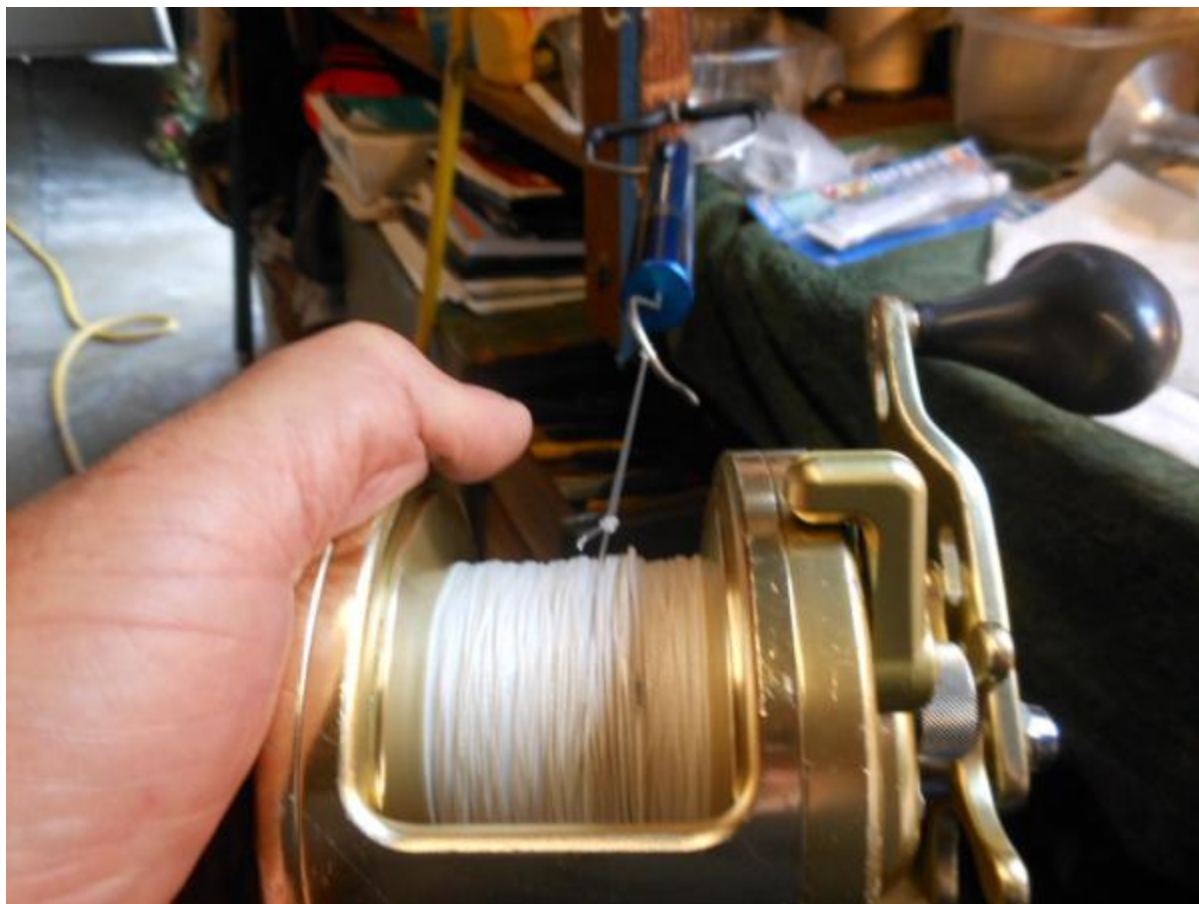
DSCN1661.JPG (227.05 KB, 1024x768 - viewed 116 times.)

3) When I attempted to set 27.5 pounds setting of drag pressure on the anti reverse bearing, I noticed that just as I was reaching 27 pounds on the scale the star started to slowly rotate backwards. It wasn't a dramatic move, it made no noise, it didn't "jump" when it reached it's maximum pressure, it just started to slowly attempt to release that pressure. I think the movement was the tube that is inside the bearing was rotating. My belief is that the rollers weren't turning backwards but I don't know how to test this so I'm absolutely not sure this is true.

Picture 3: Reel connected to the scale for the test described above.
