Servicing a Penn 9500 SS Spinning Reel

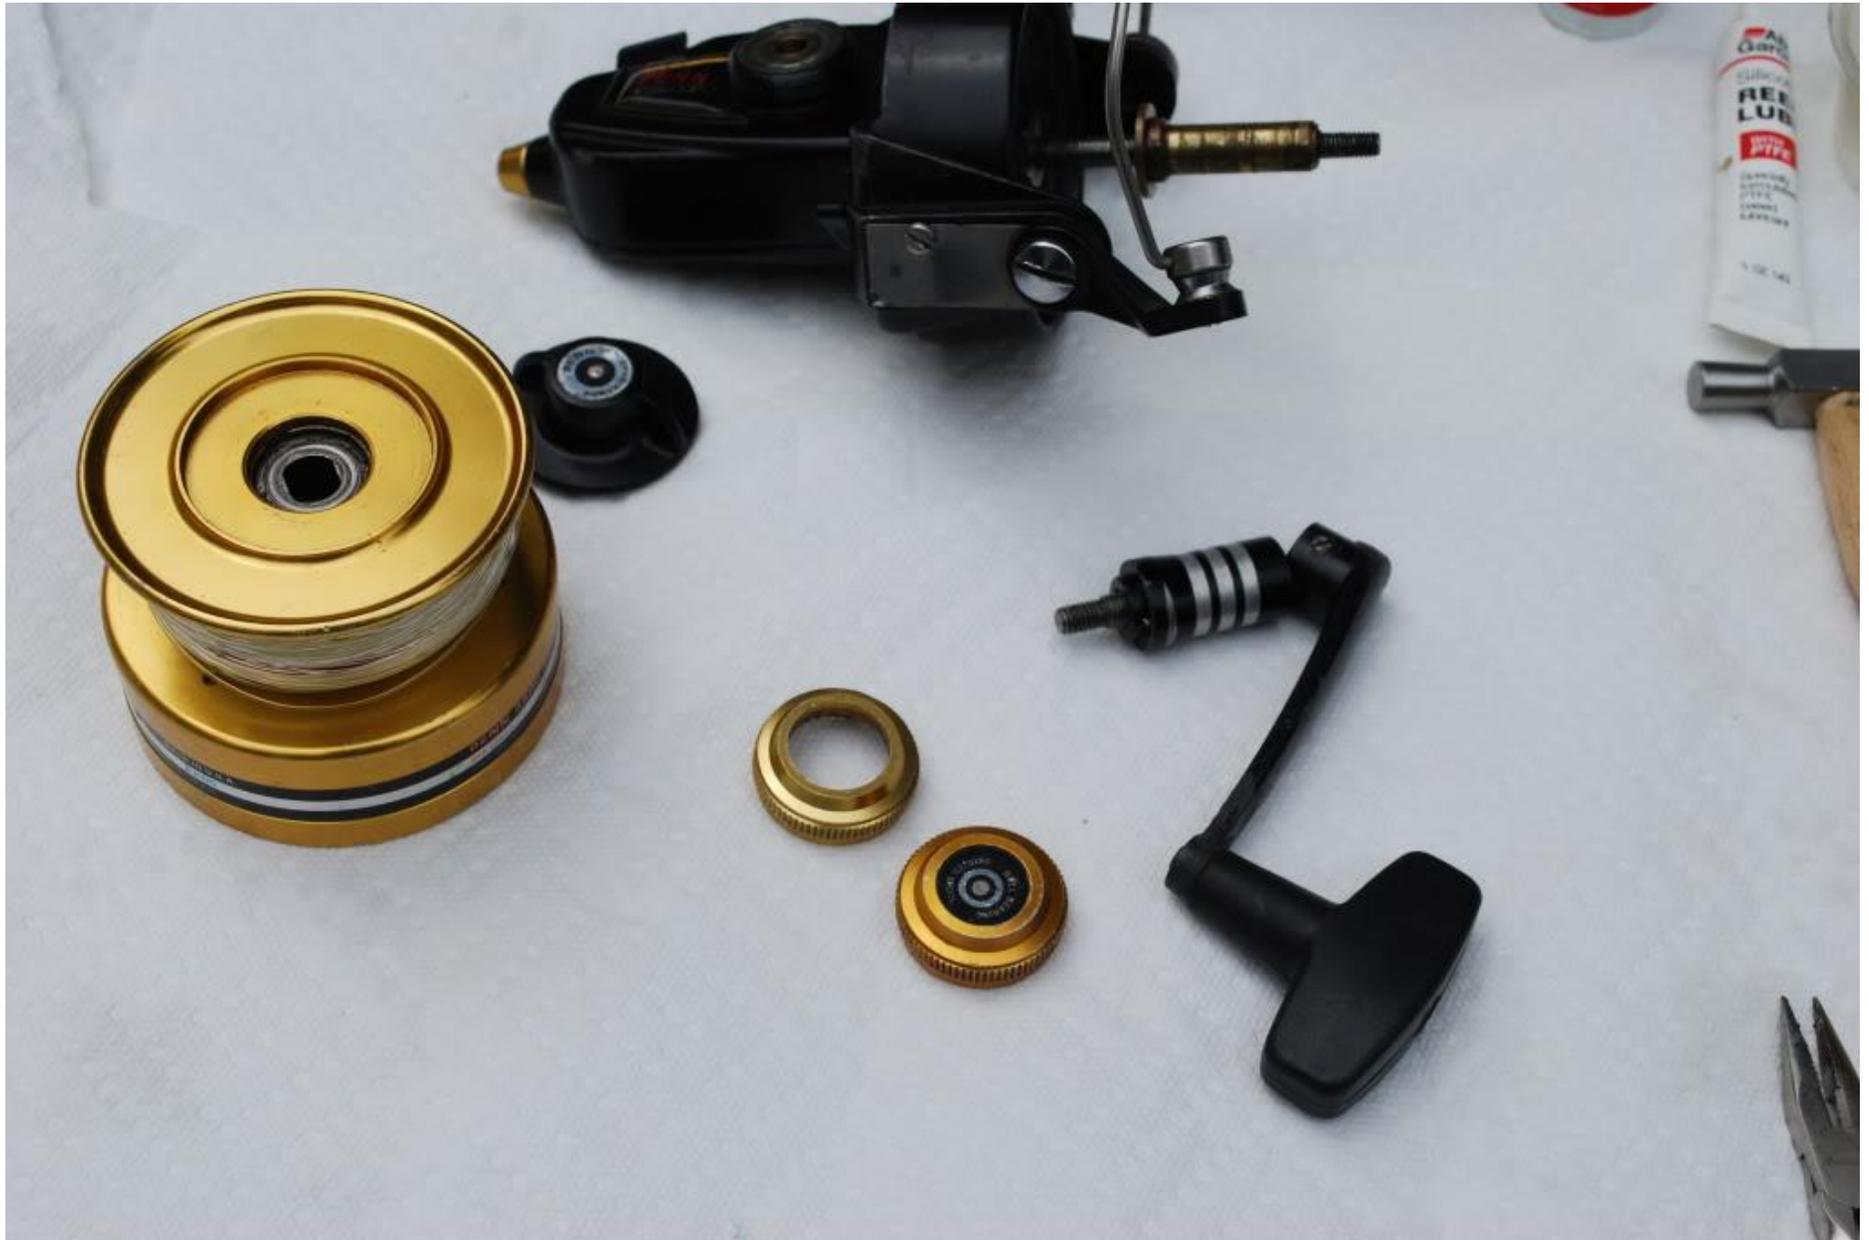
I started by removing the handle and spool, key #15 and 47.

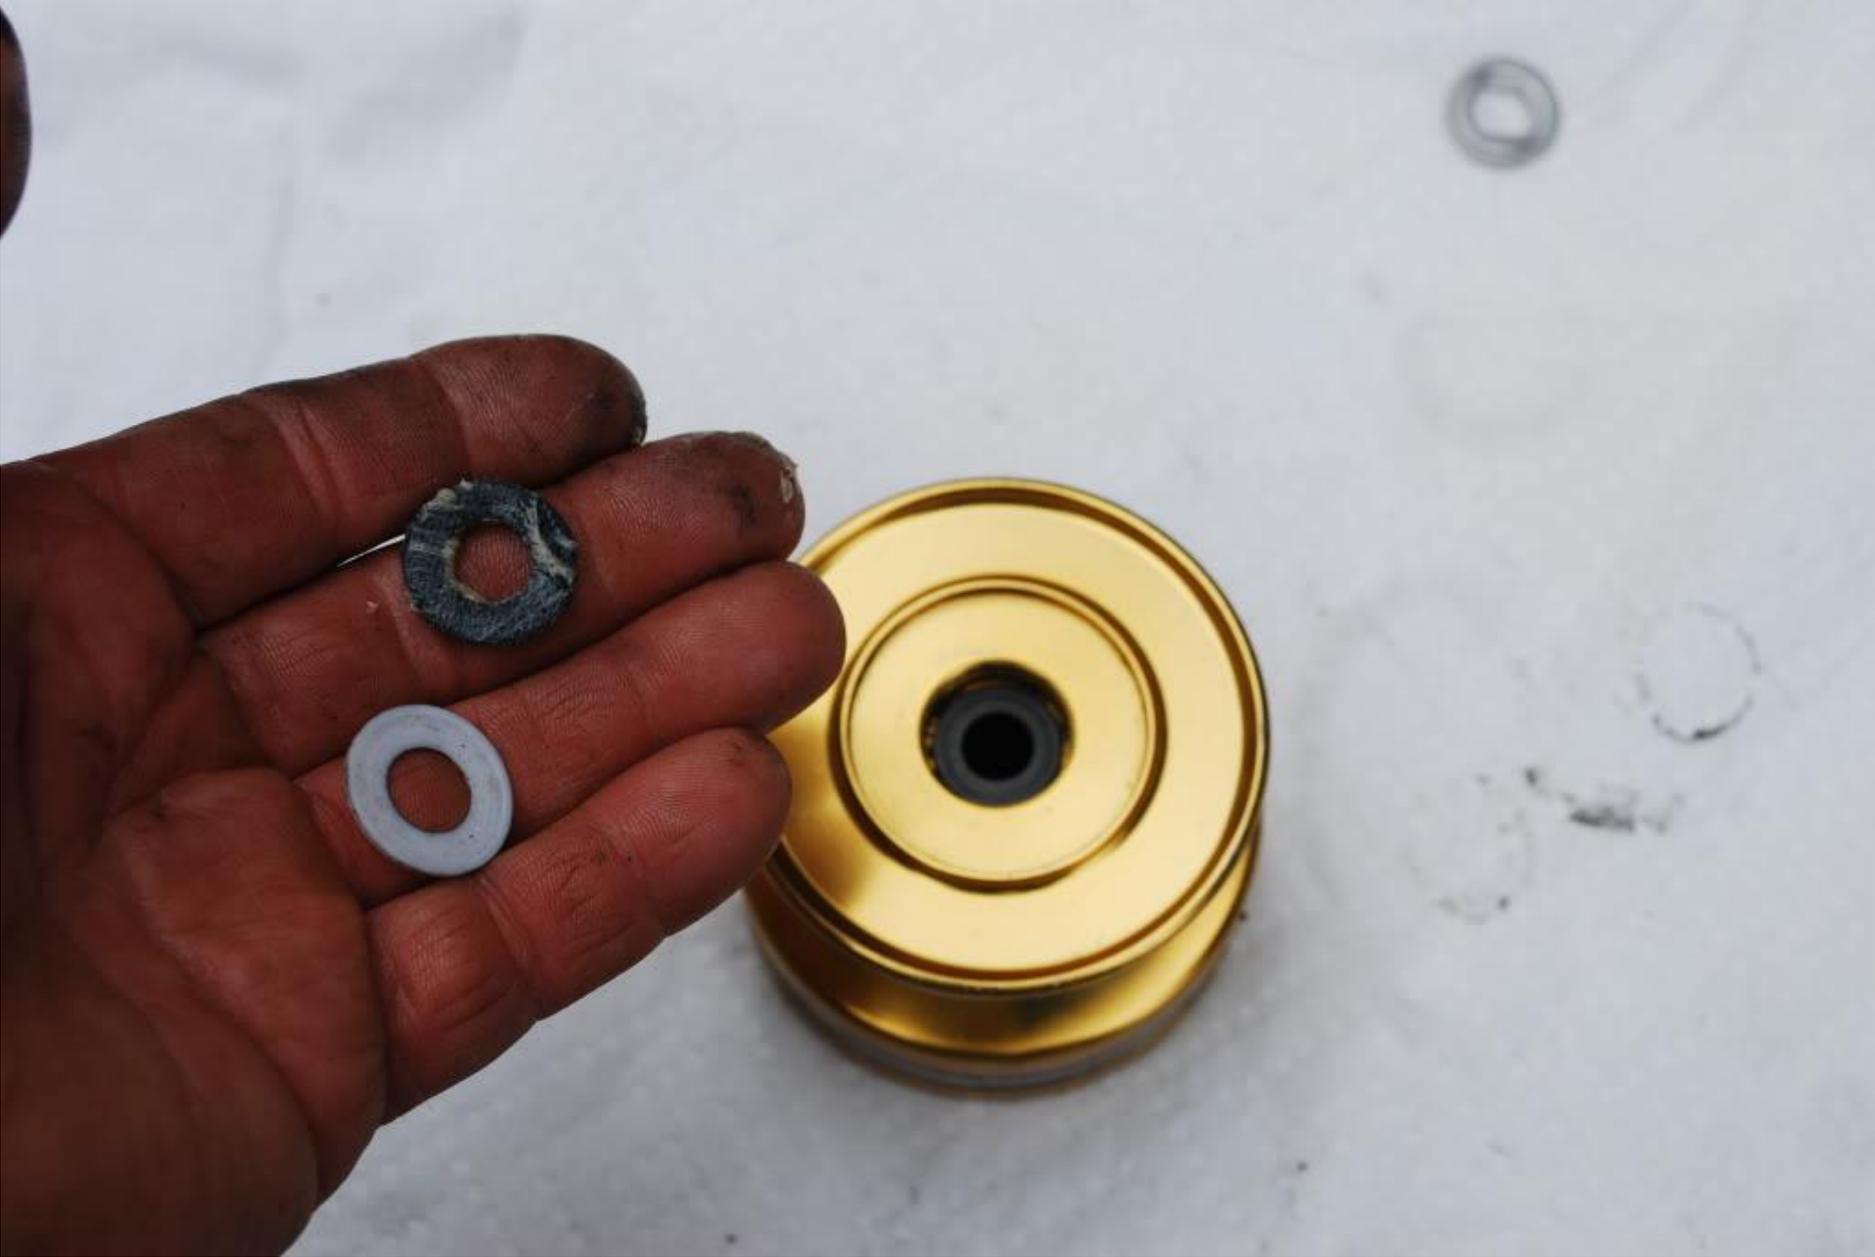
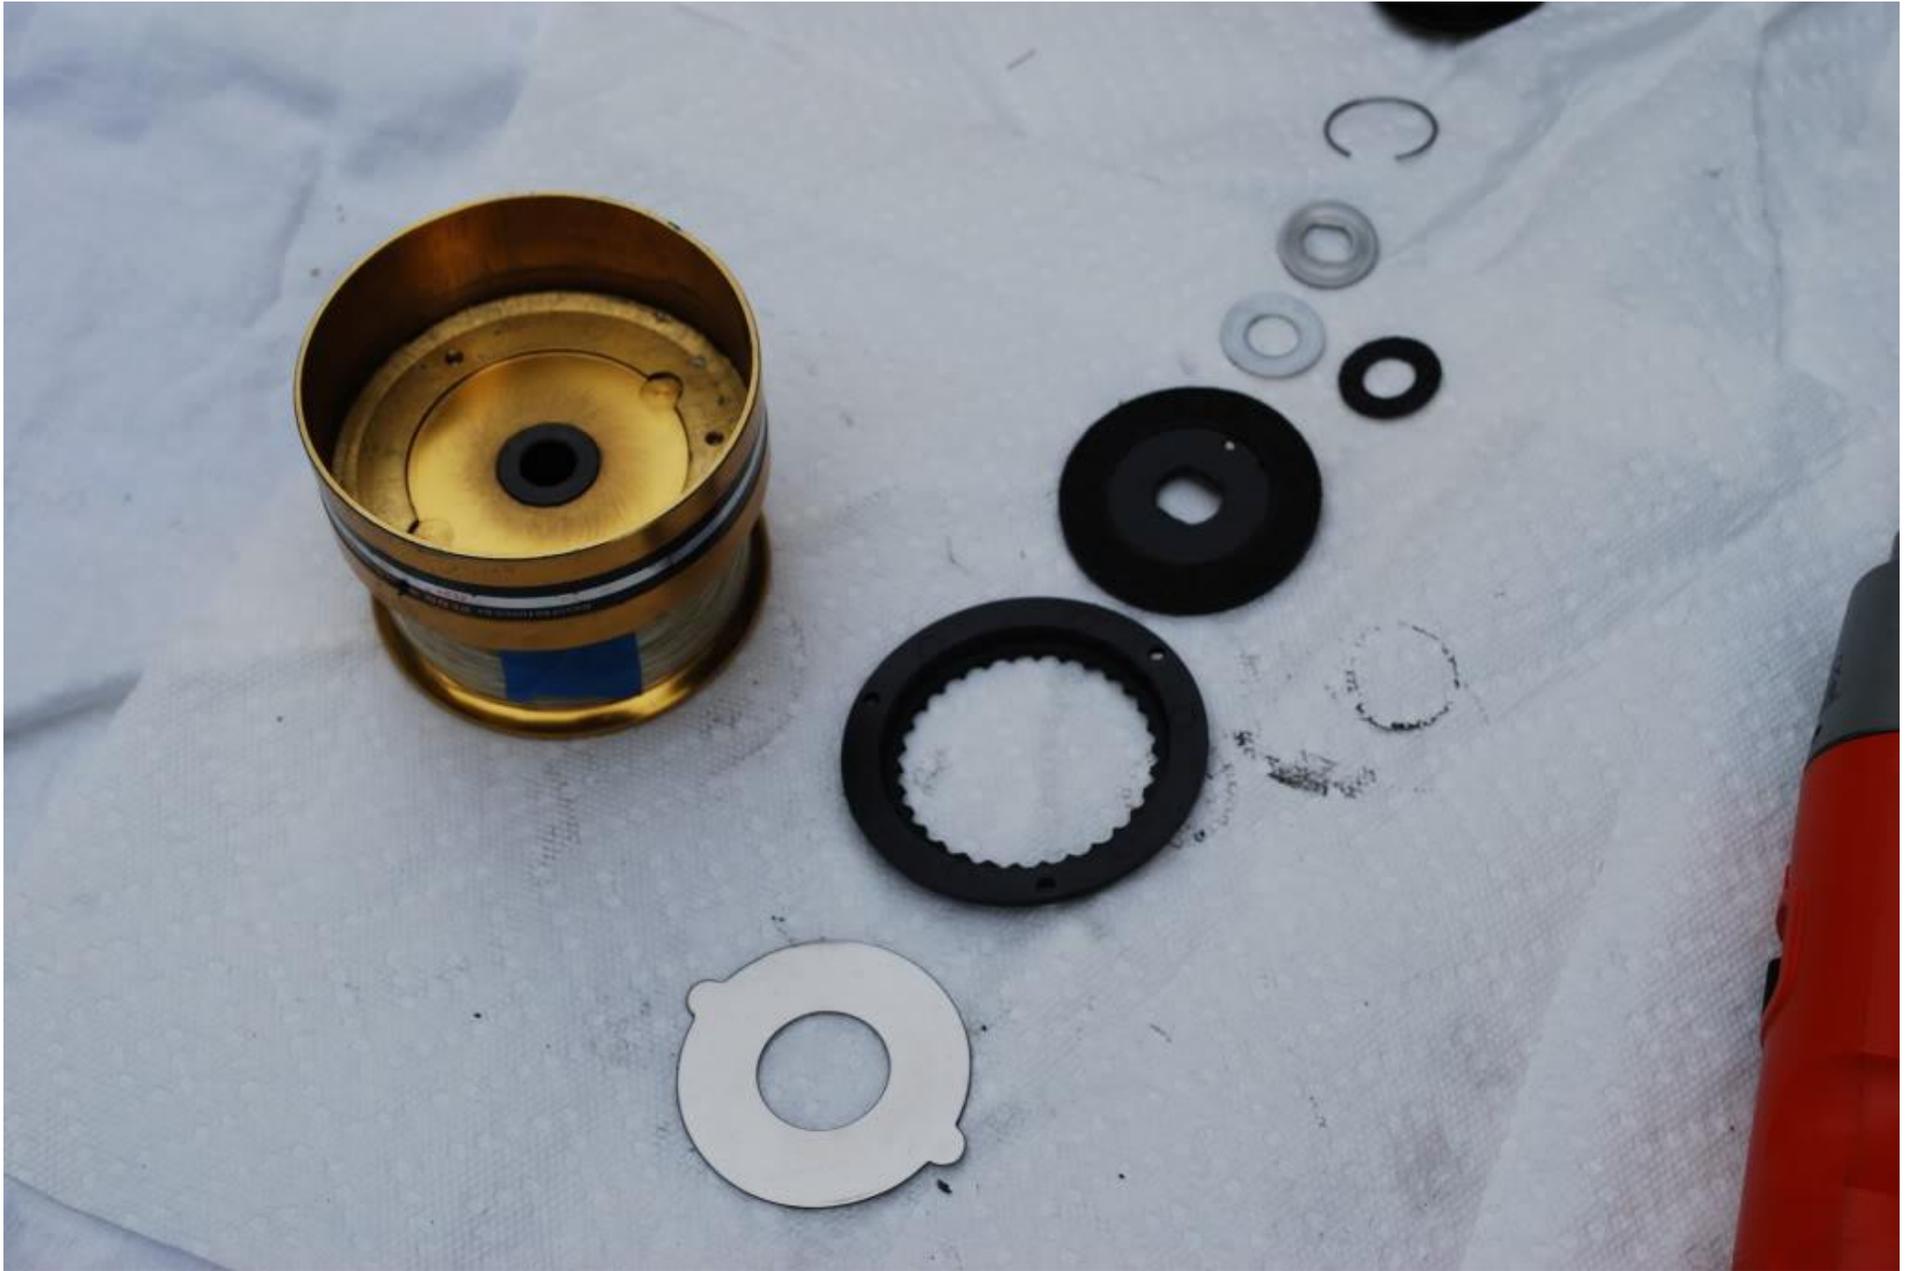
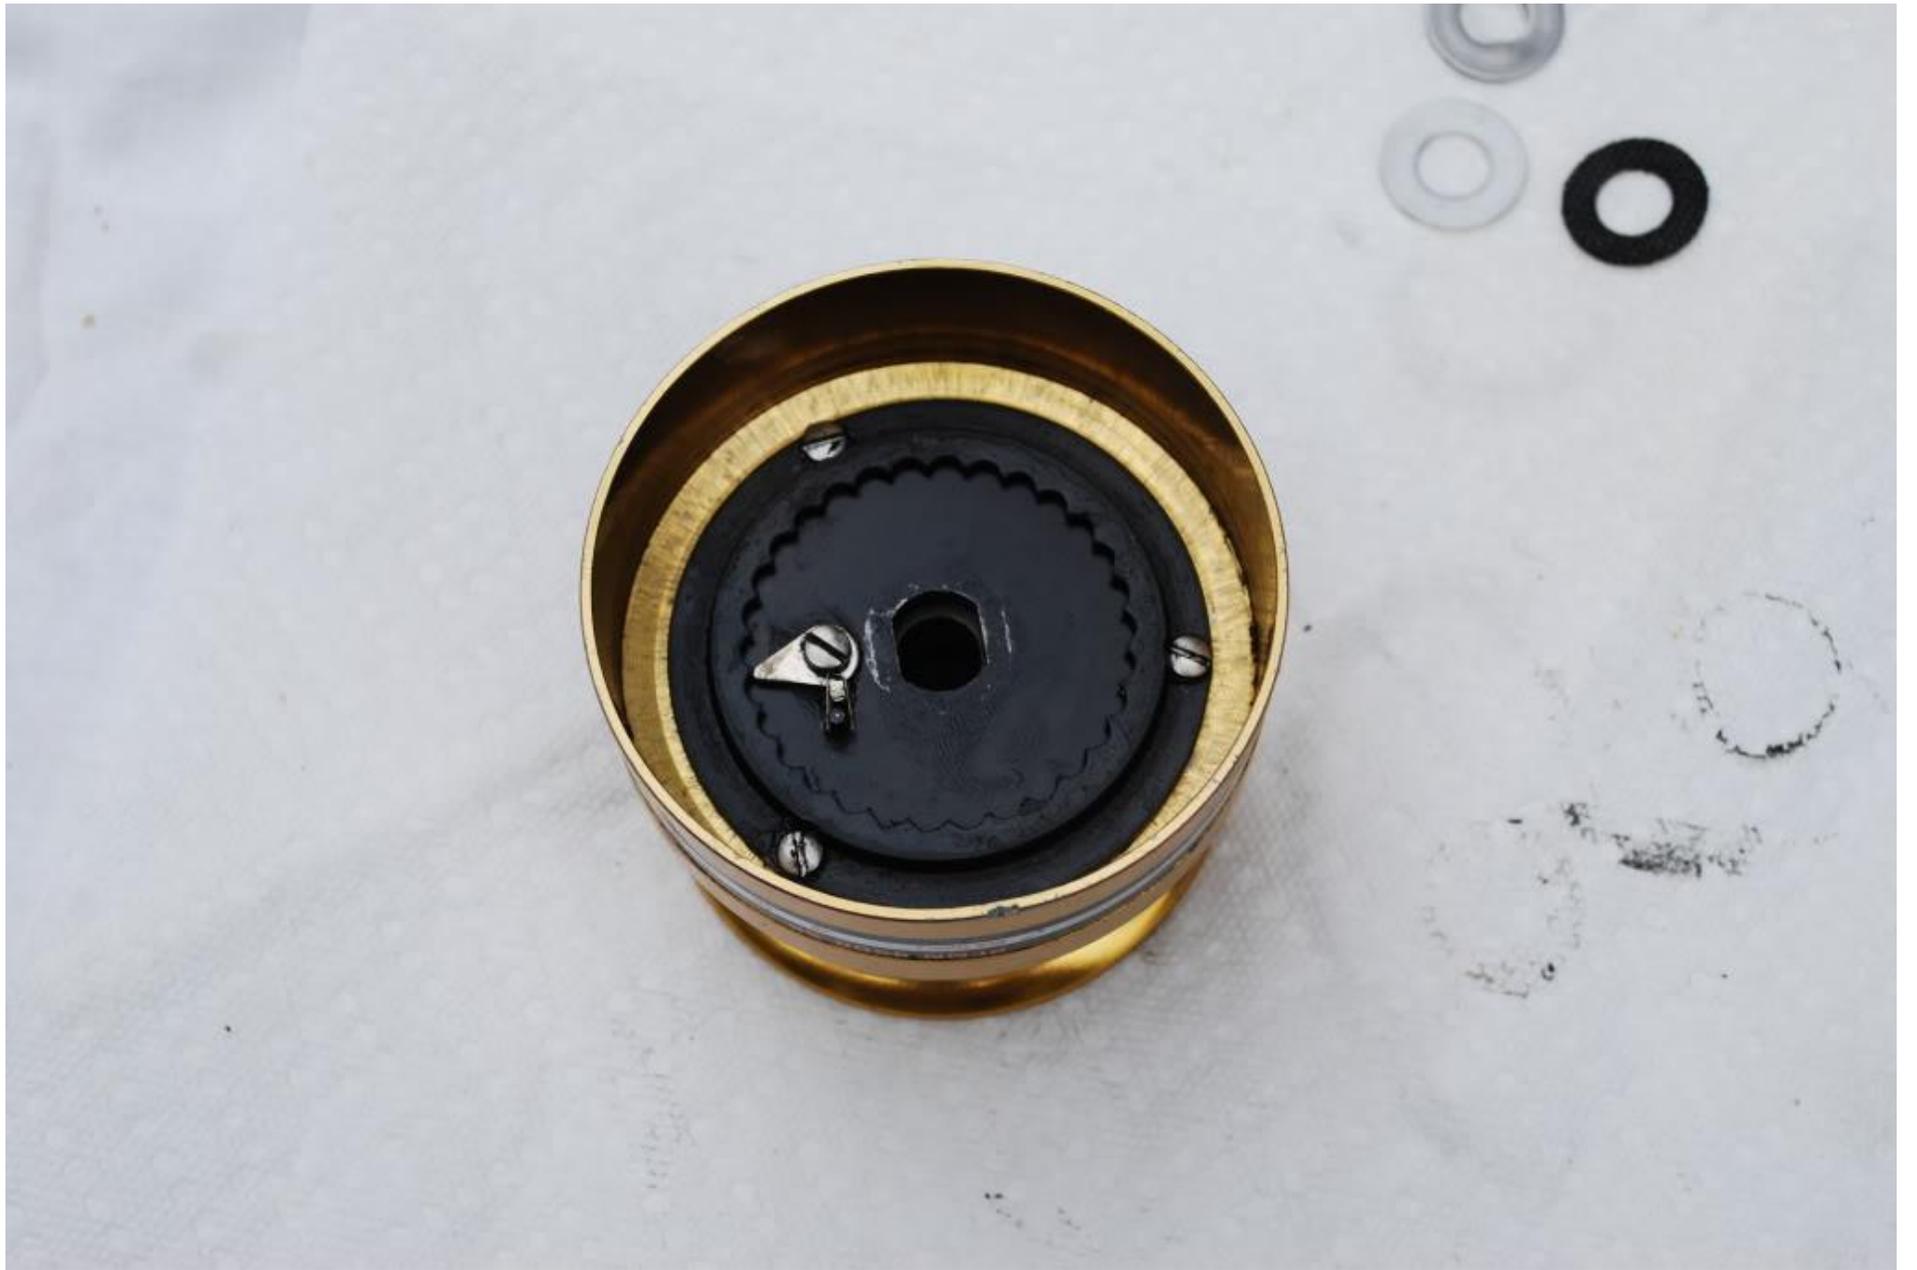
I then checked the drags. The drag washer and drag plate looked good, key #117. I replaced the Teflon washer (key #56t) with a carbon washer.

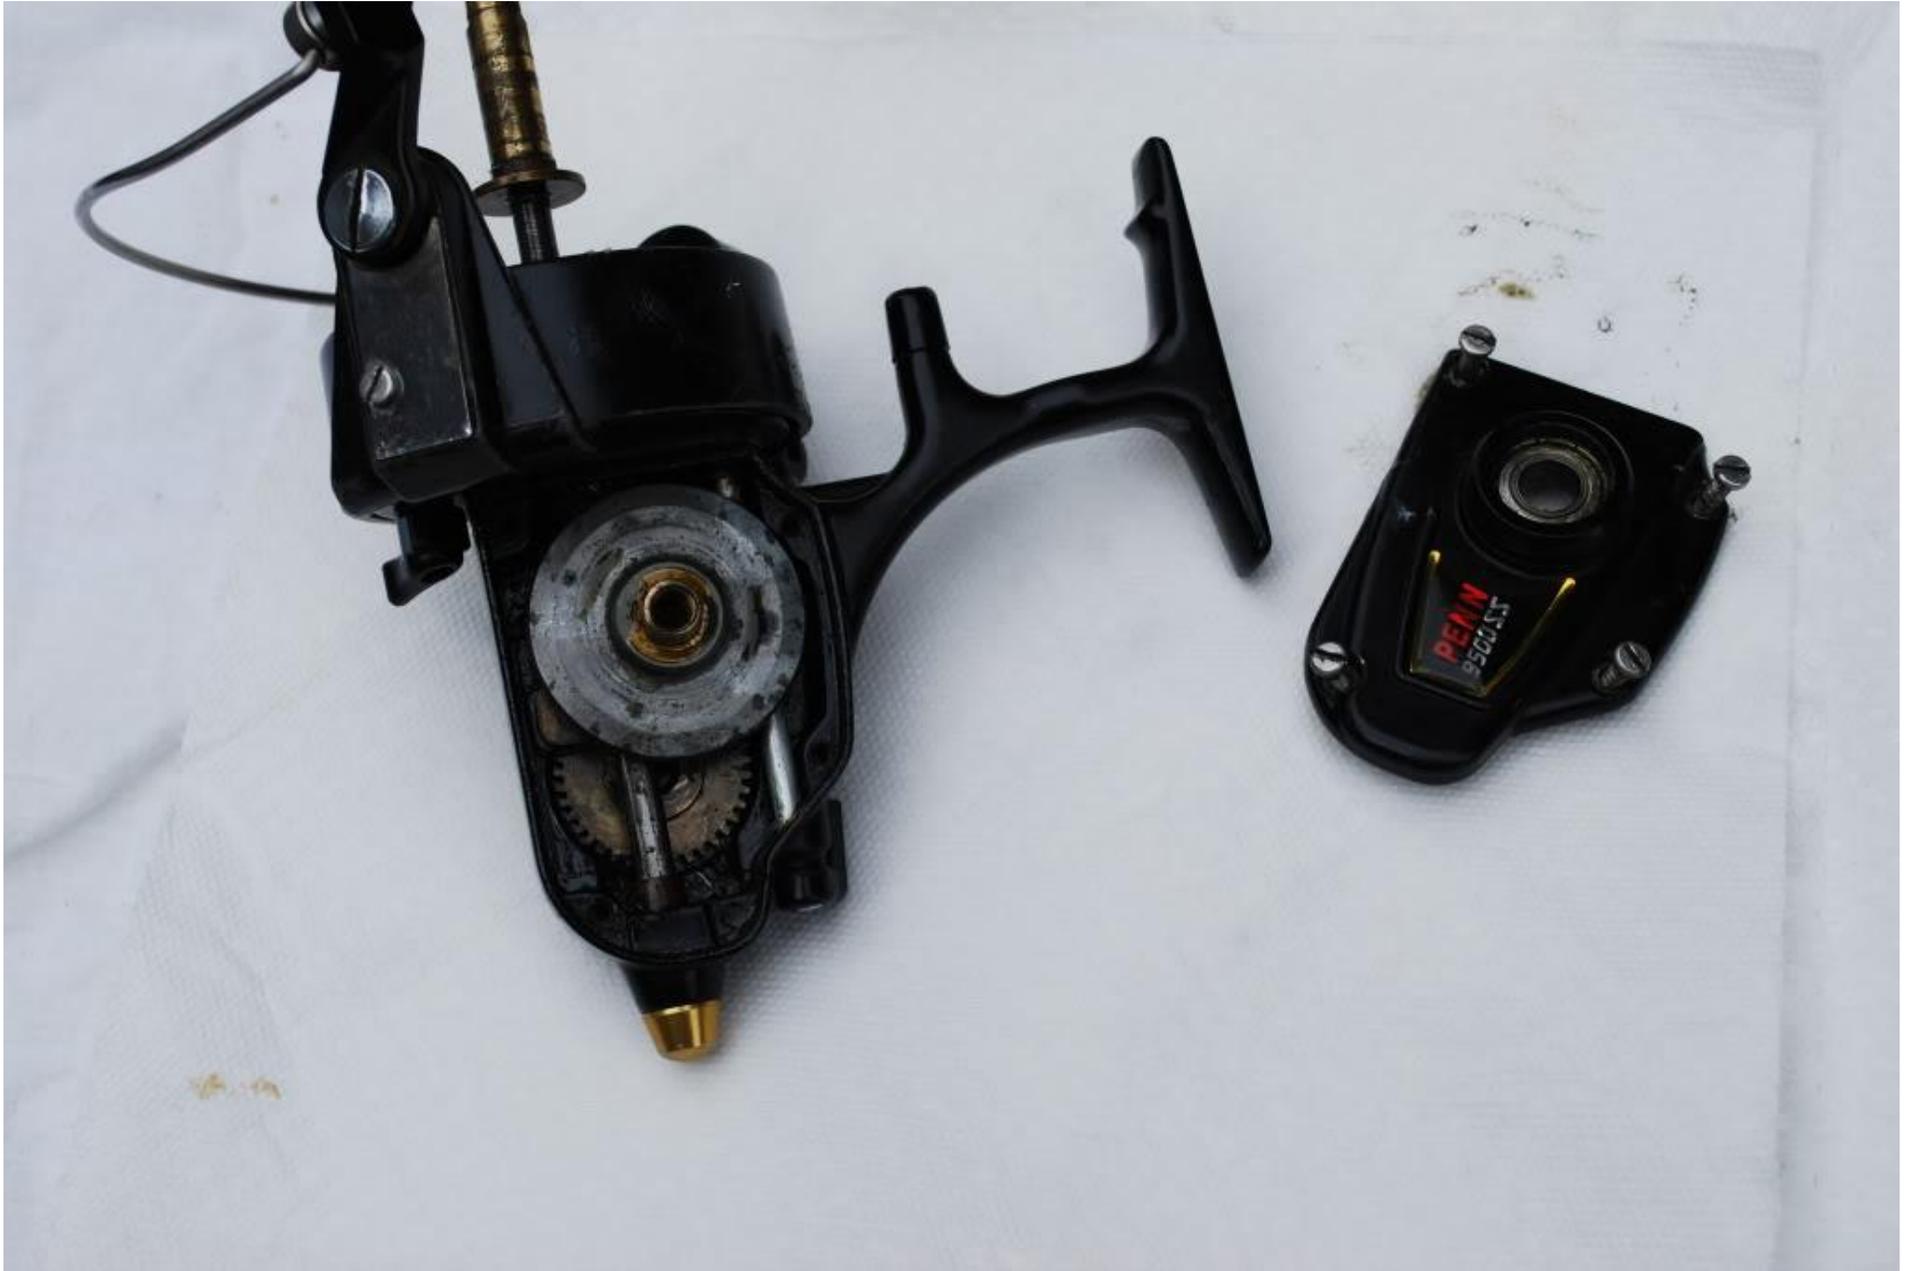
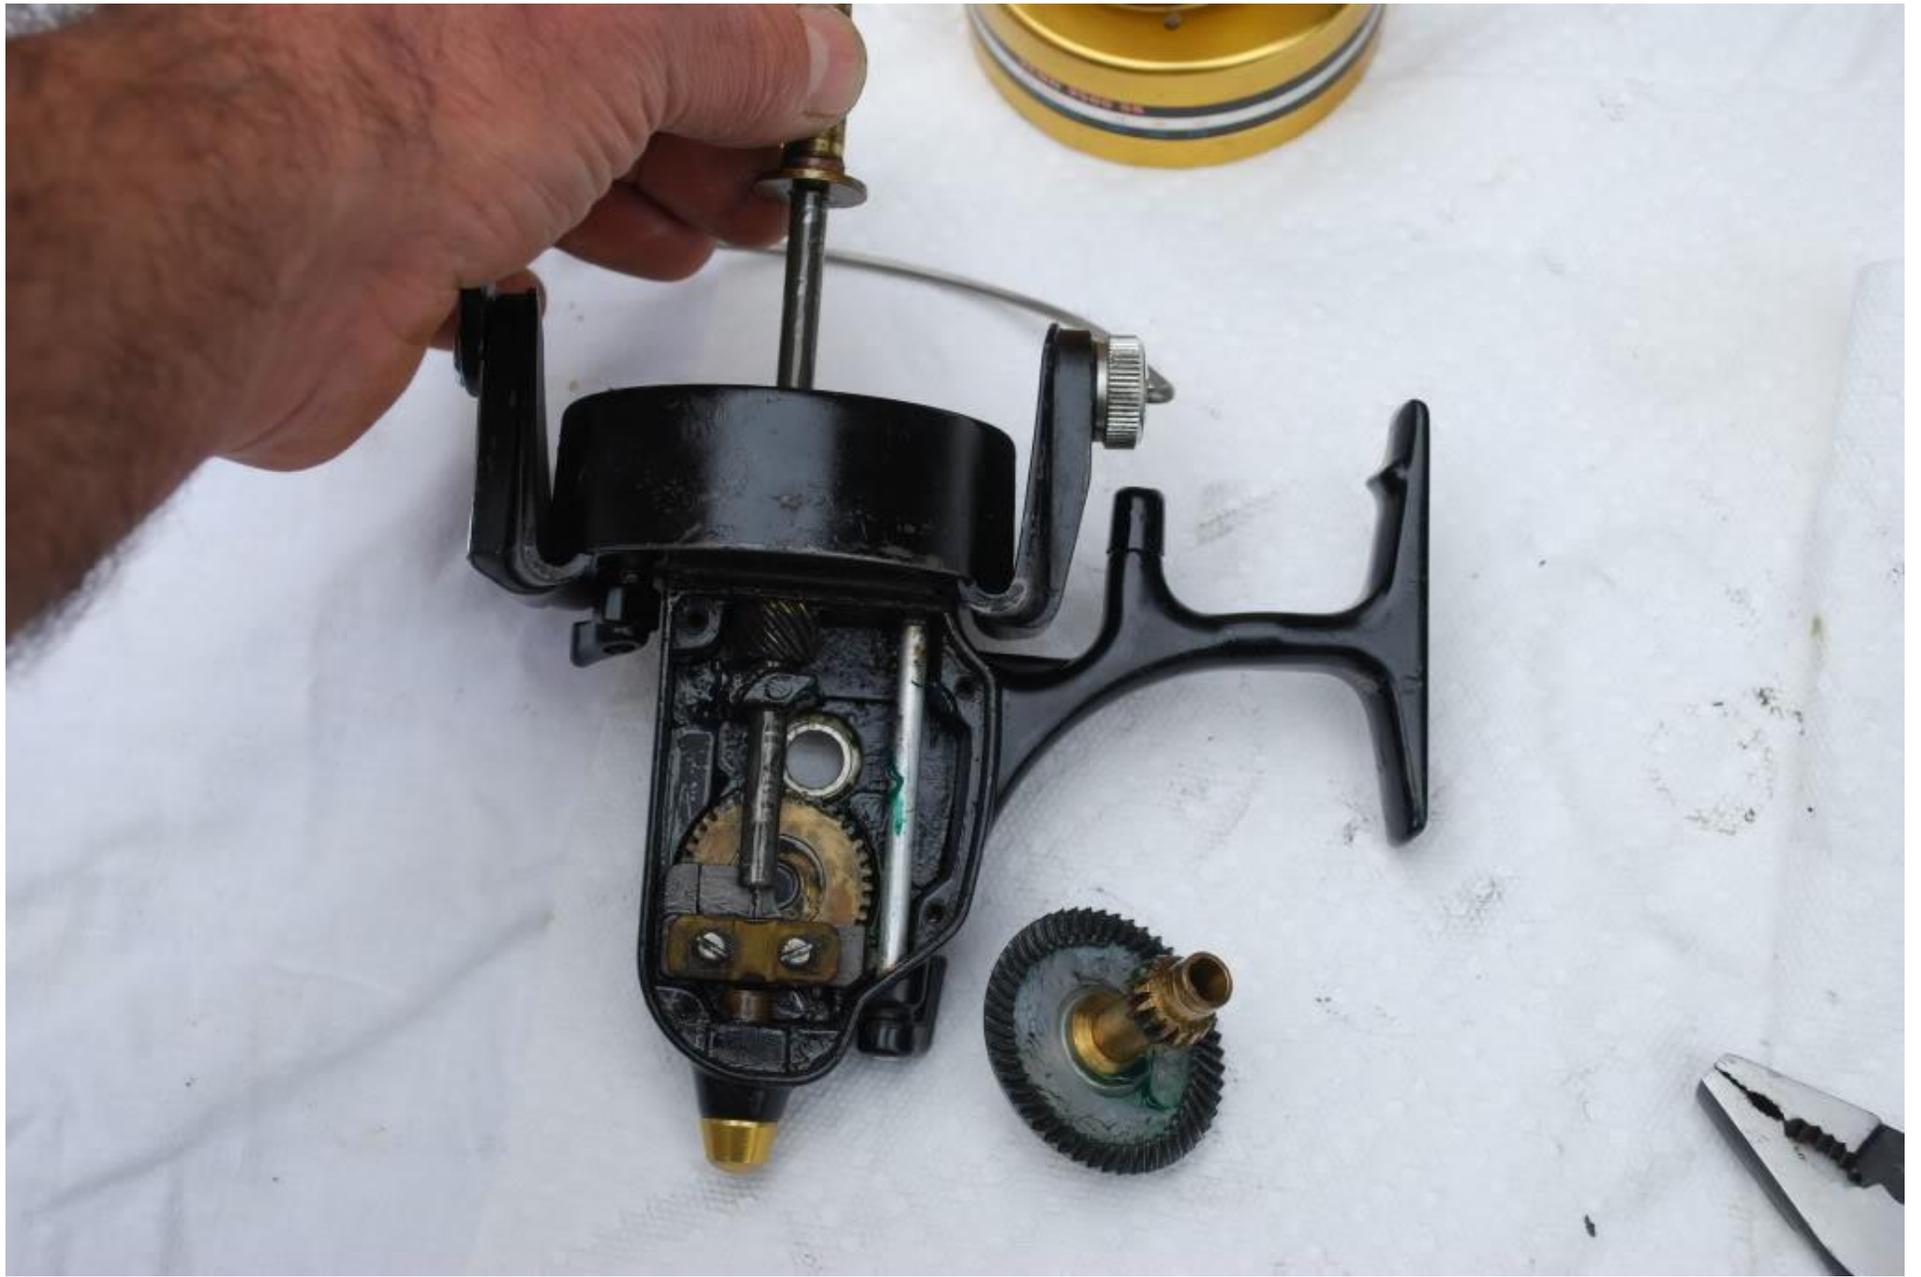
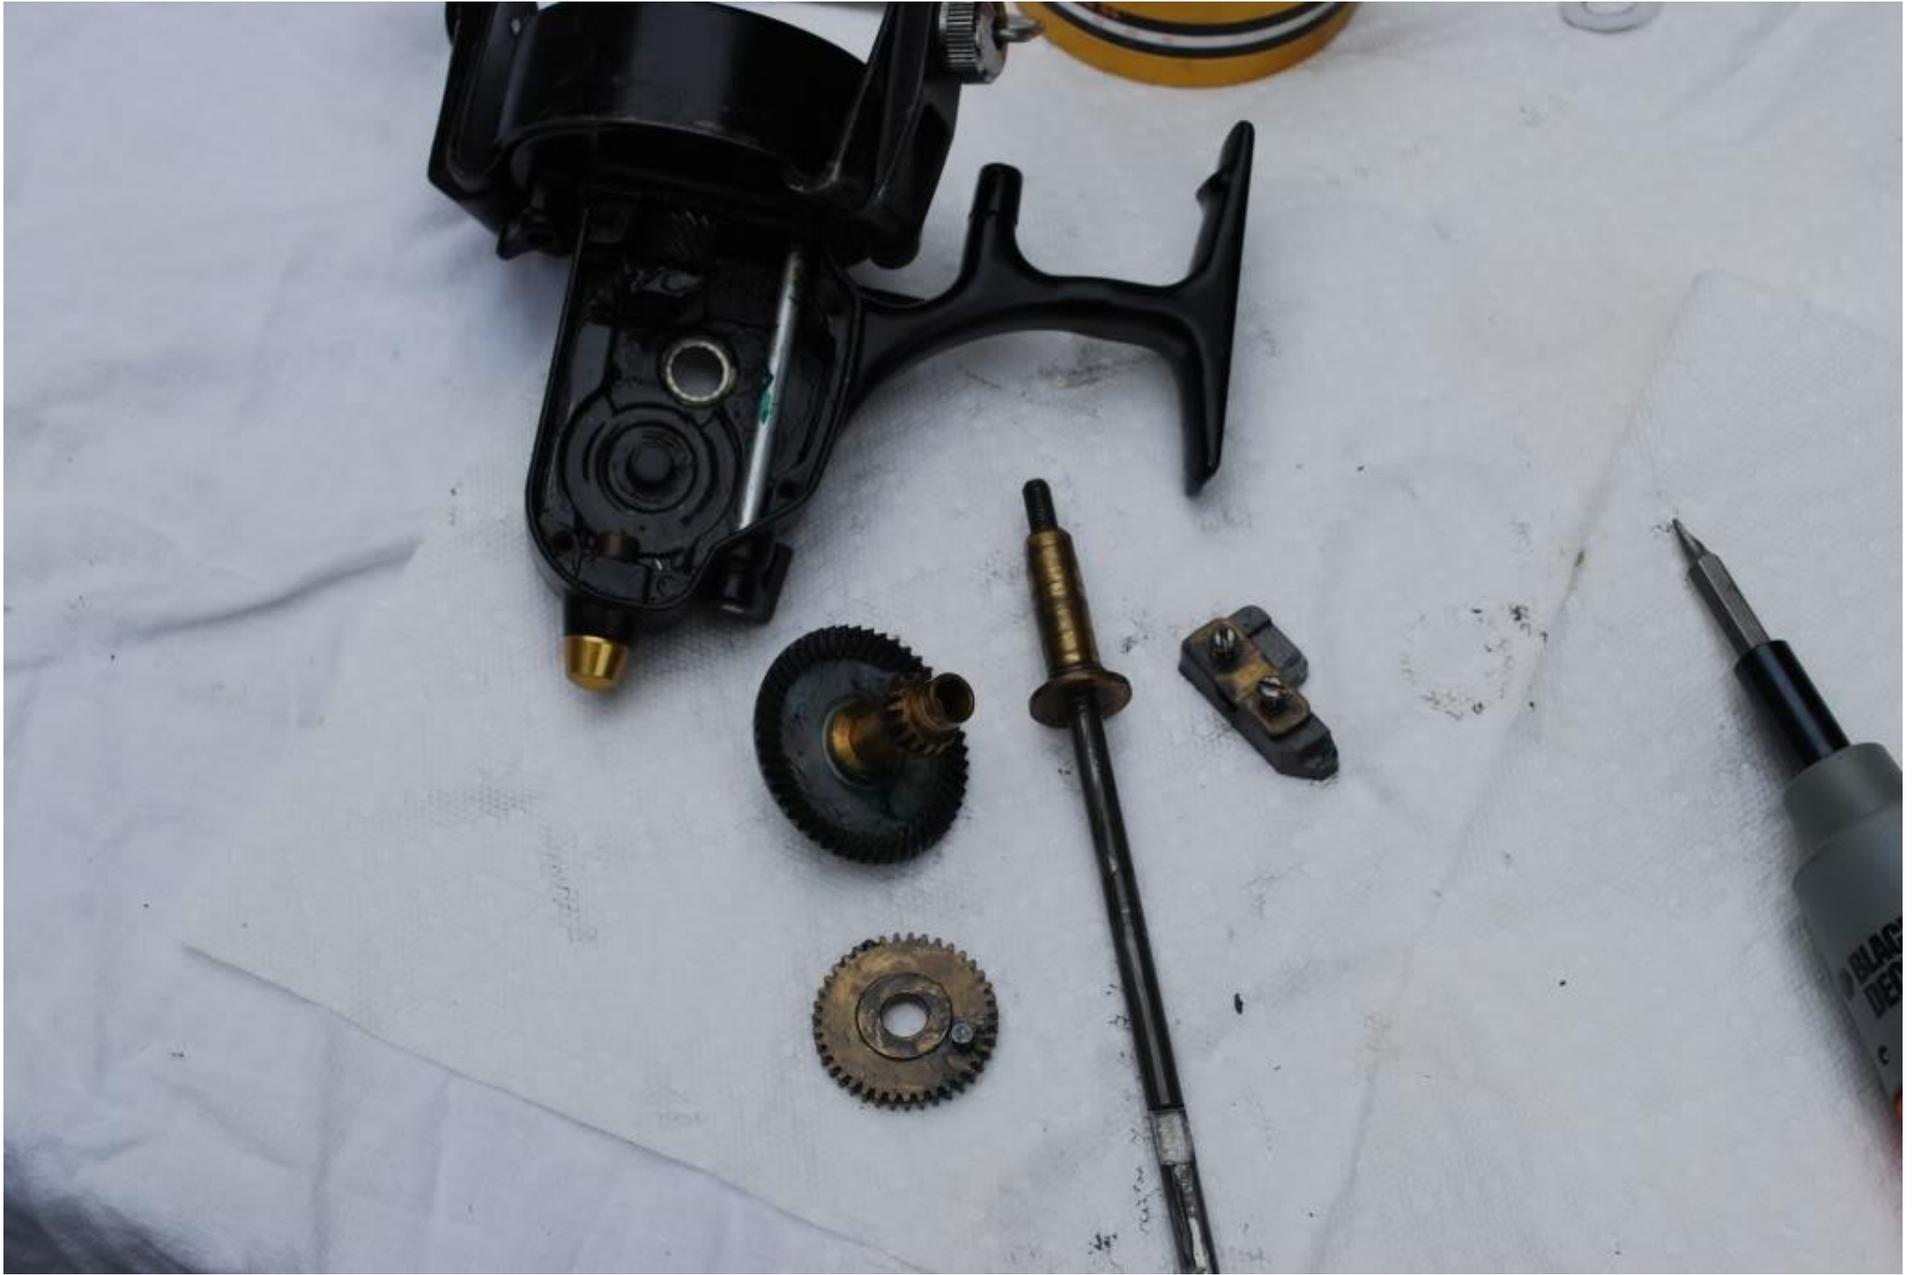
I then removed the plate and pulled the main gear out, key #8. I also removed the spool shaft, #39.

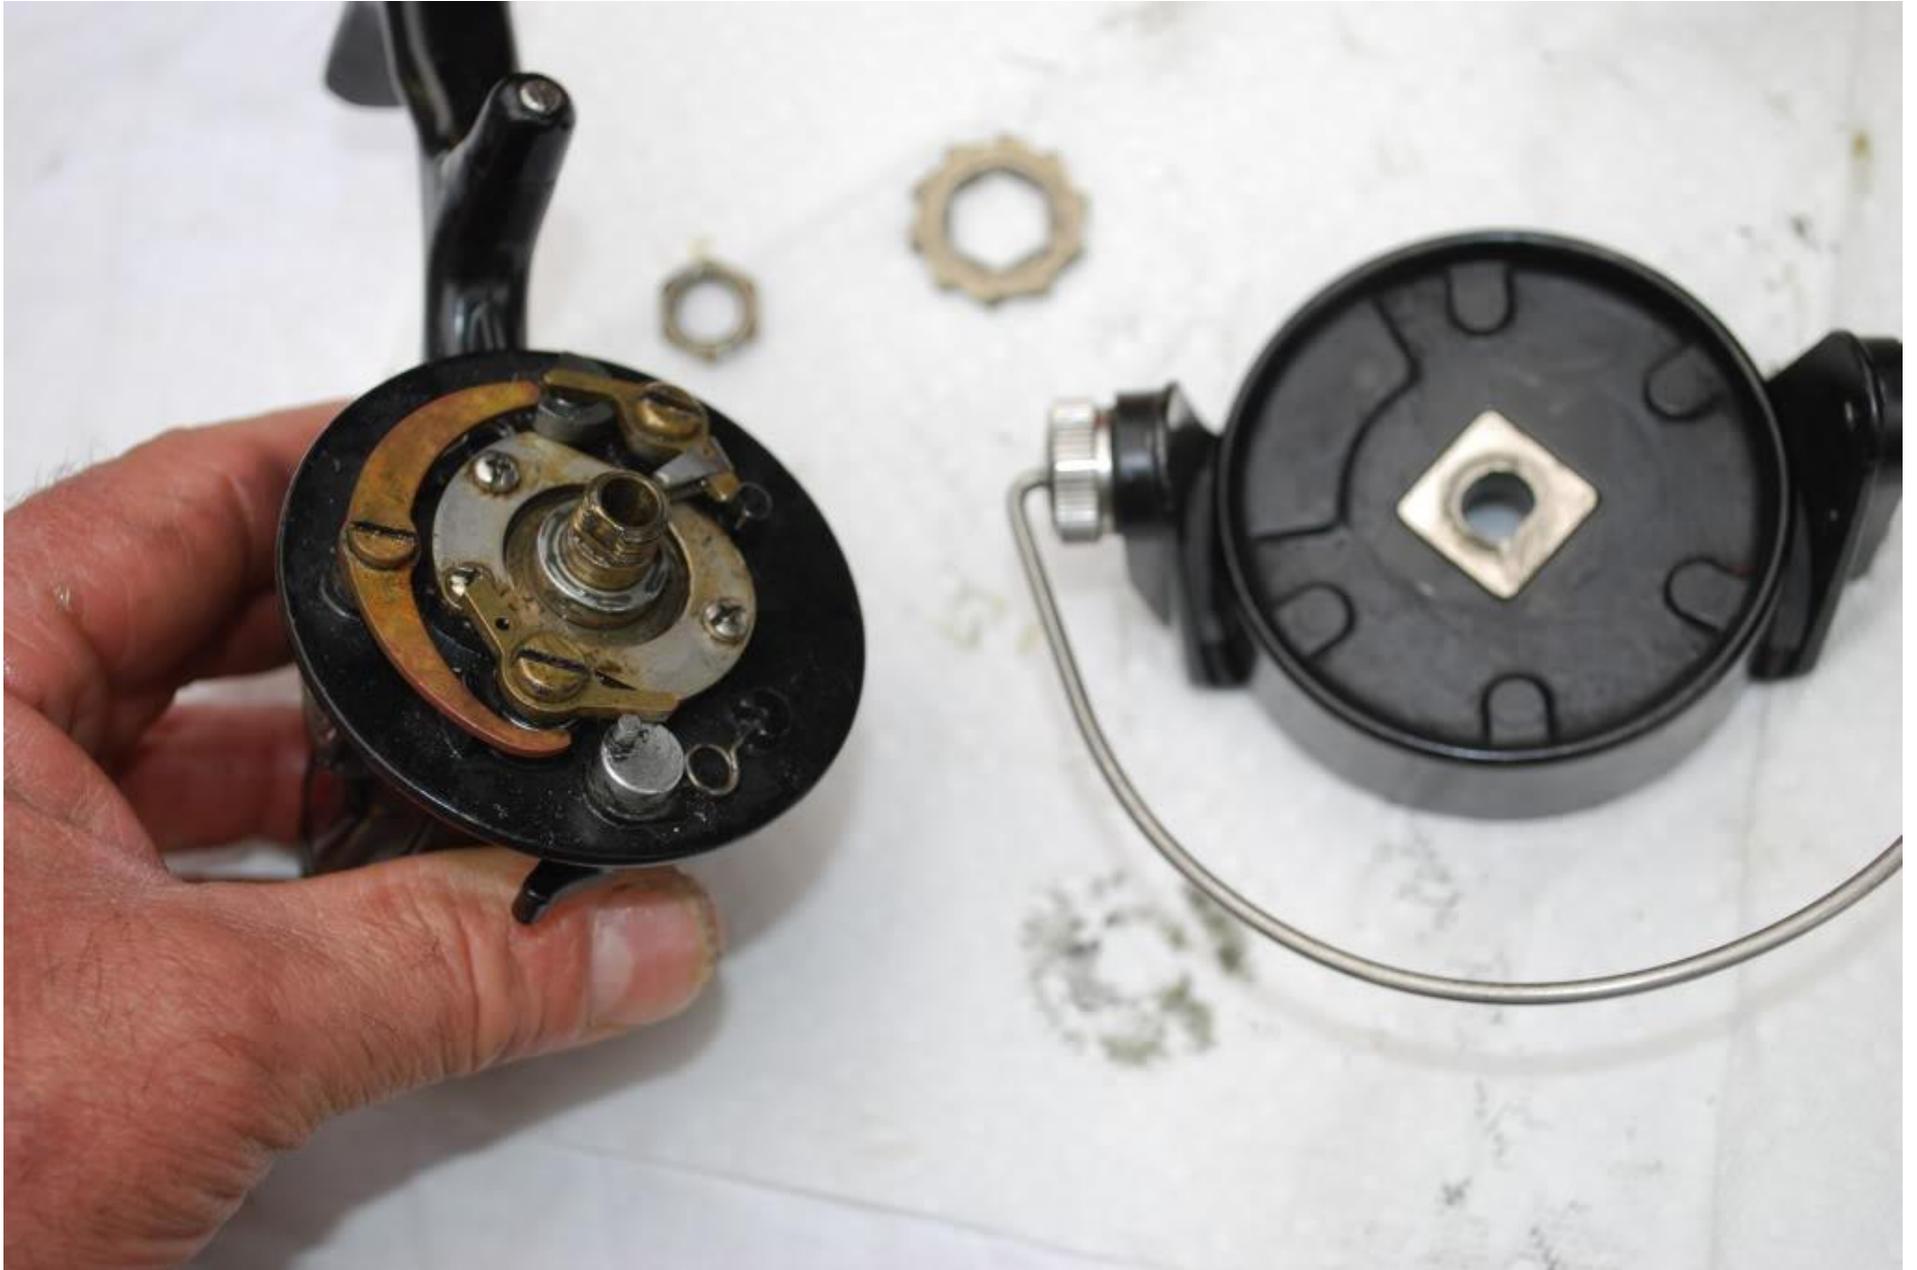
I then removed the transfer lever, the dog, and silent dog, key #4 and 4a. I also removed the bearing cover, the upper eccentric, and the silent eccentric, key #21, 6a, and 6l.

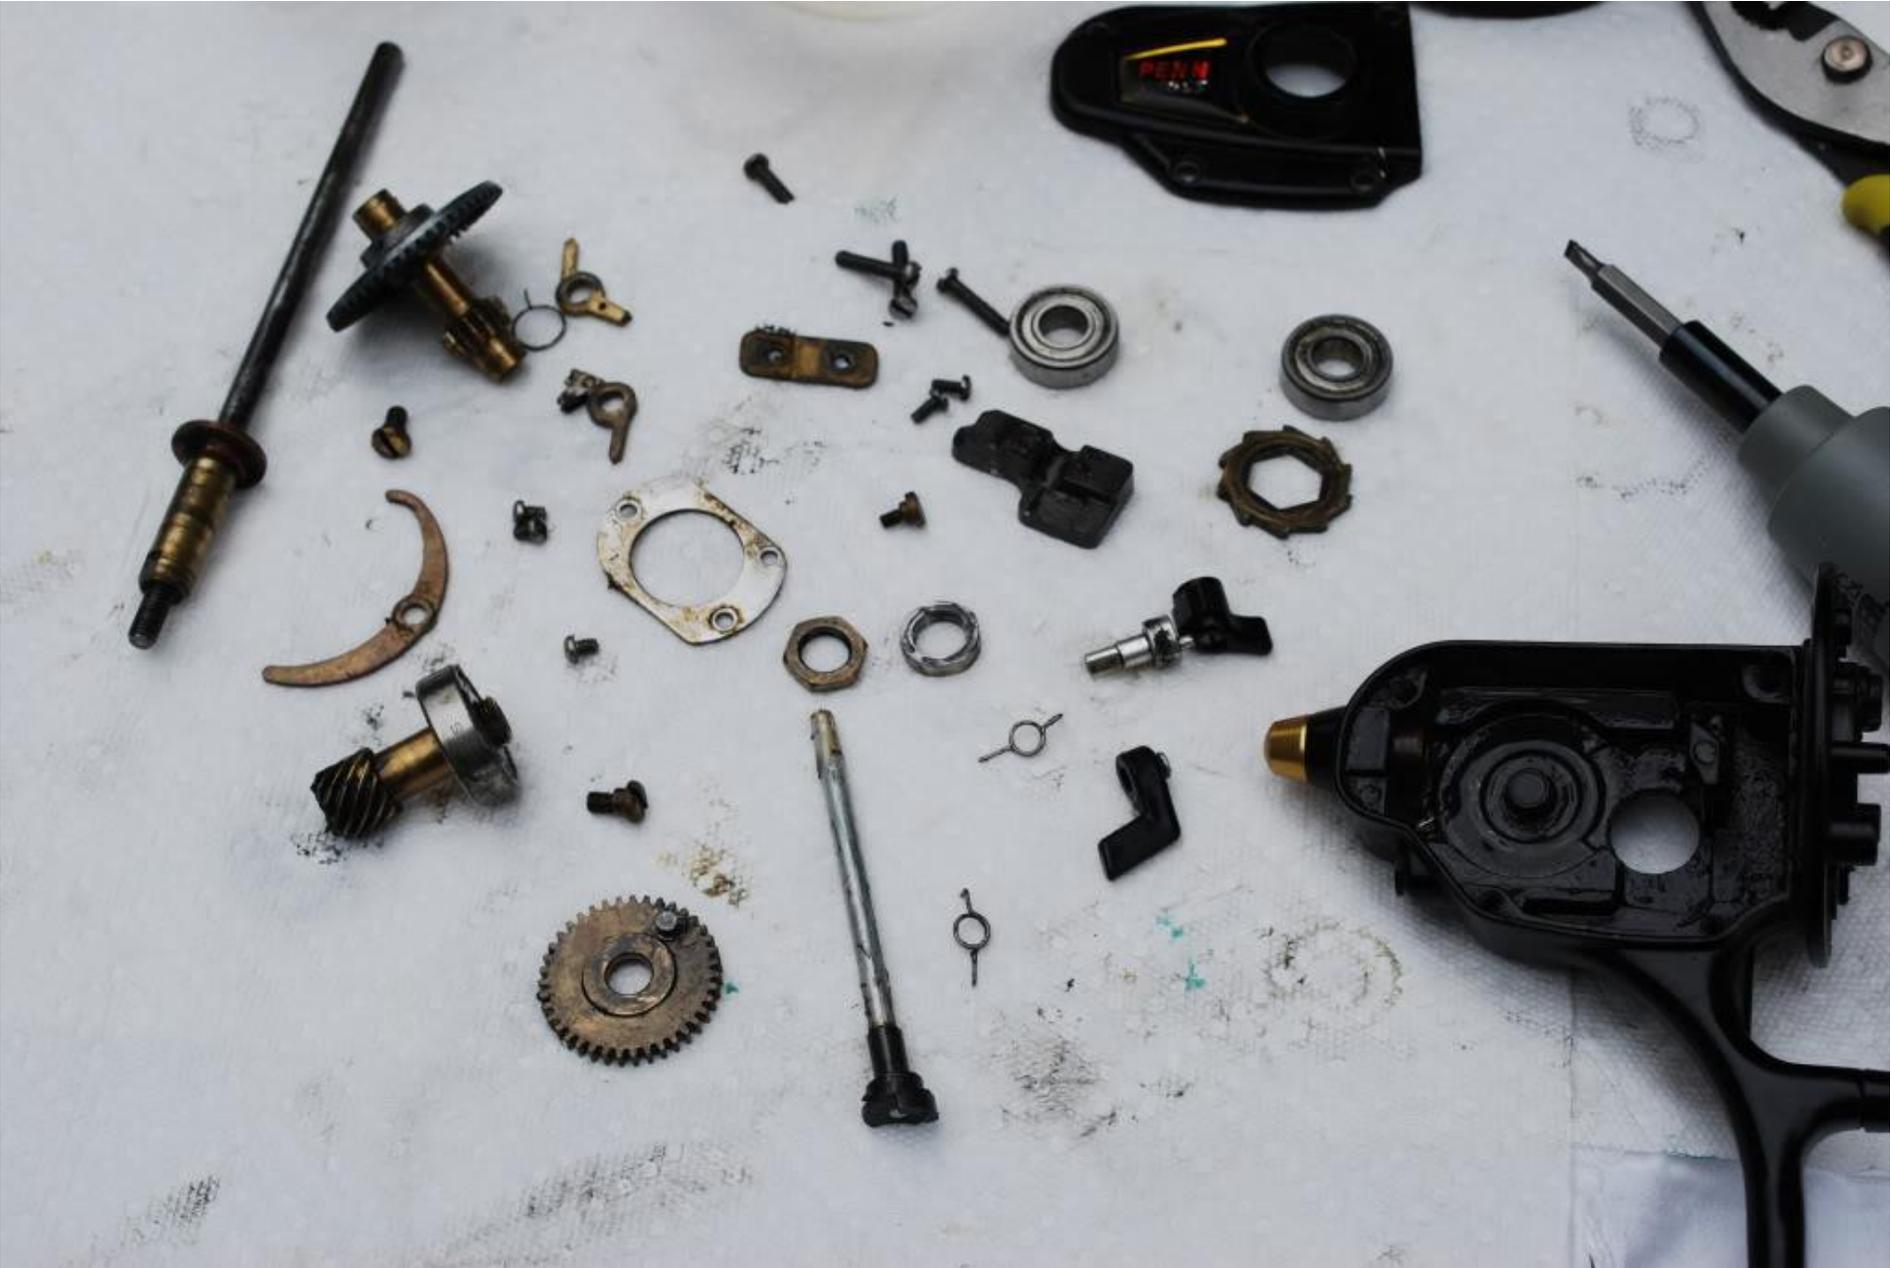
I then cleaned all parts and checked them.
