Servicing a Penn 9500 SS Spinning Reel

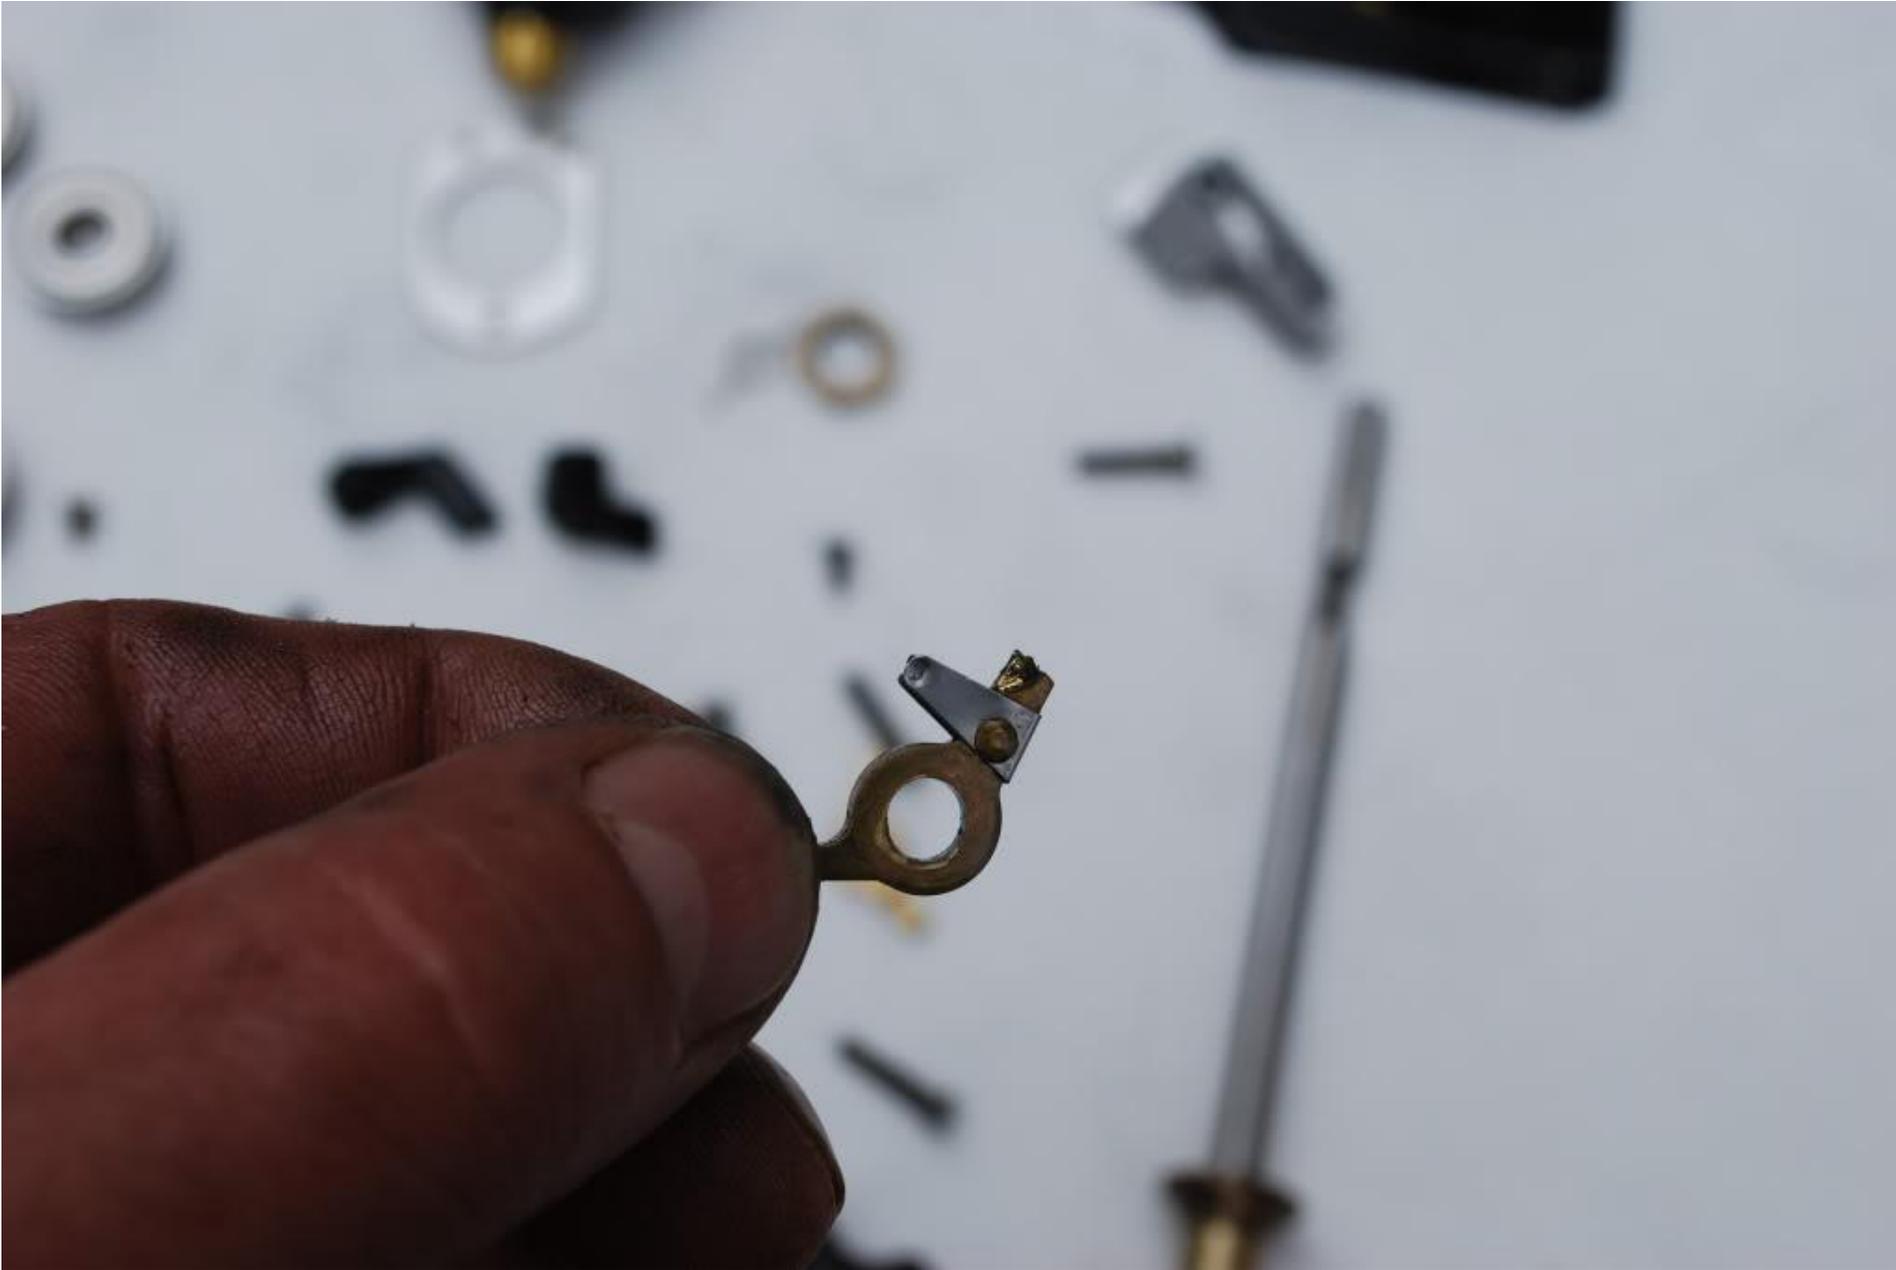
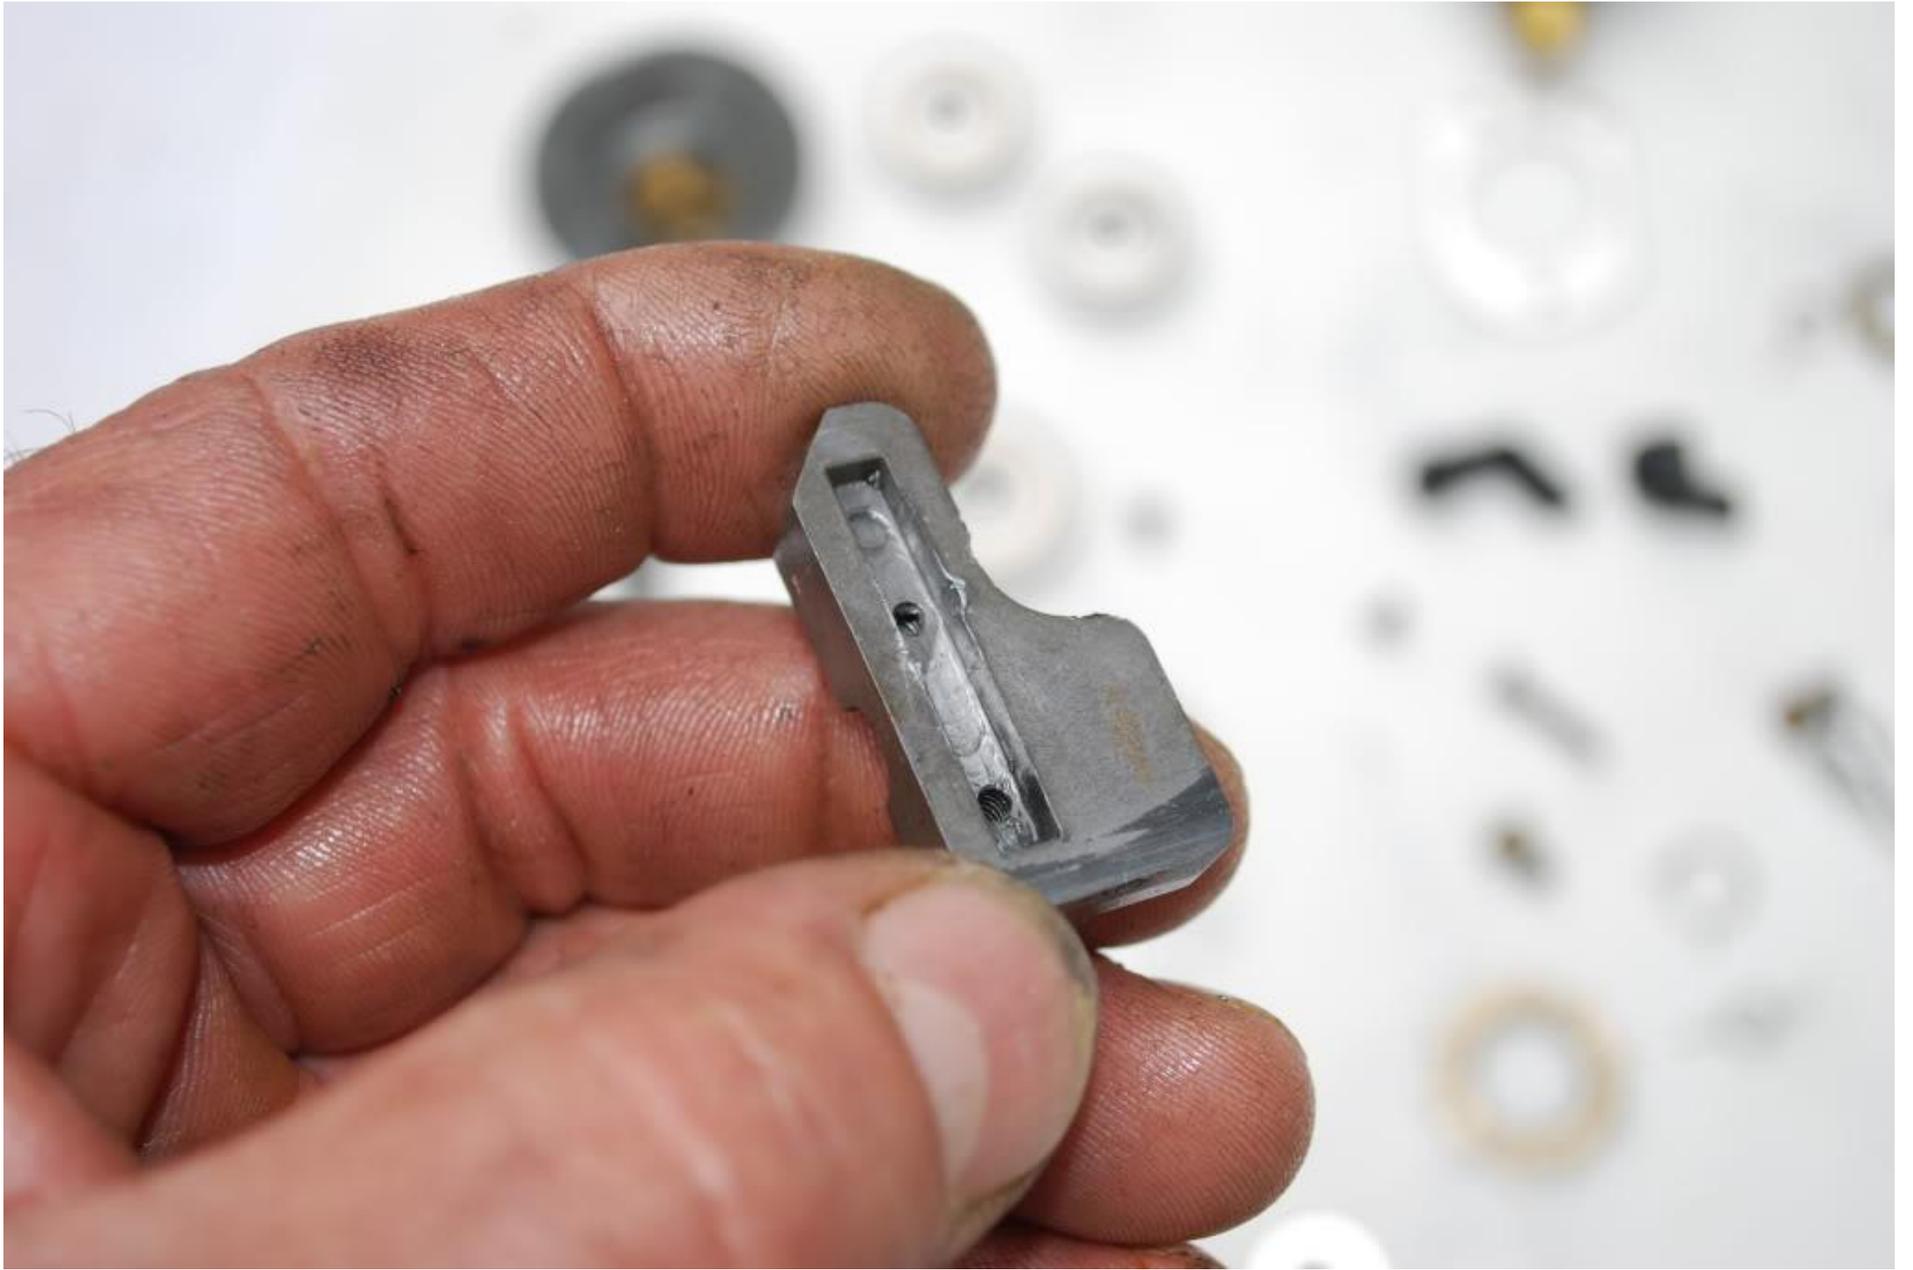
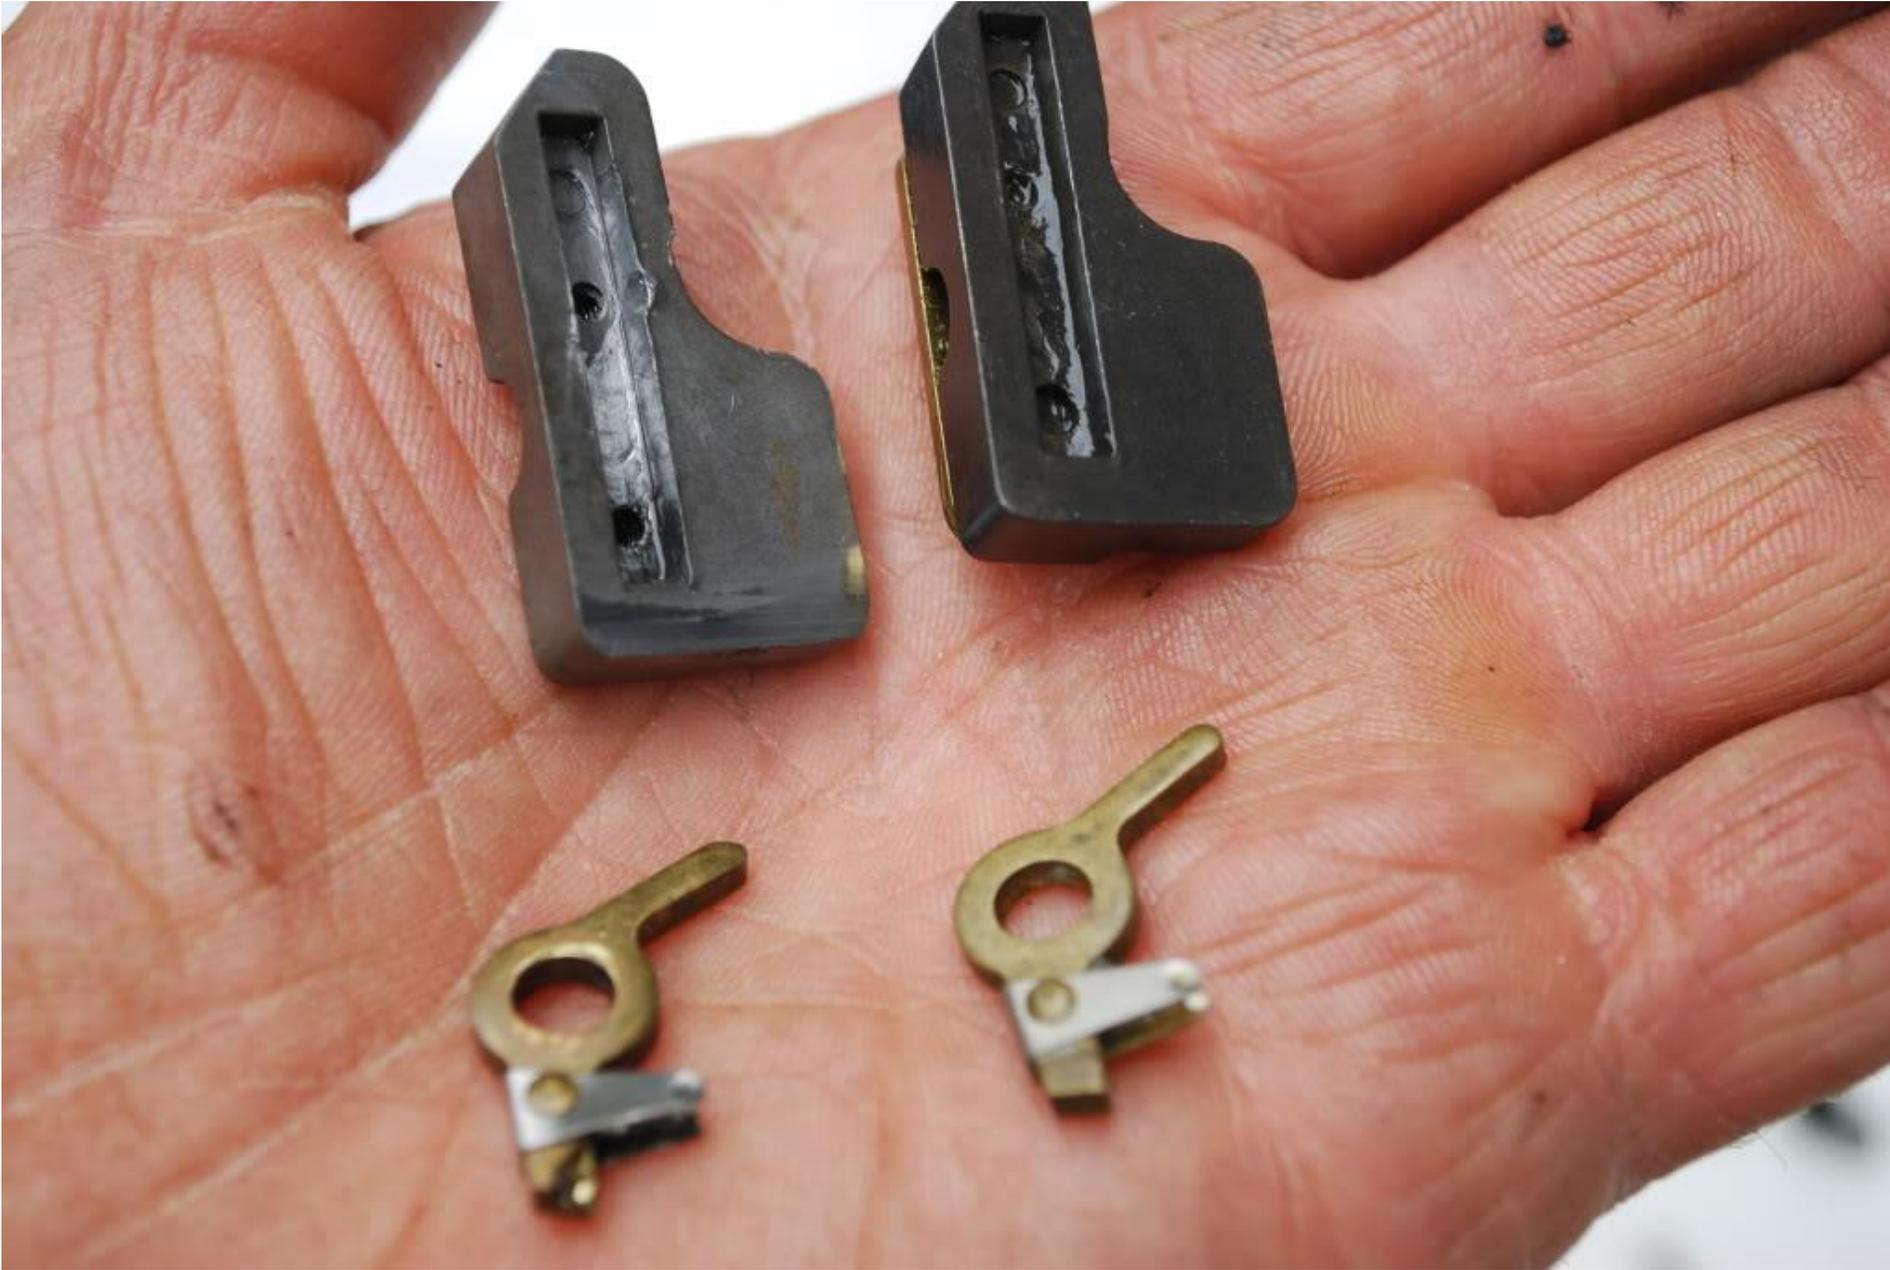
The silent dog needed to be replaced, along with the spool block, key #4a and 43.

The ones on the right are the replacements.

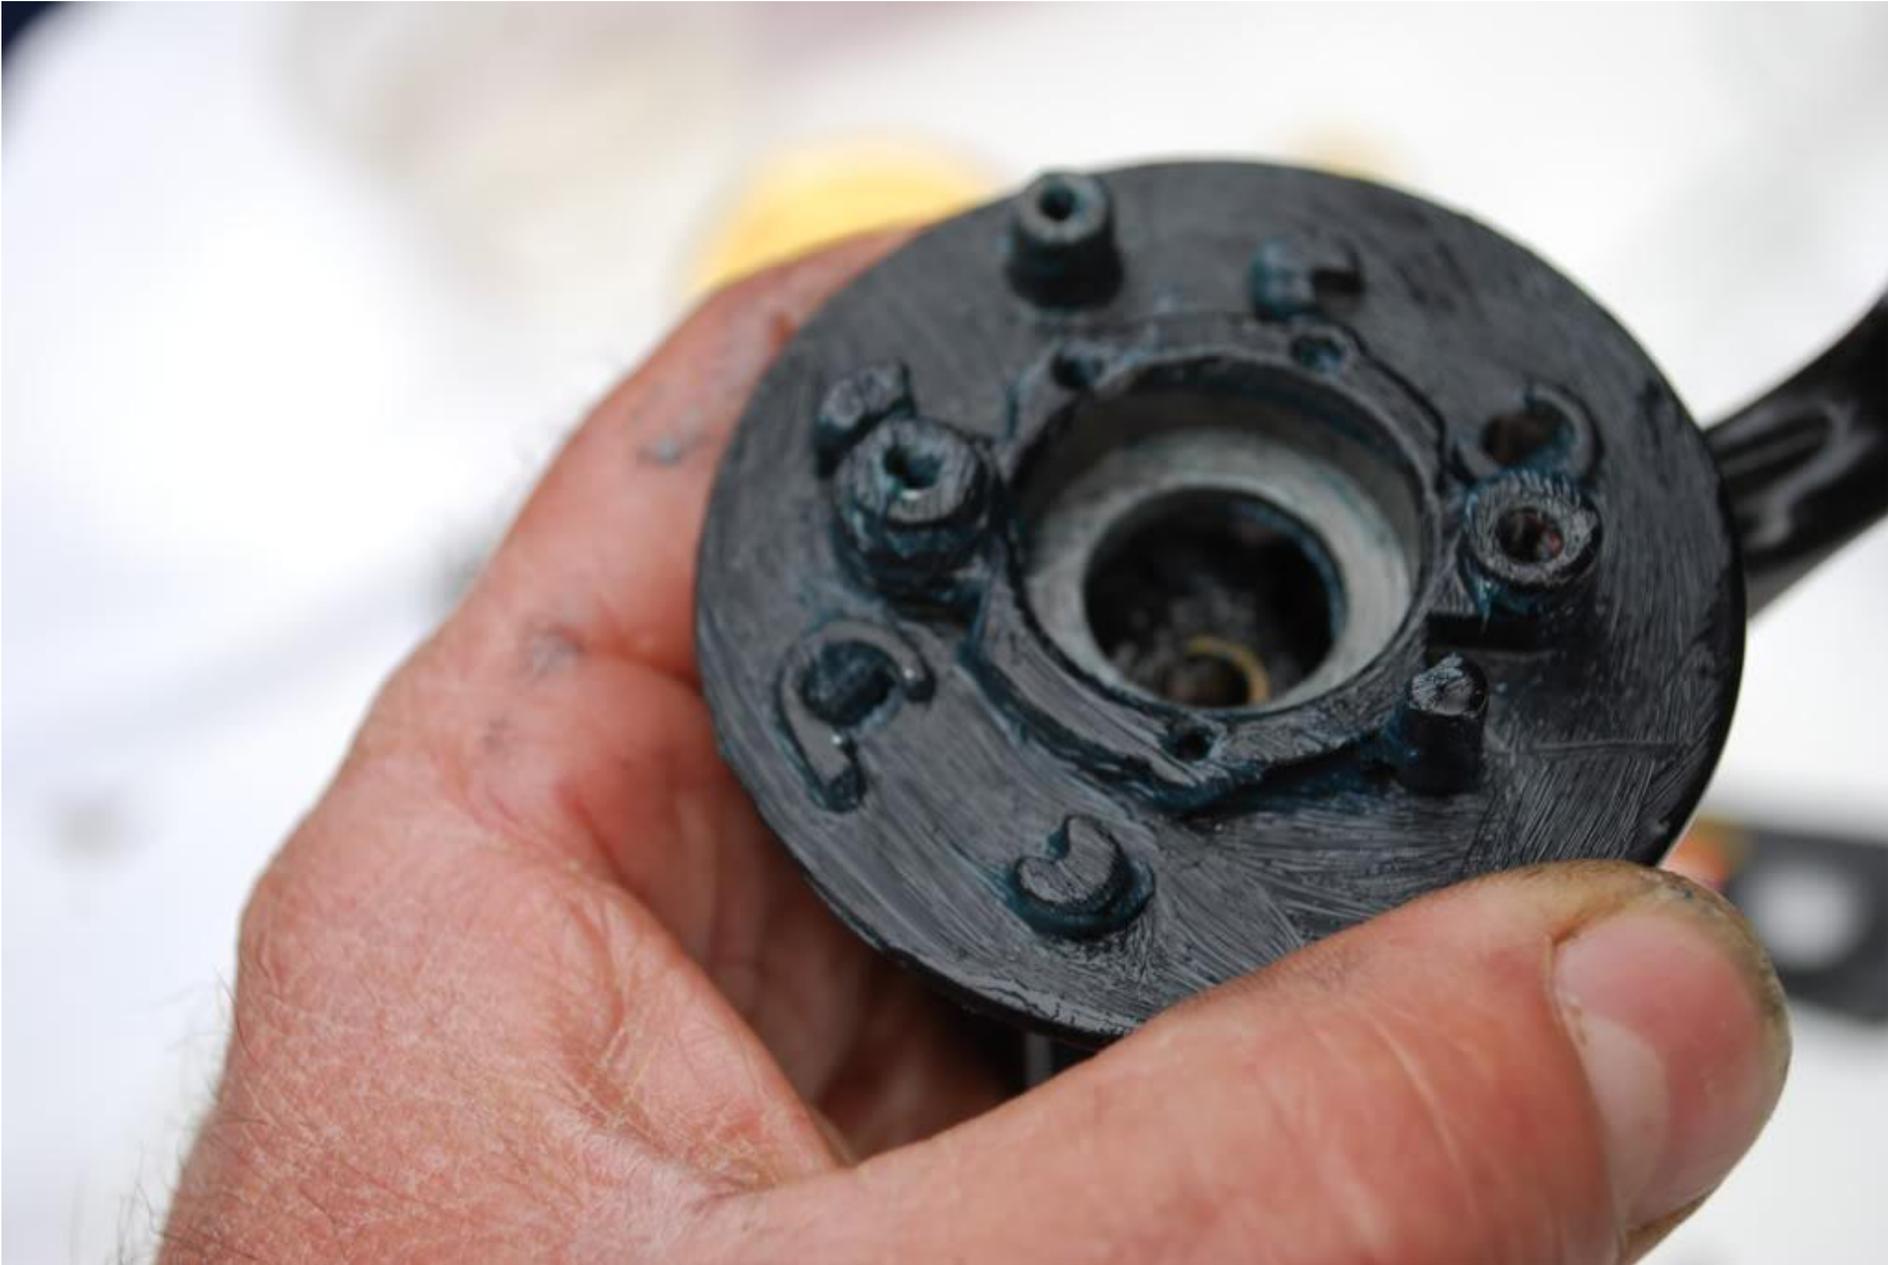
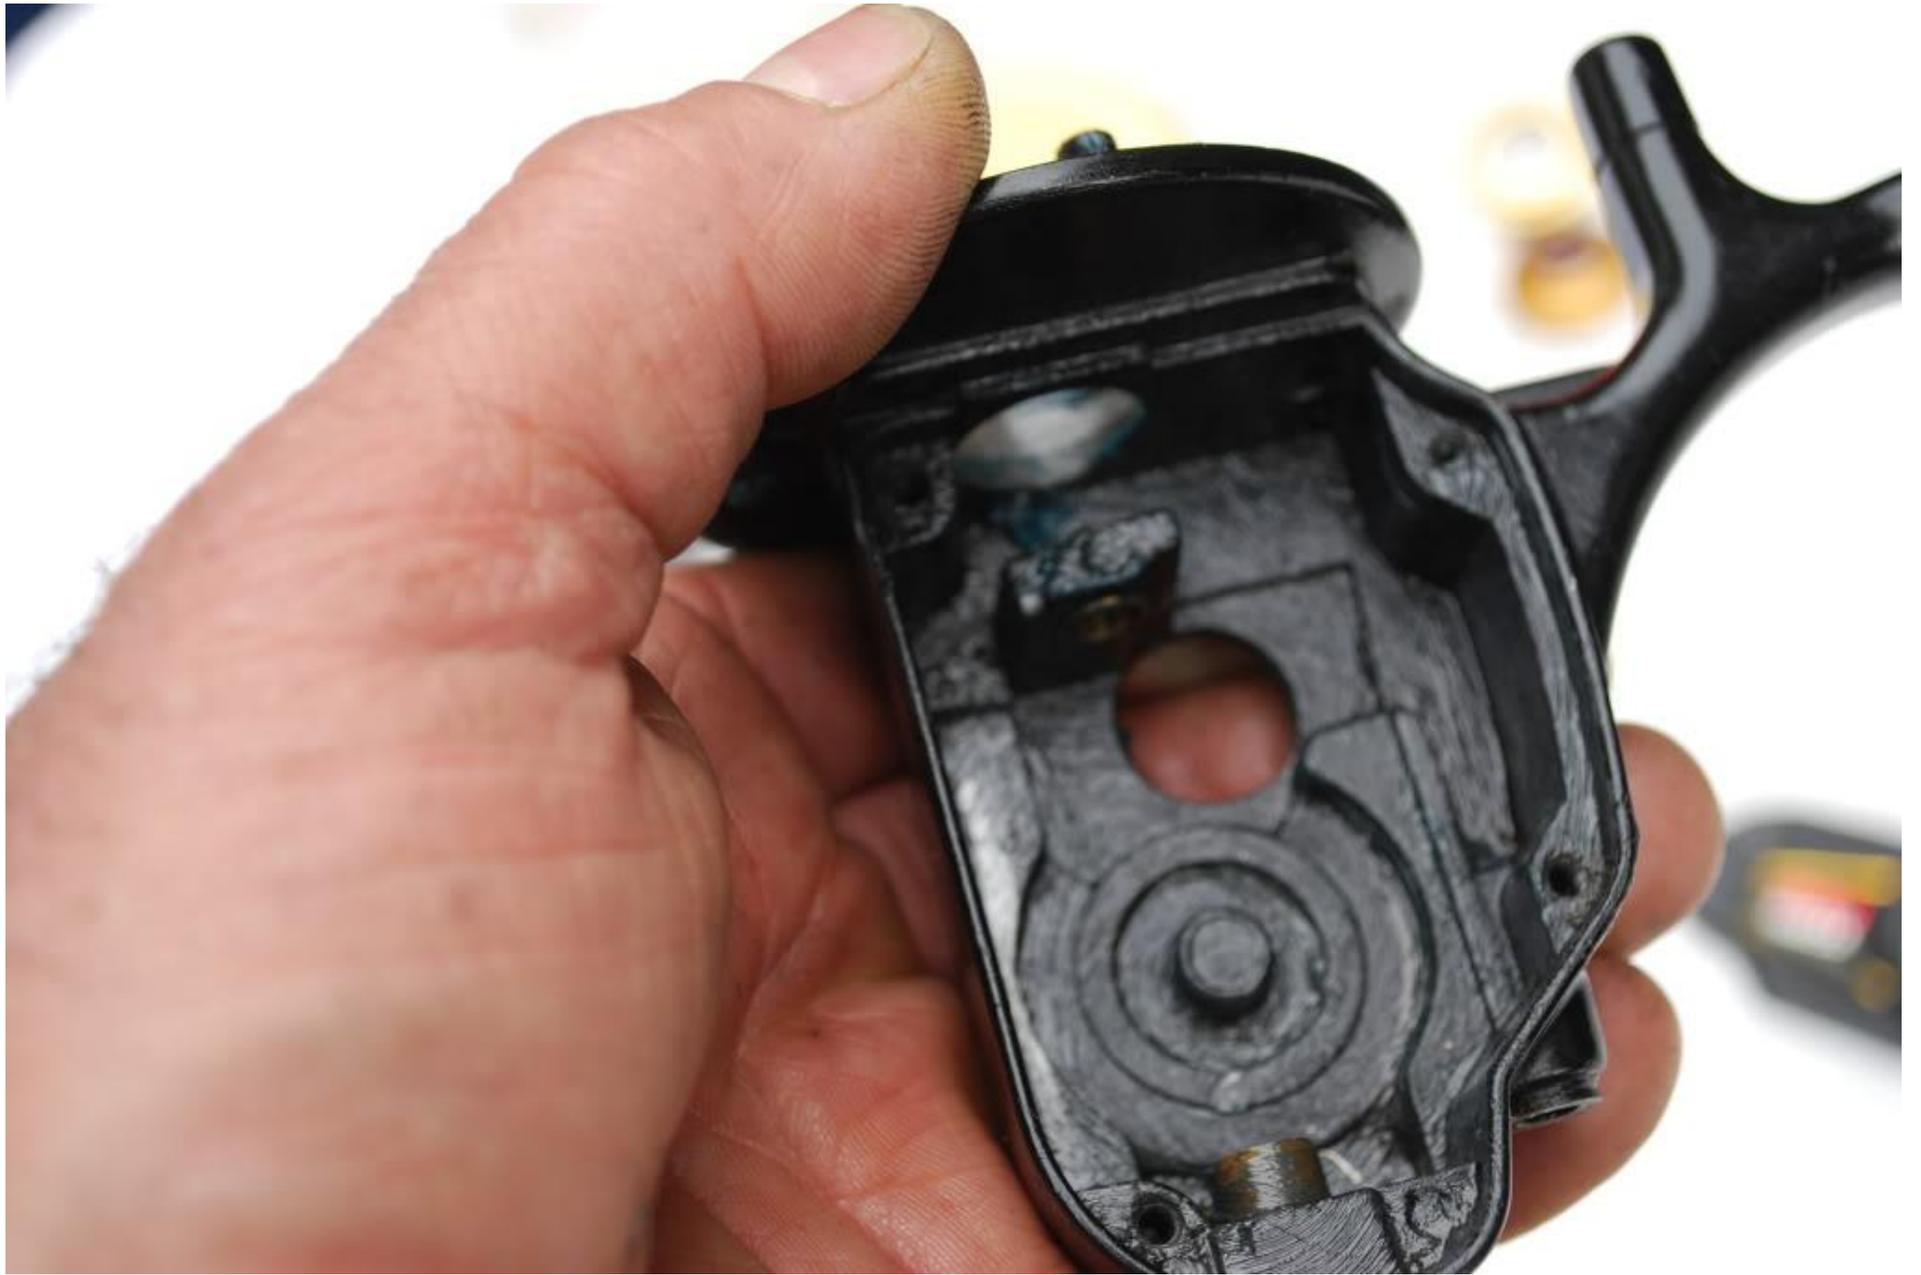
I then lightly greased the housing before reassembly.

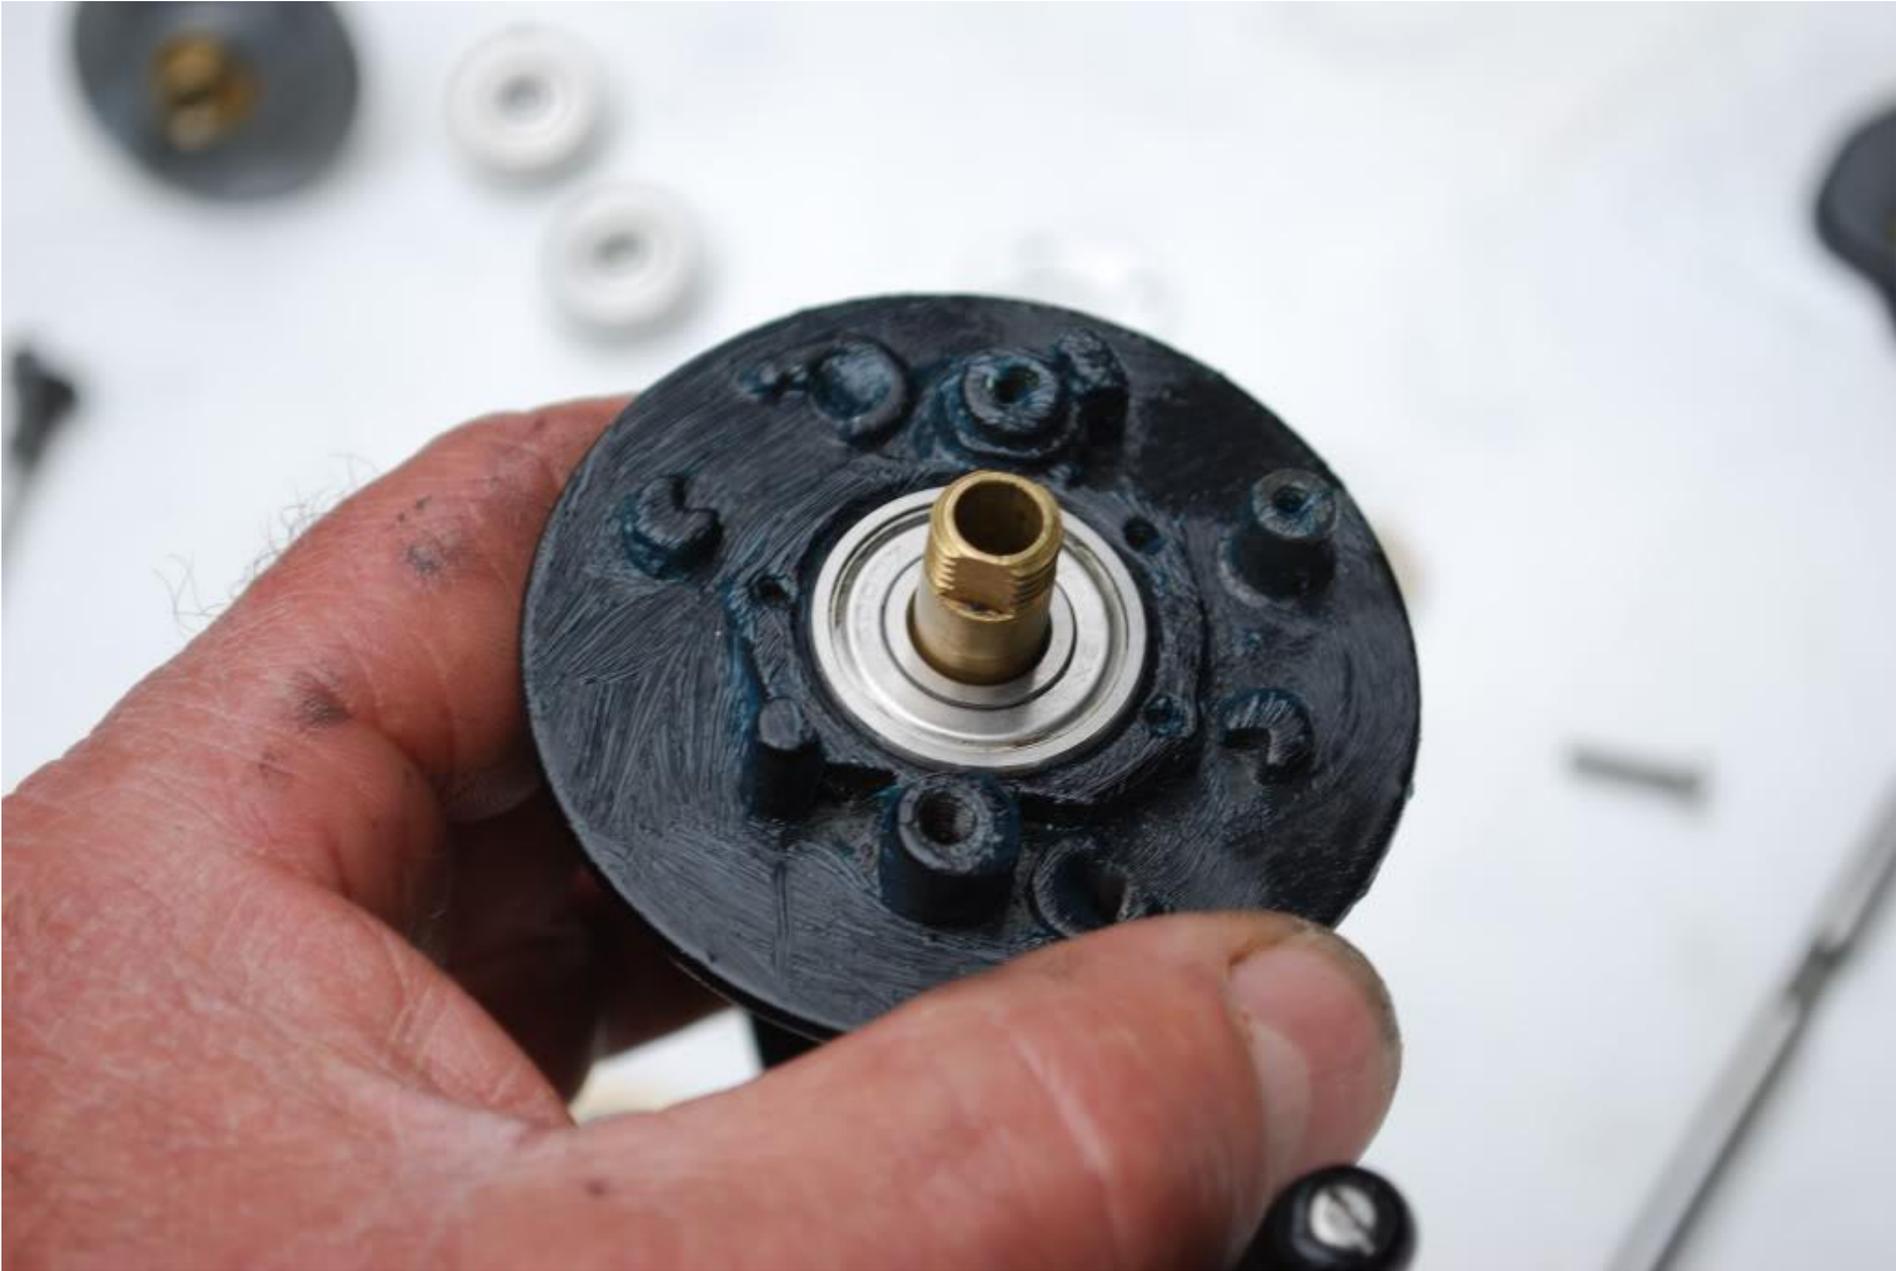
I started reassembly with the pinion gear and bearing, key #19 and 55.

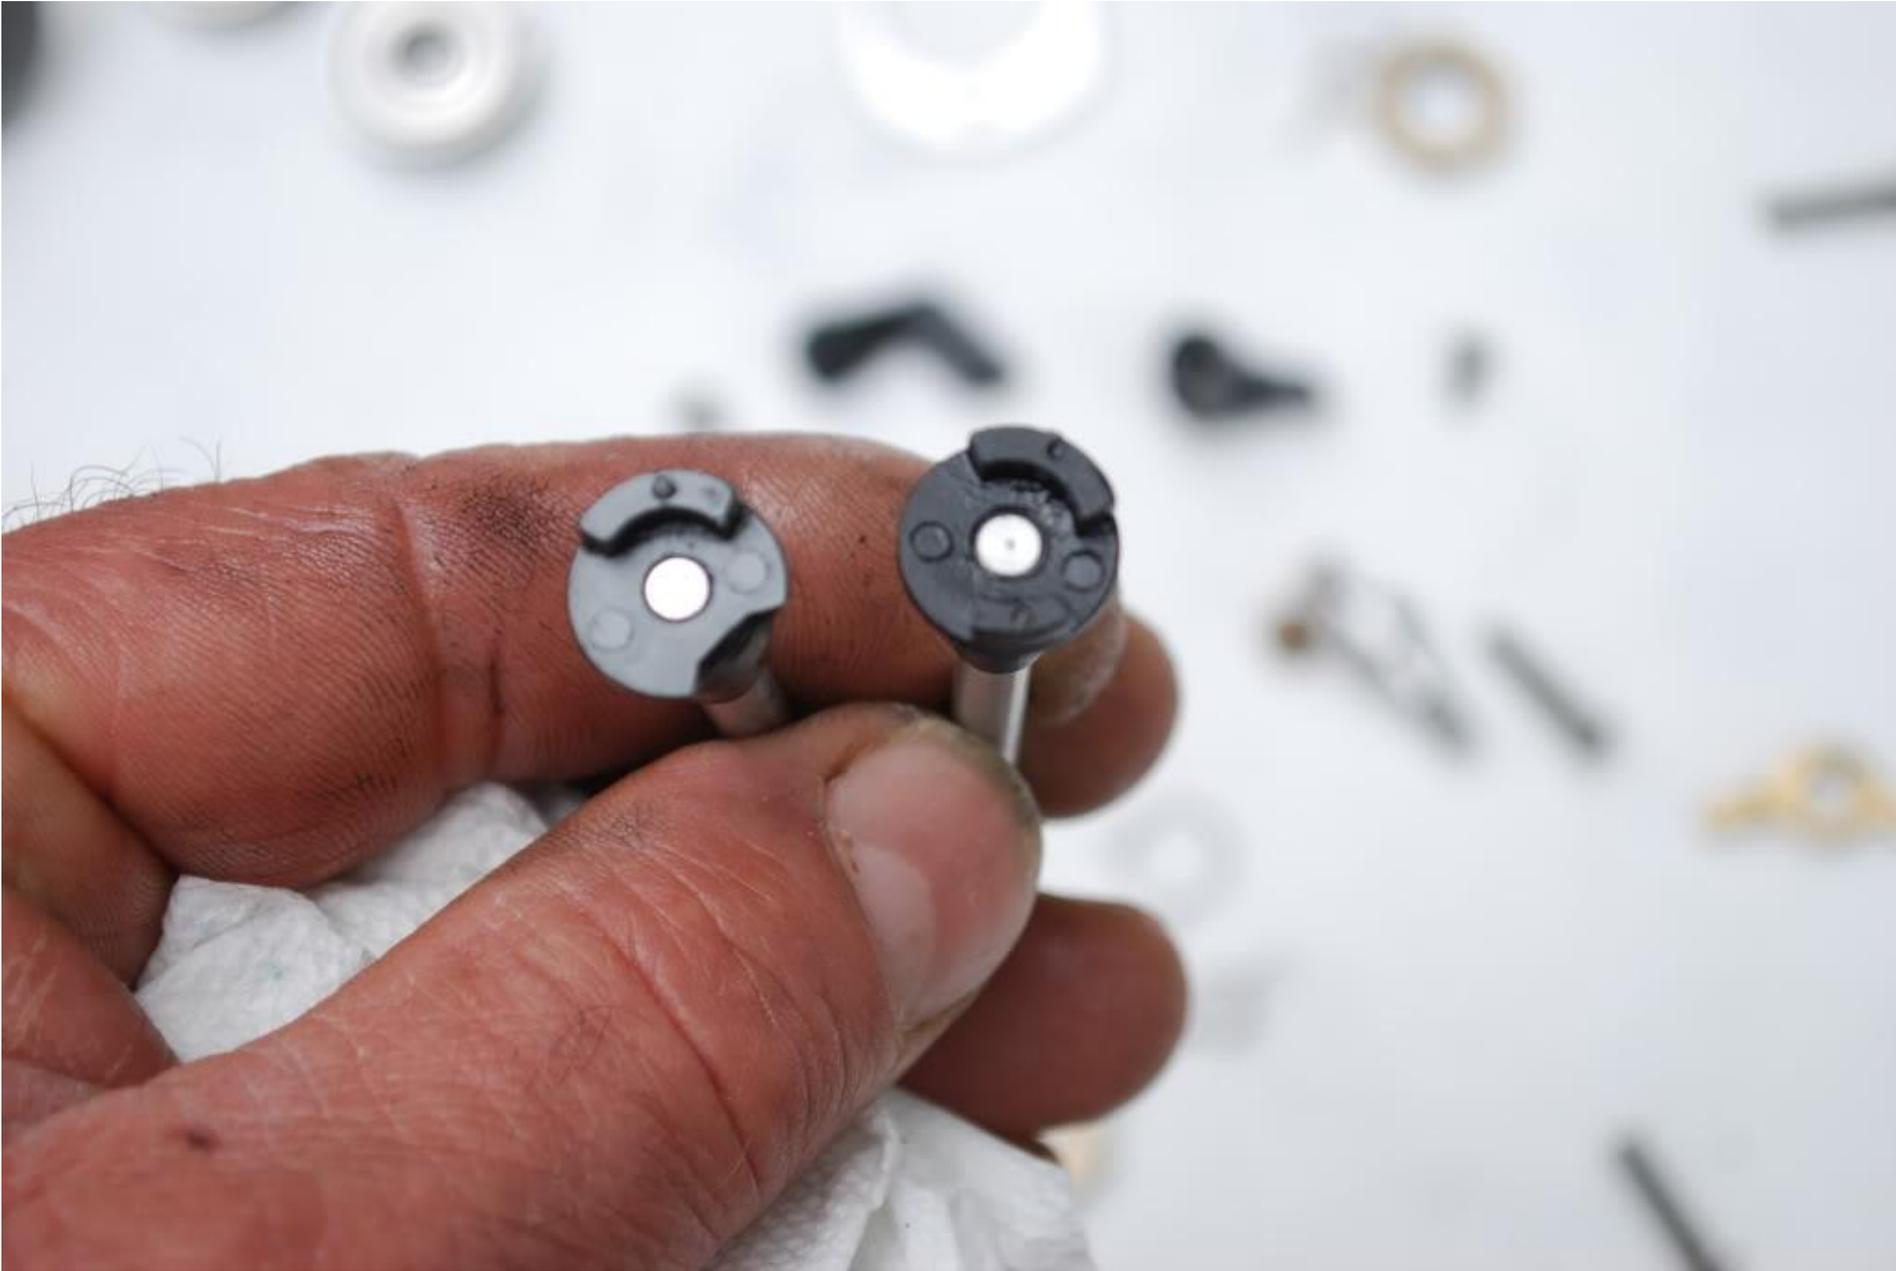
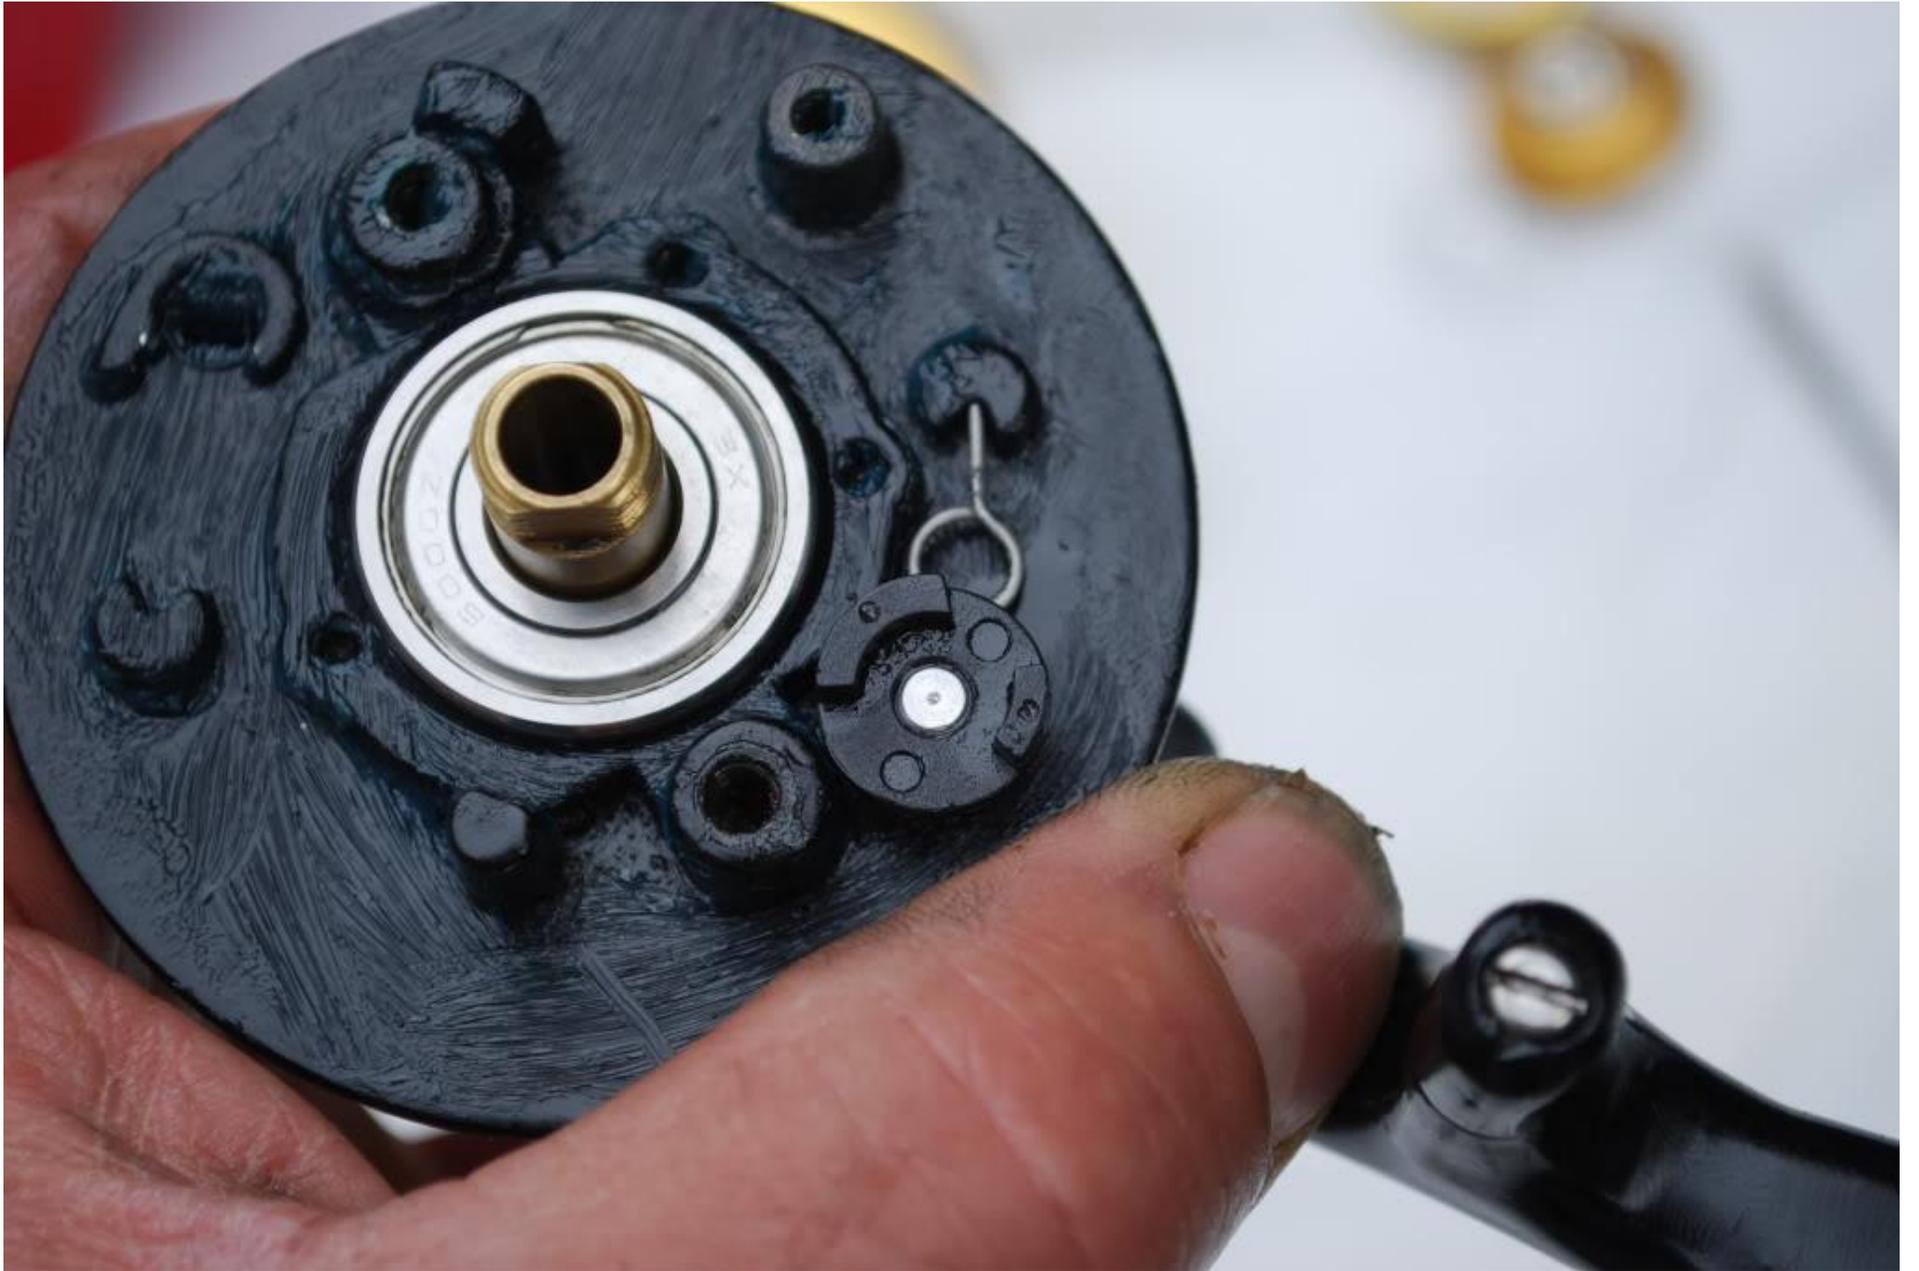
While putting back the upper eccentric, I noticed that it was chipped, so I also replaced this part (key # 6a)

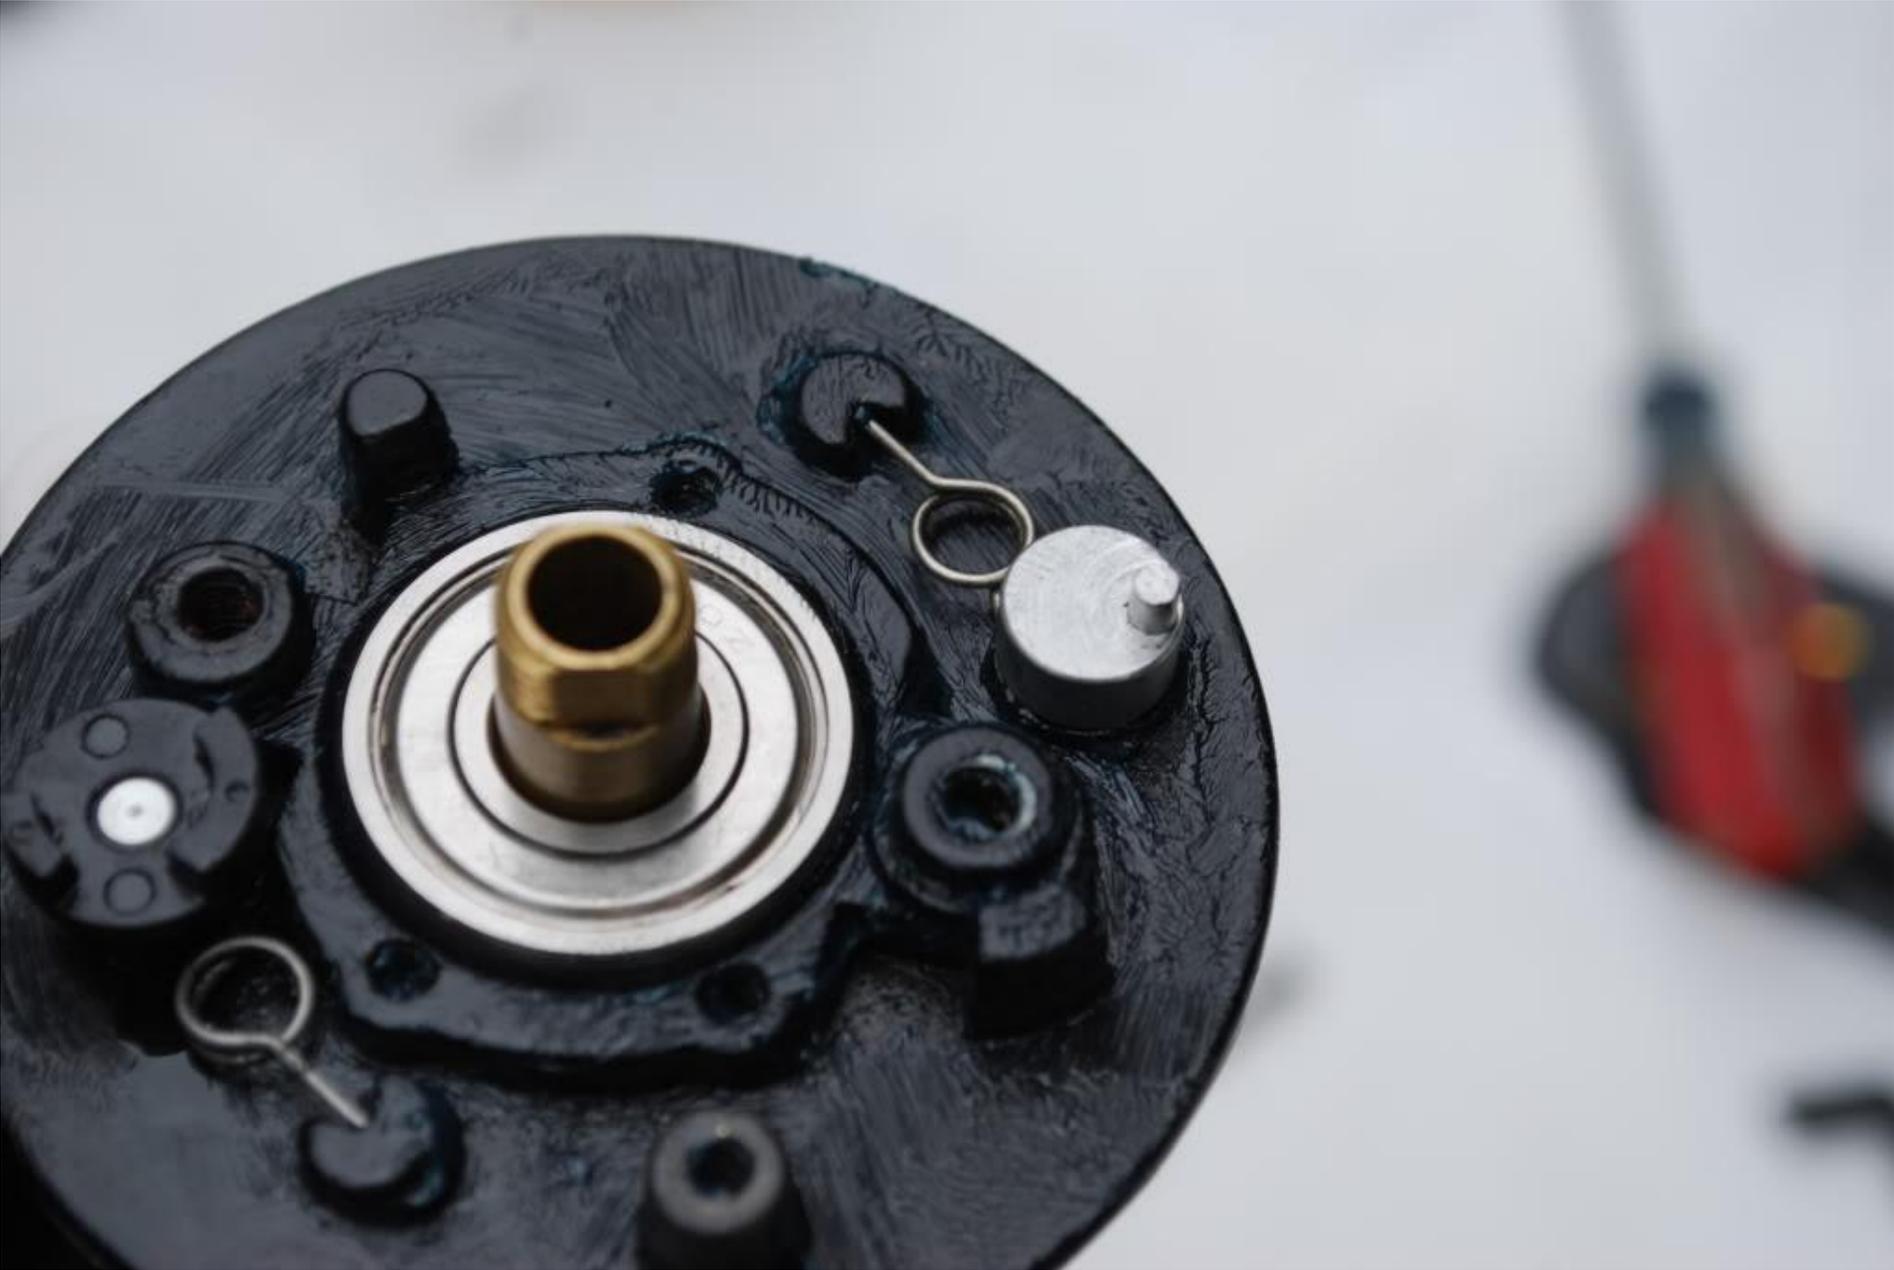
Then, I installed the silent eccentric, key #6L.
