Servicing a Penn 9500 SS Spinning Reel

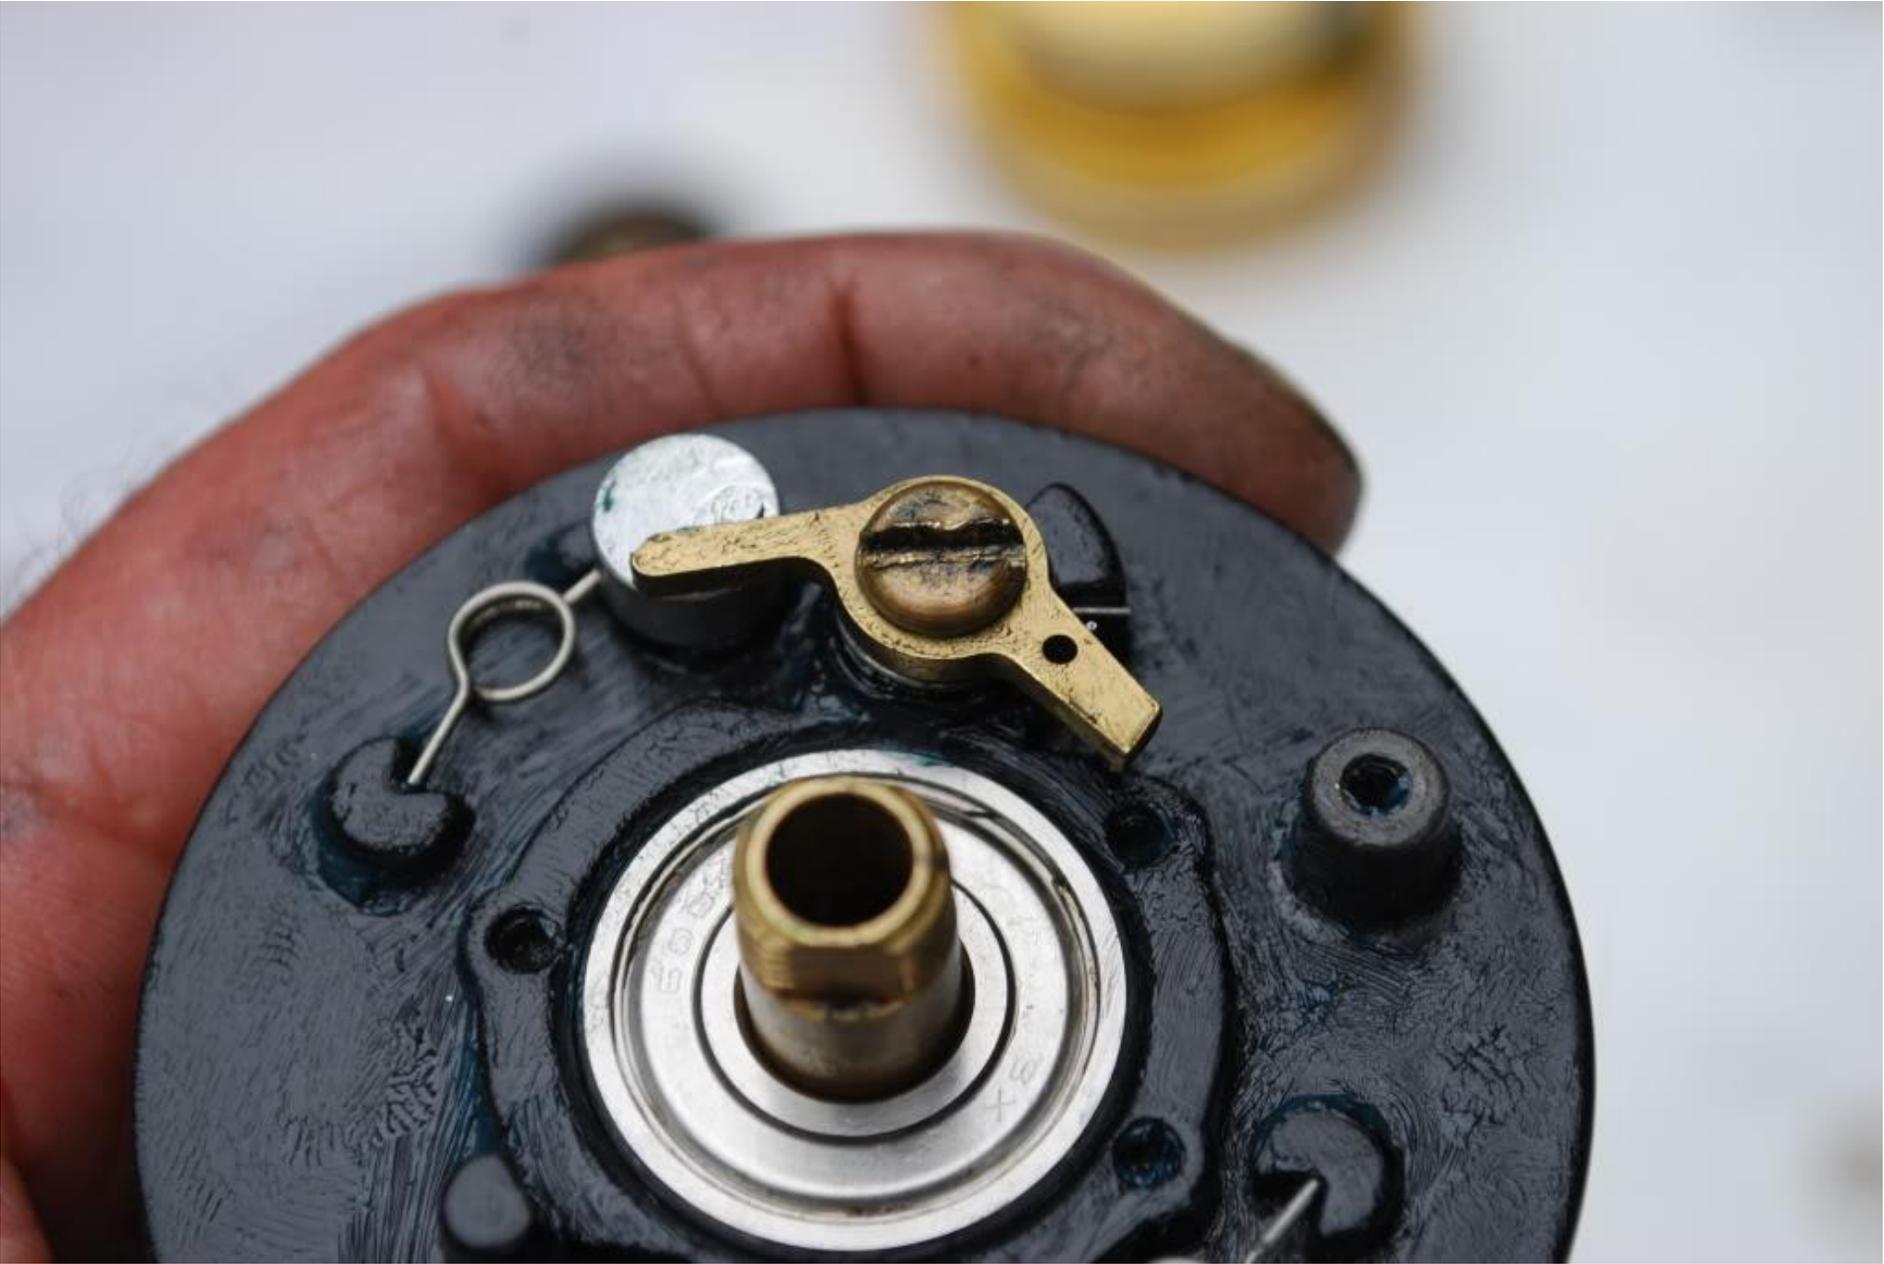
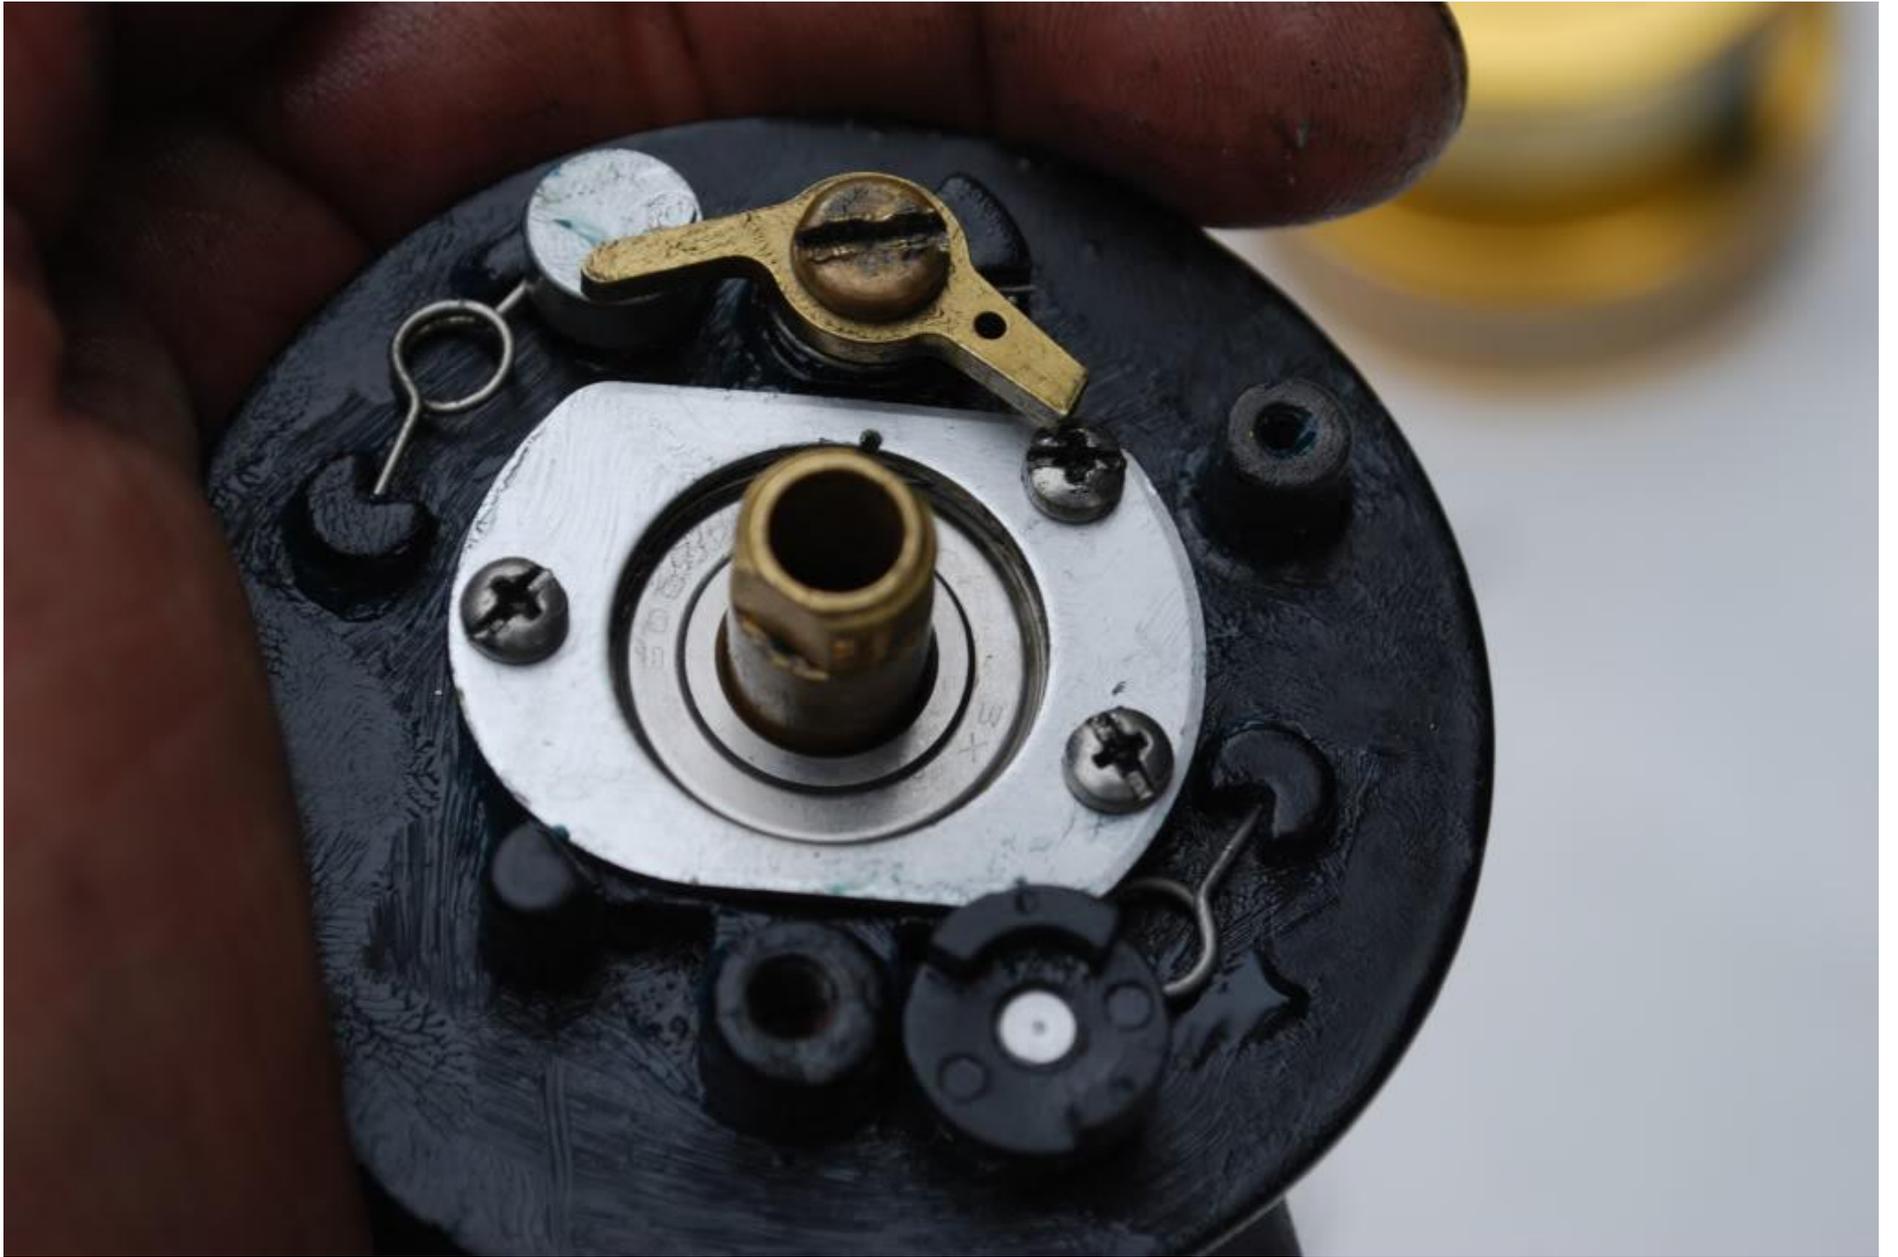
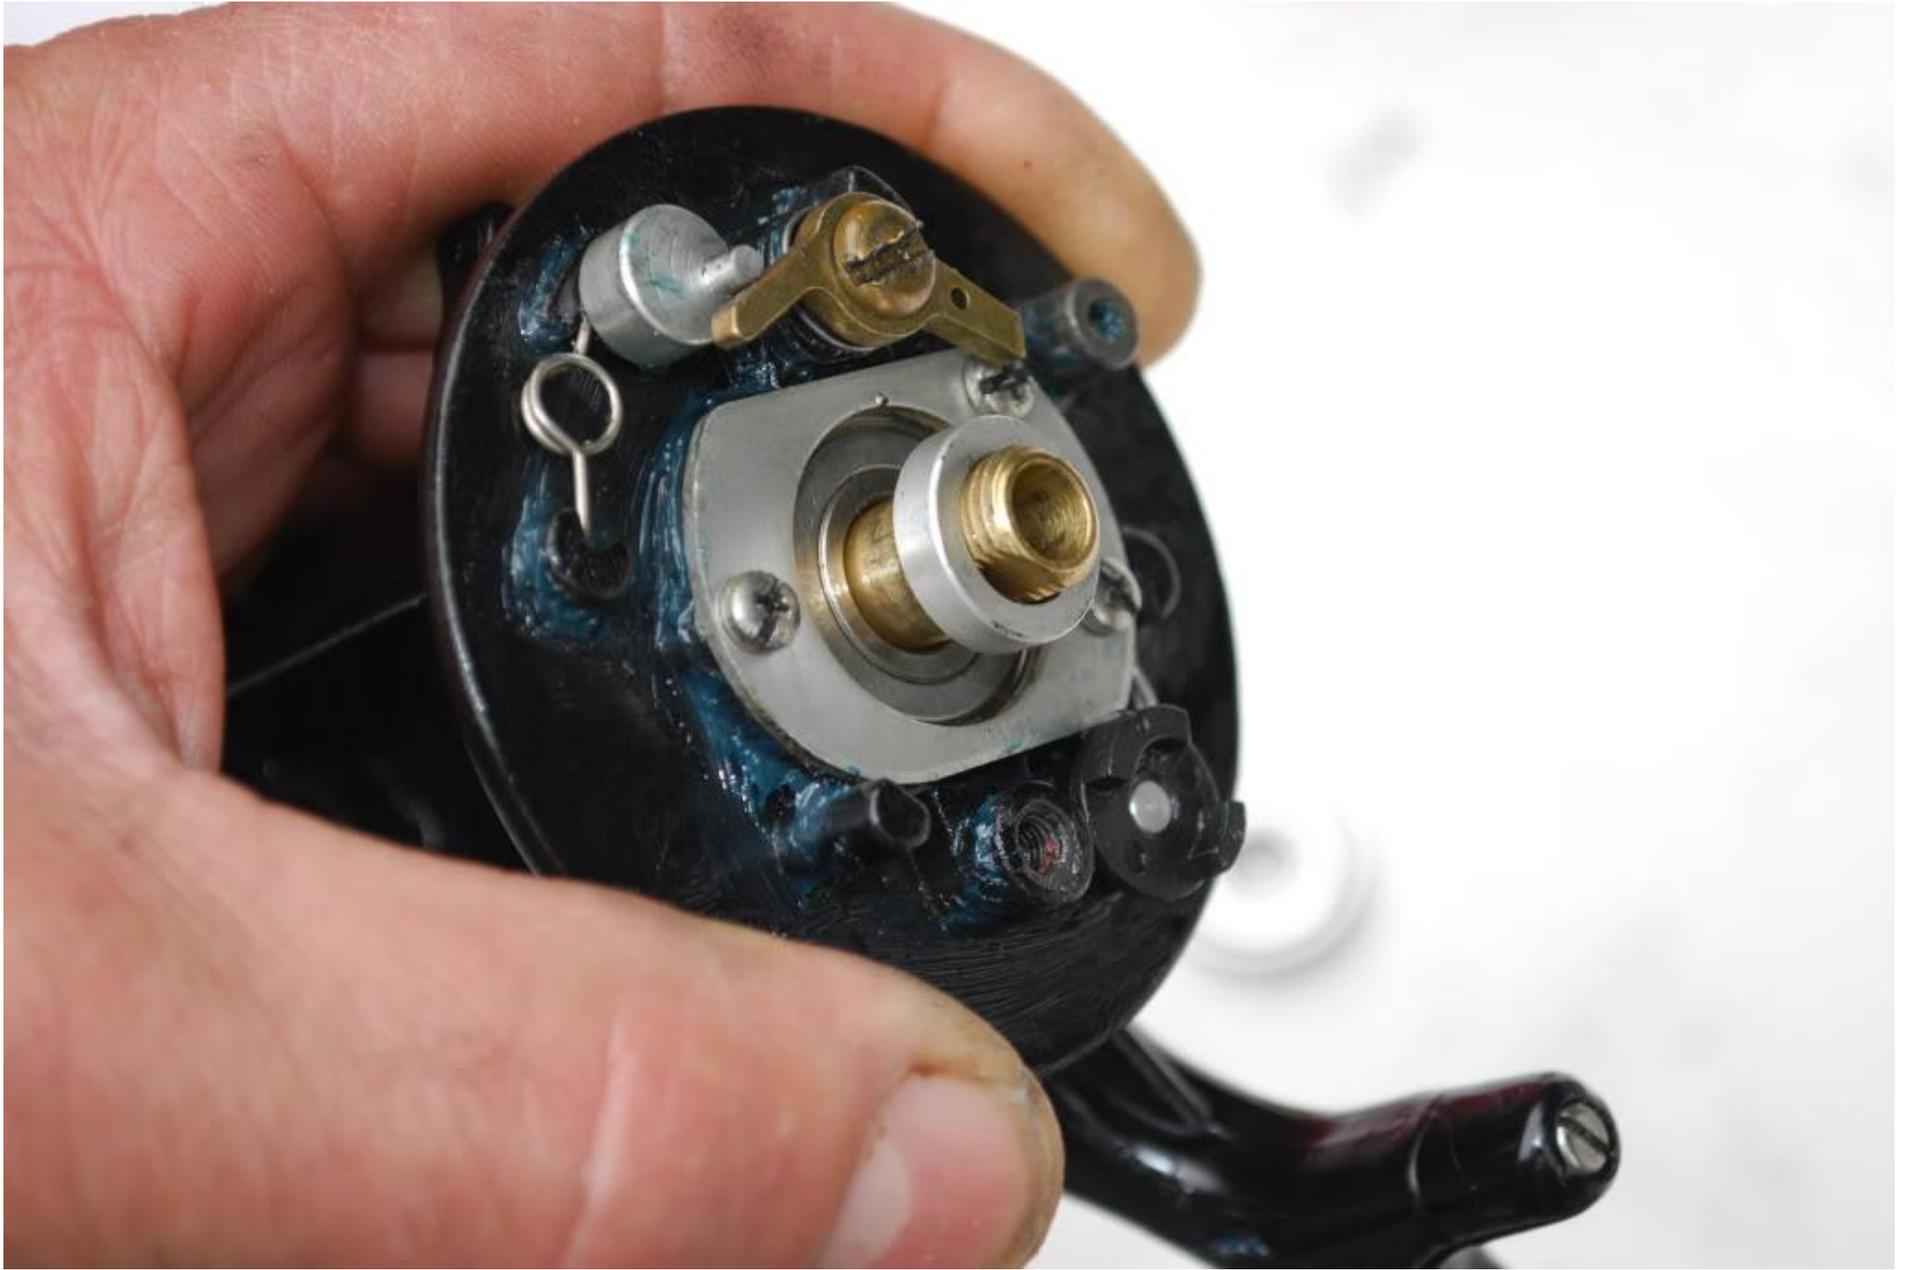
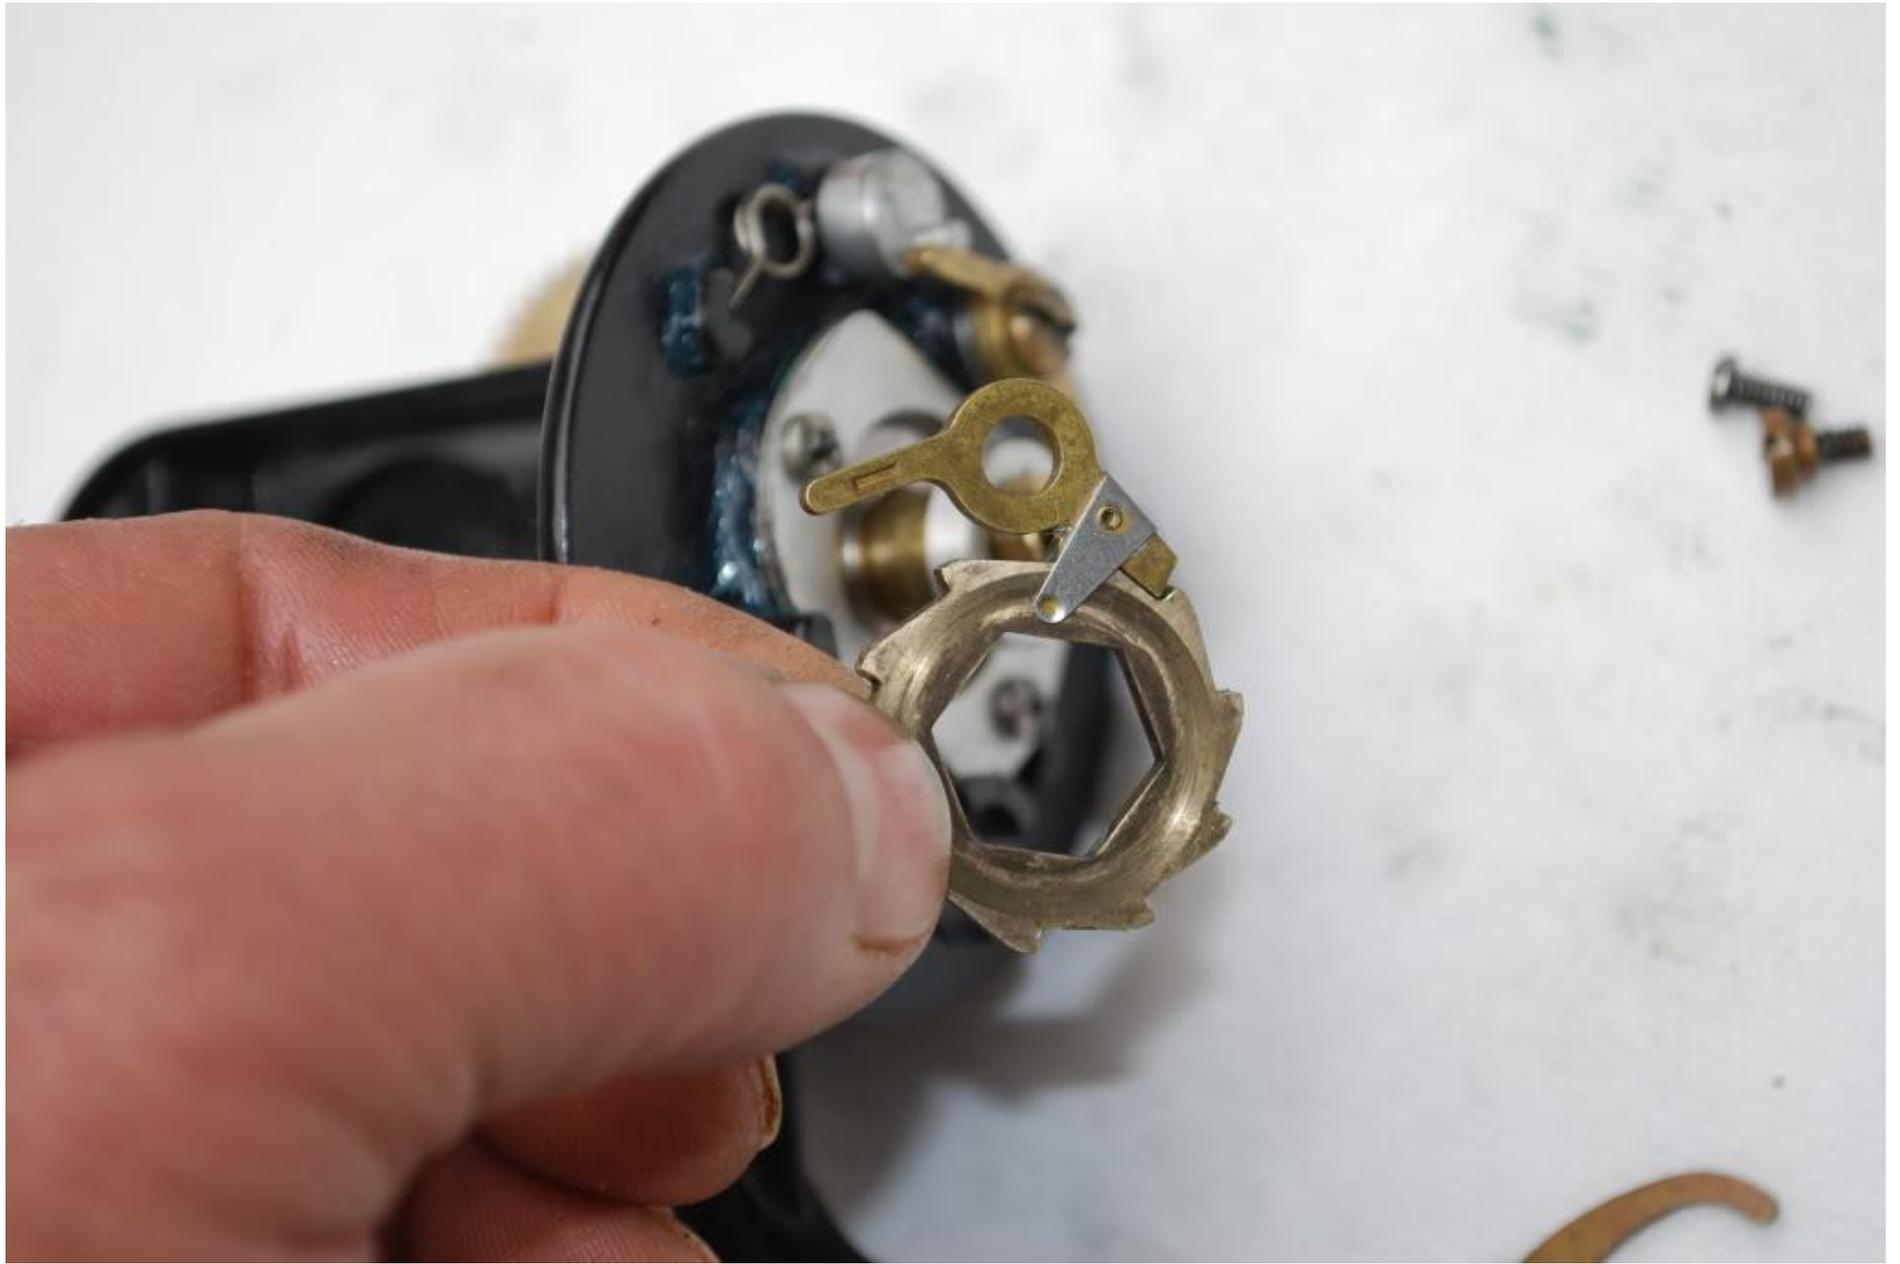
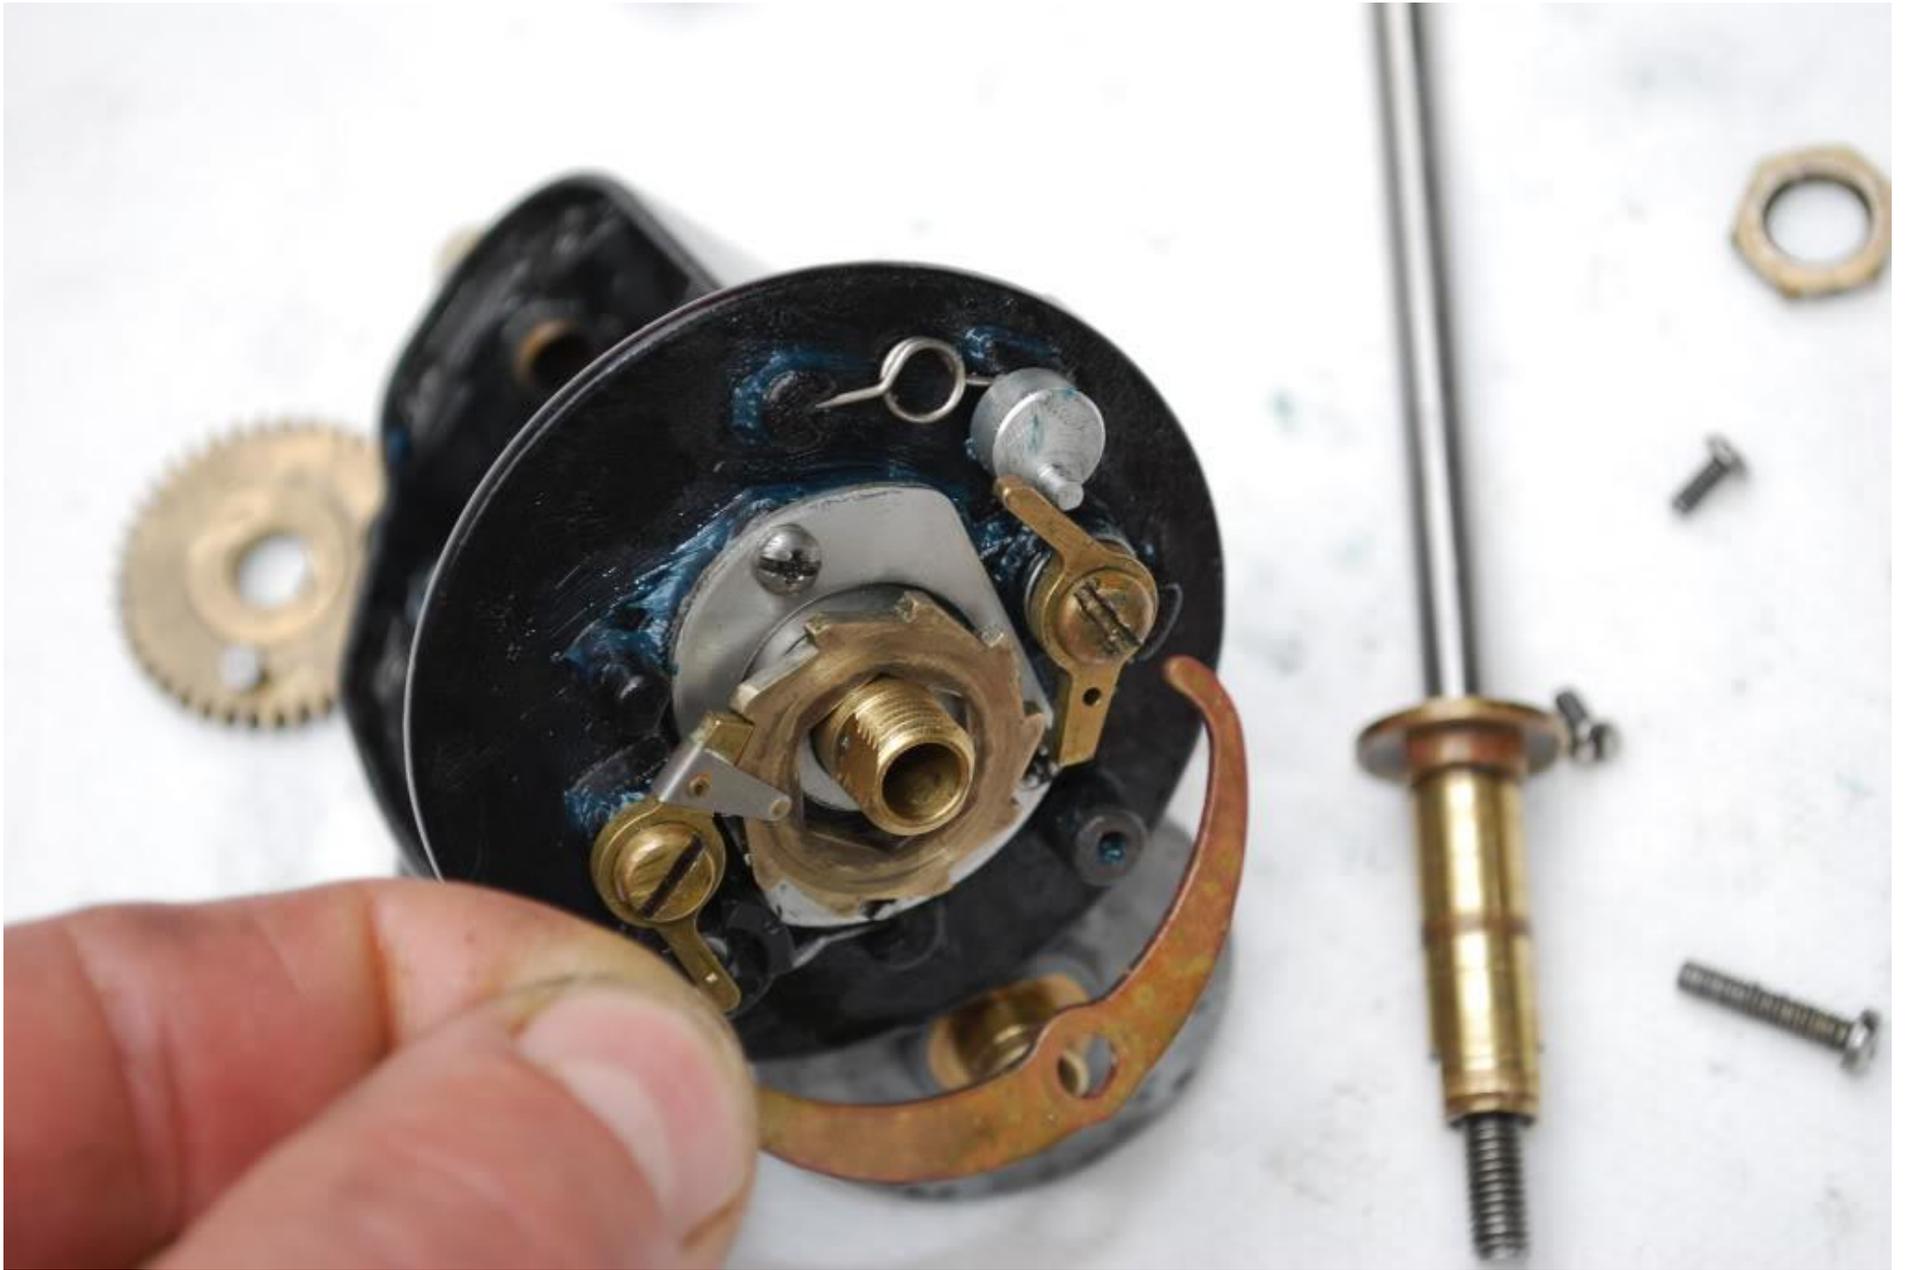
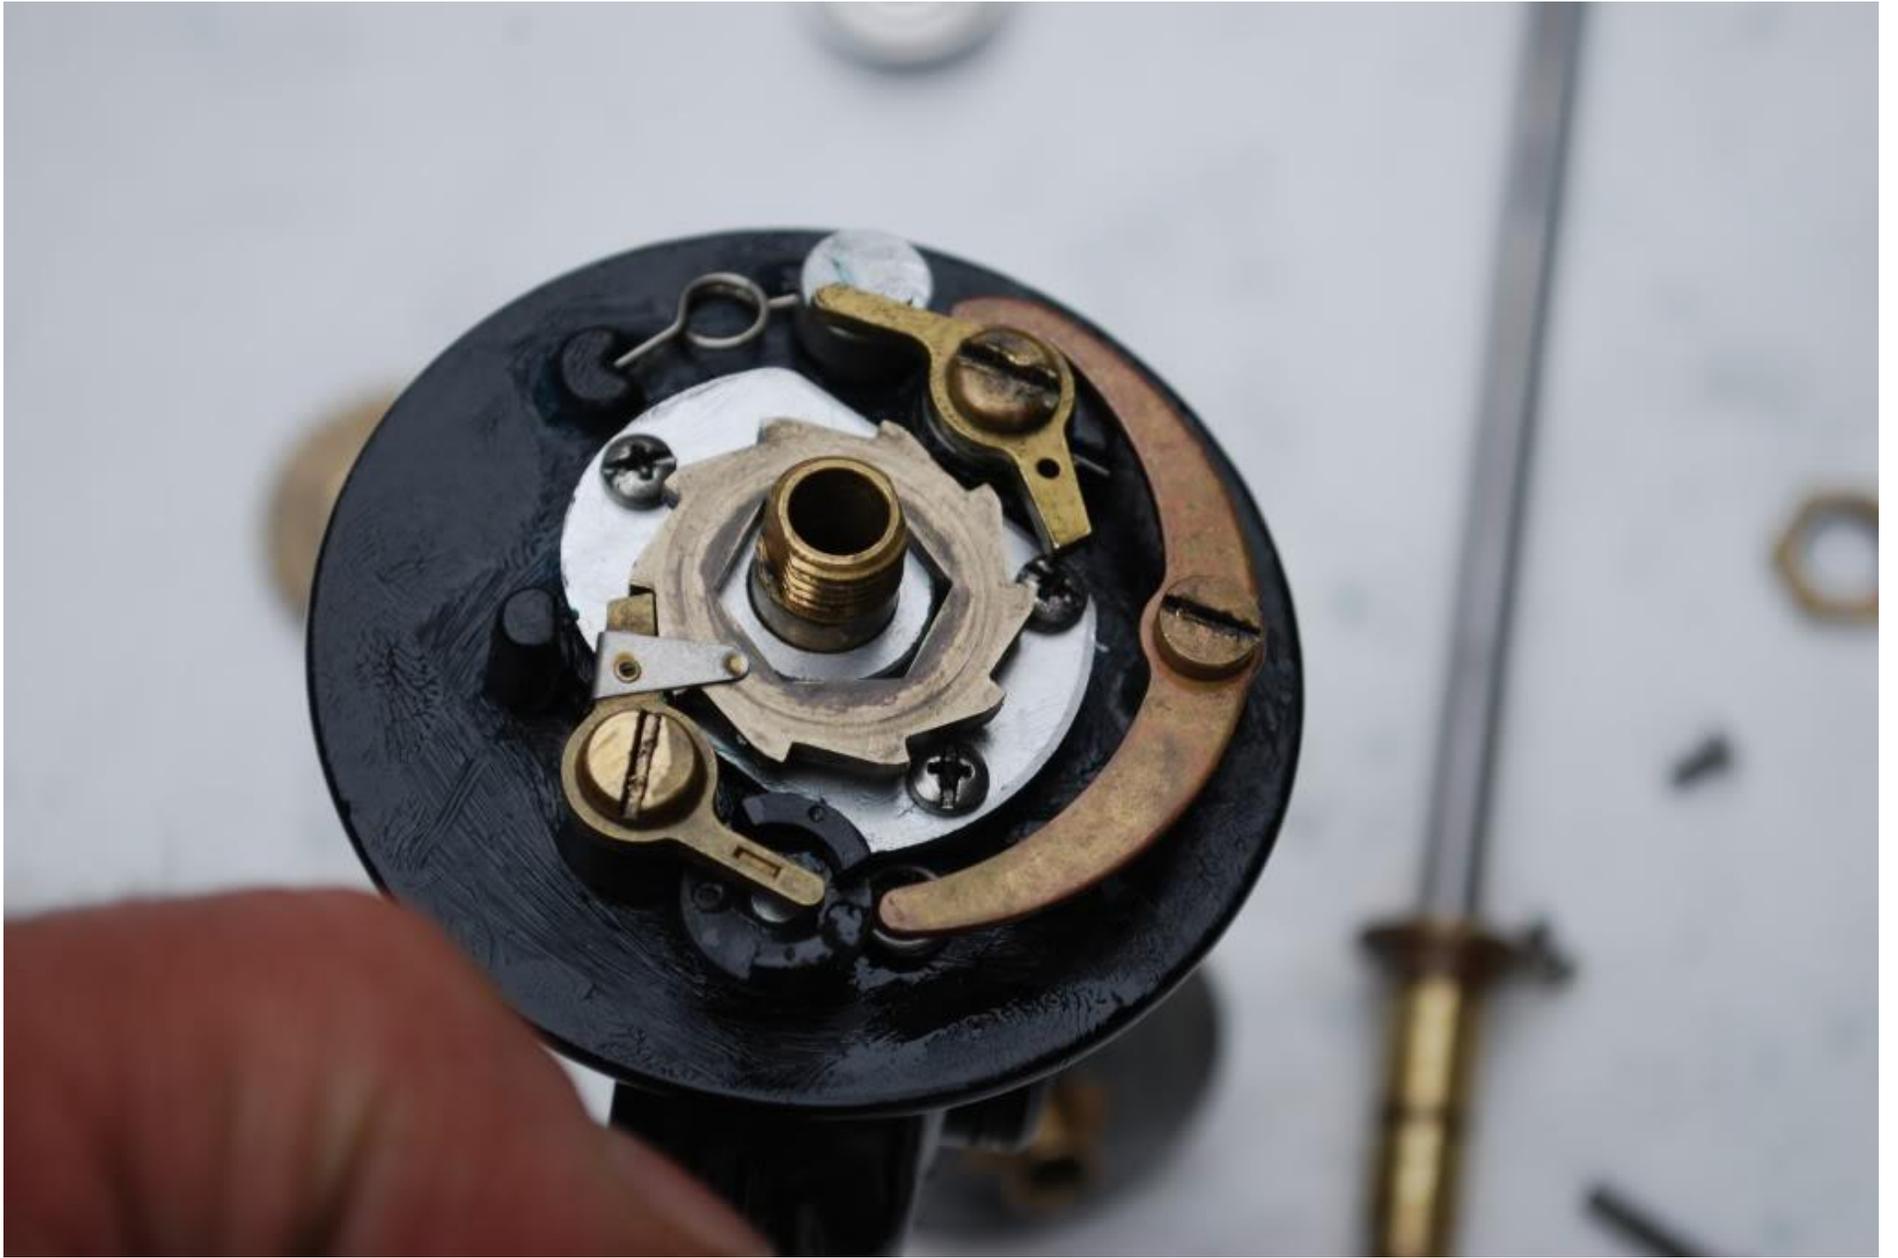
Then I installed the dog, the bearing cover, the pinion spacer, the ratchet, the silent dog, and the transfer lever (key #4, 21, 19a, 10, 4a, 224)
