Servicing a Penn 9500 SS Spinning Reel

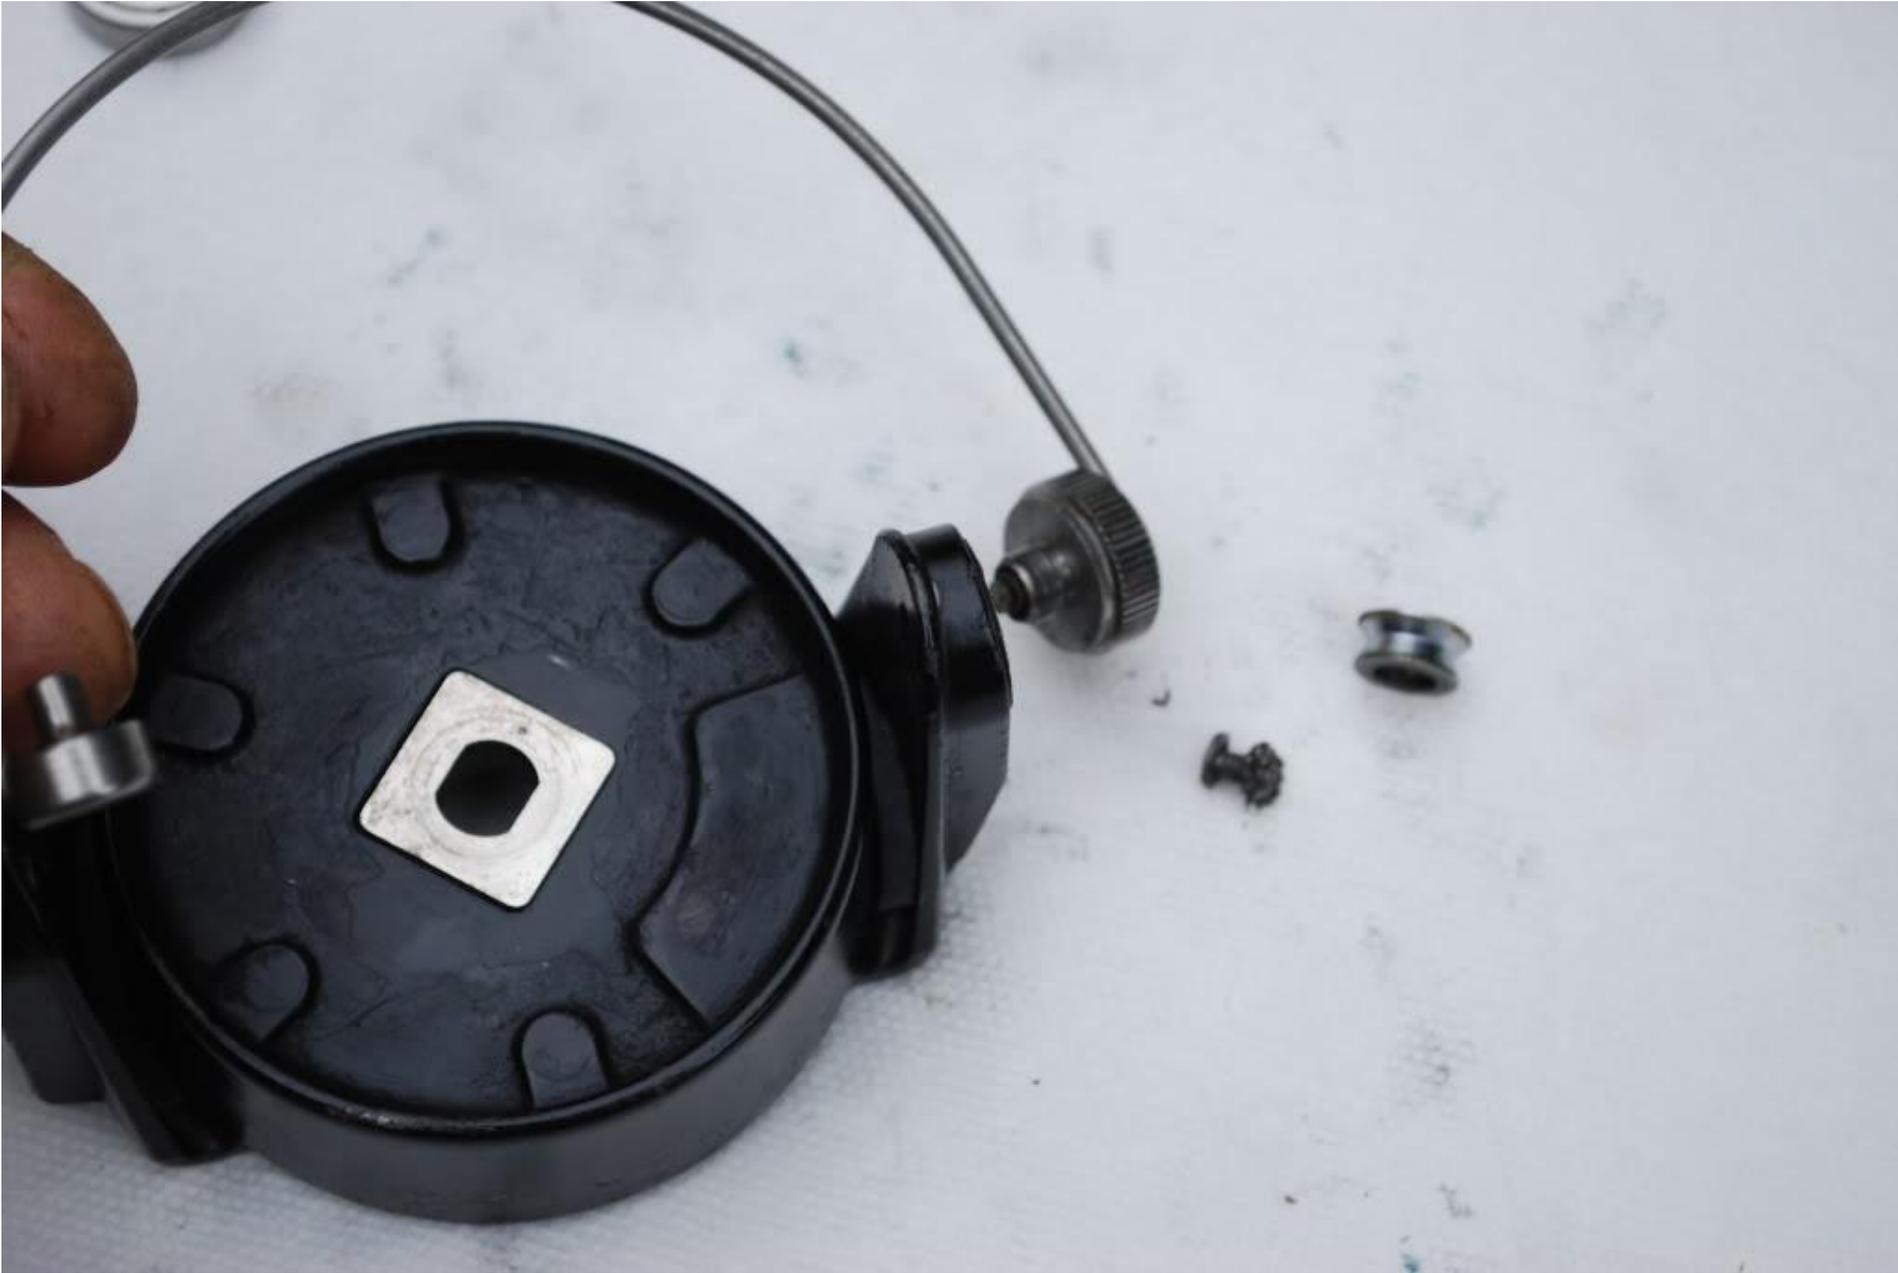
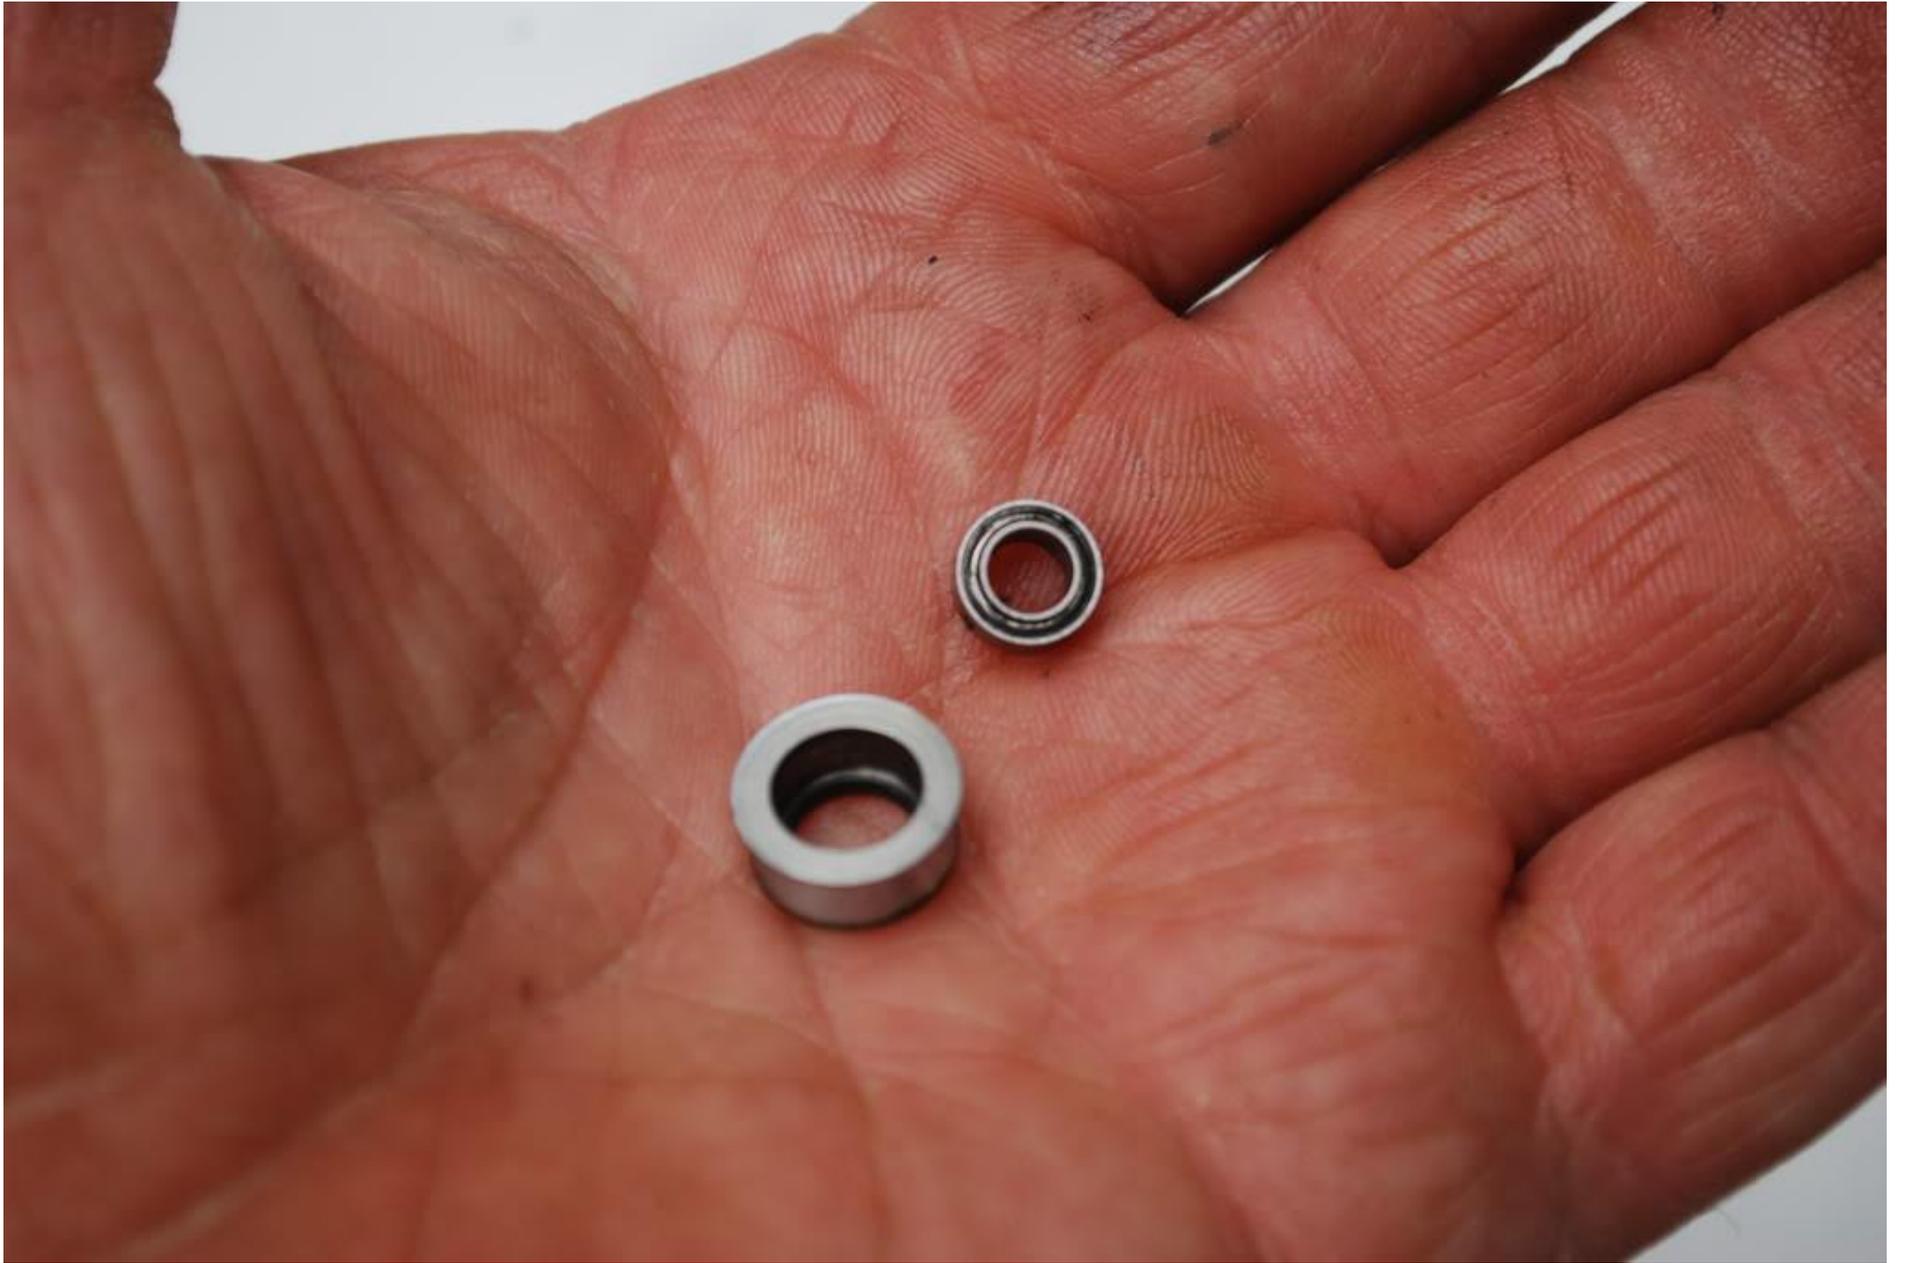
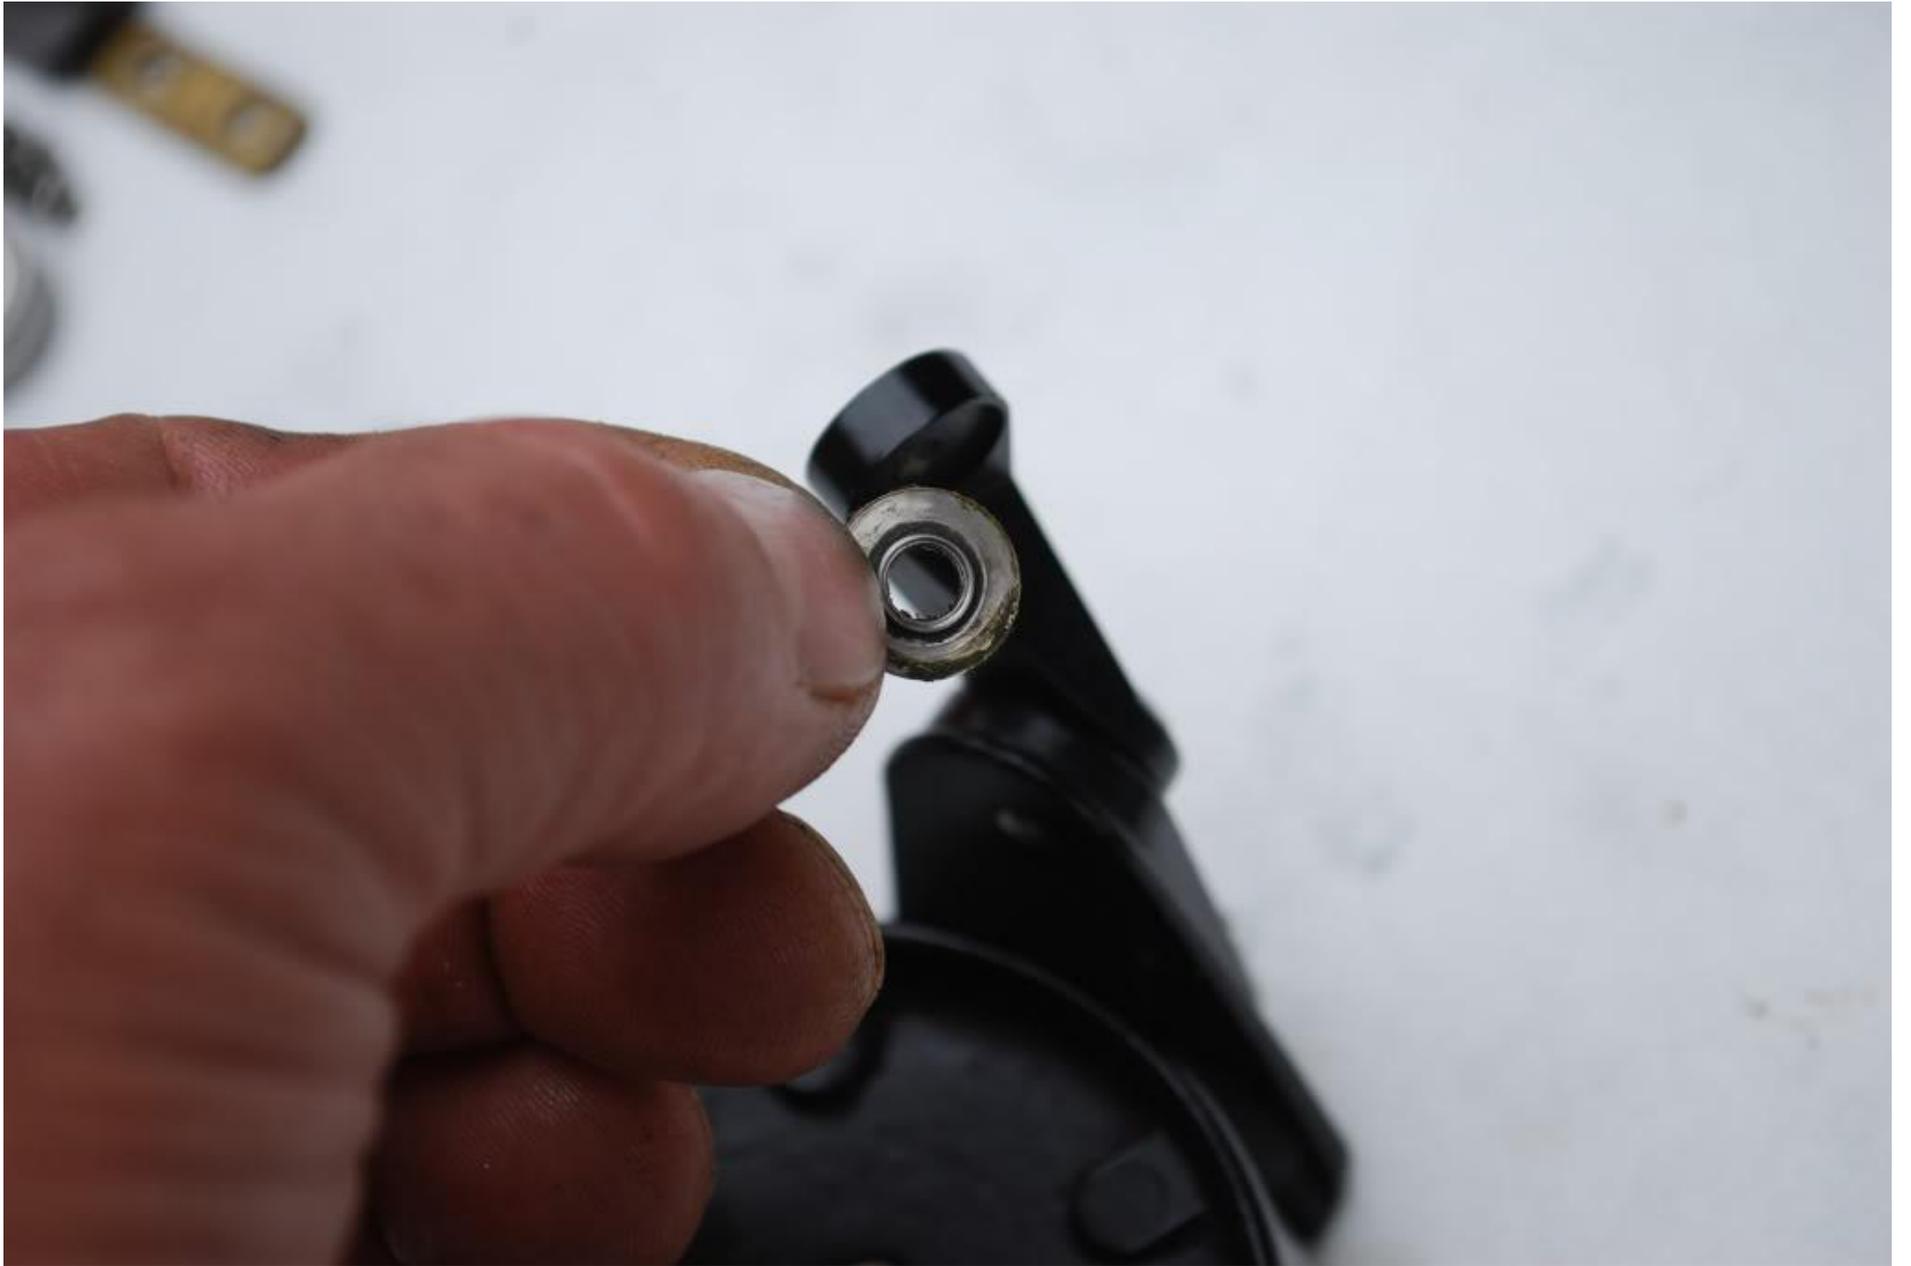
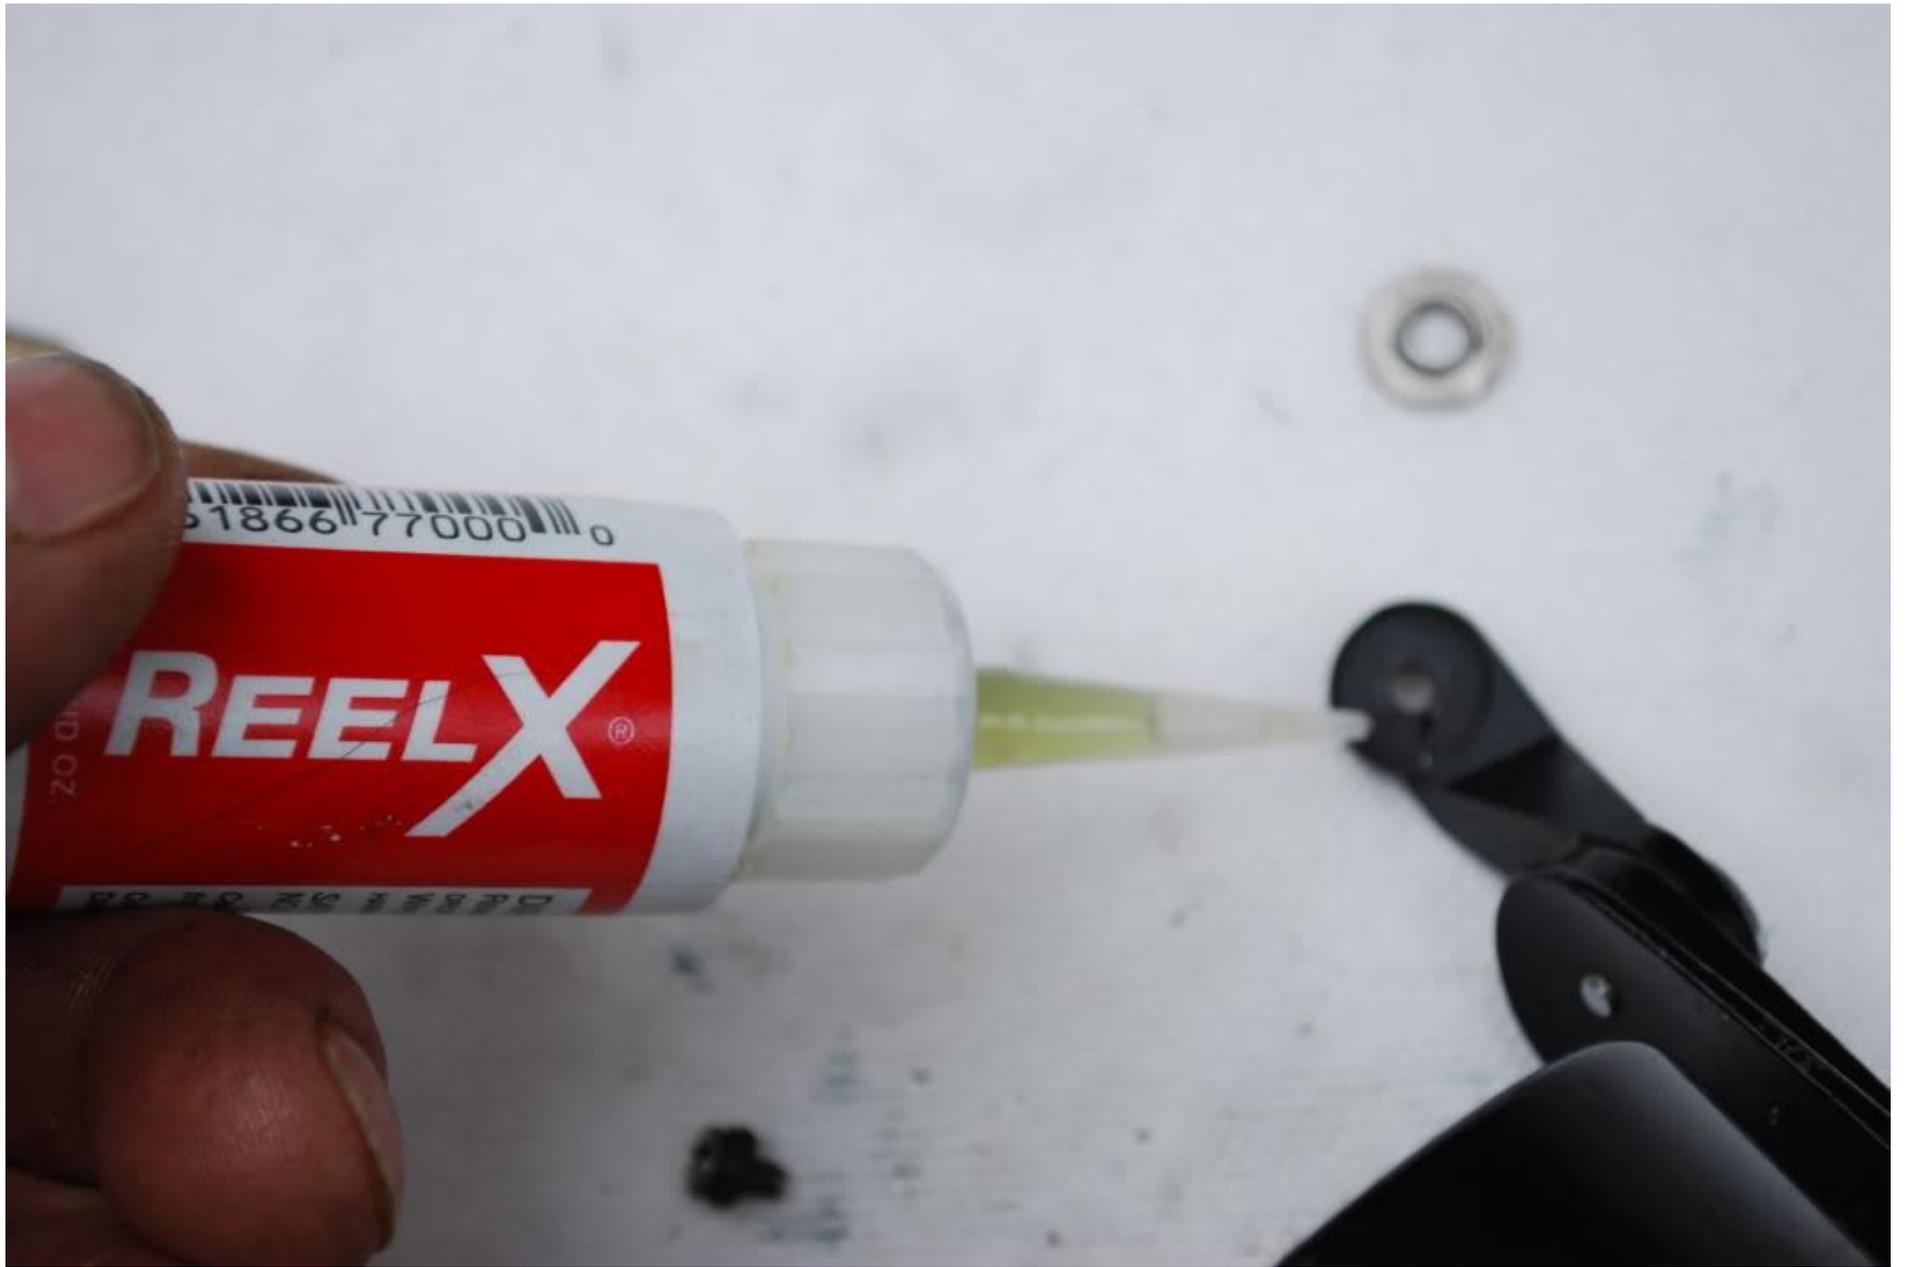
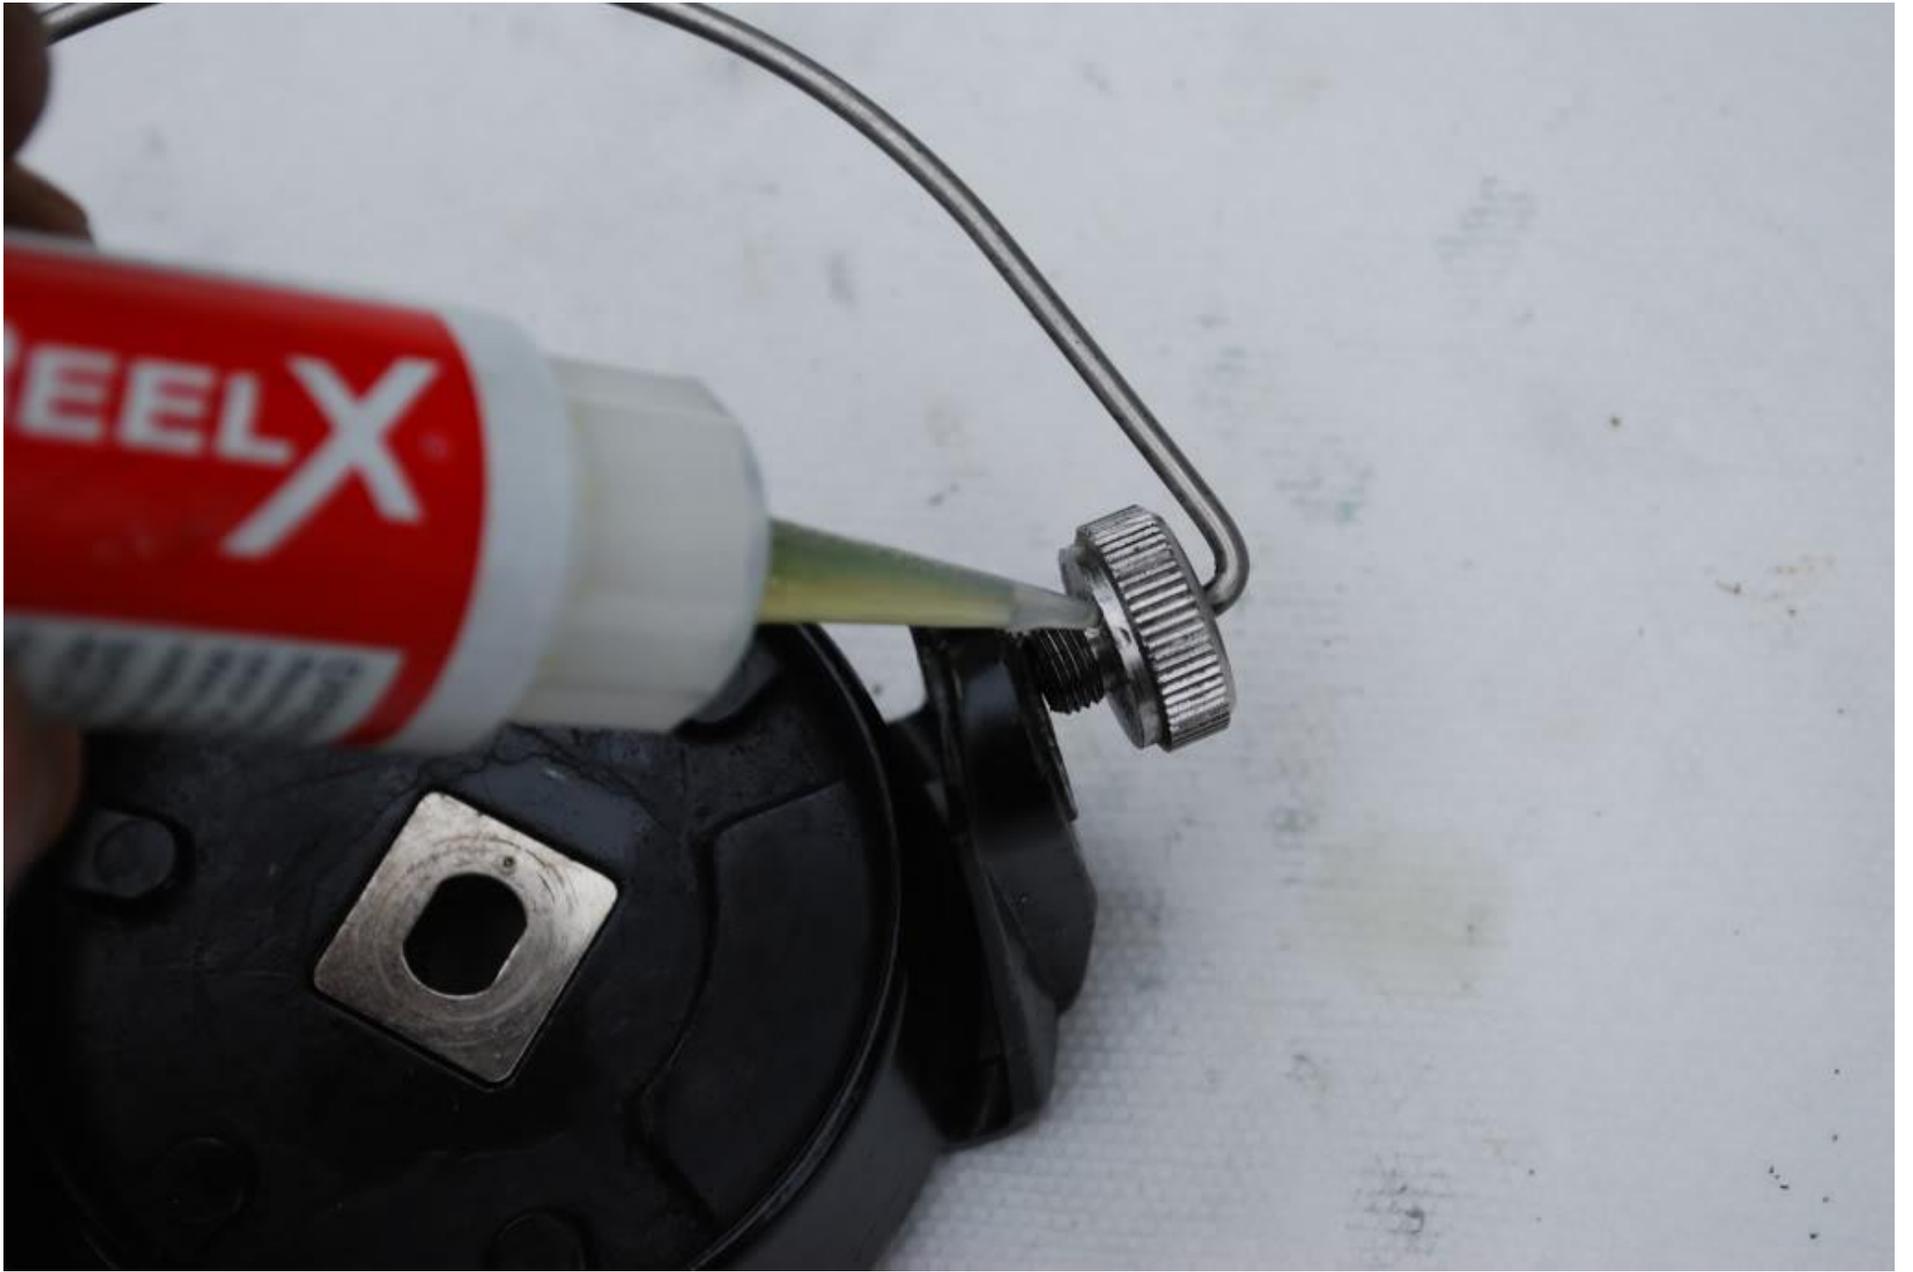
Then I removed the bail wire, key #24. I cleaned the line roller, #35, and the line roller bearing, #35a and reinstalled them.

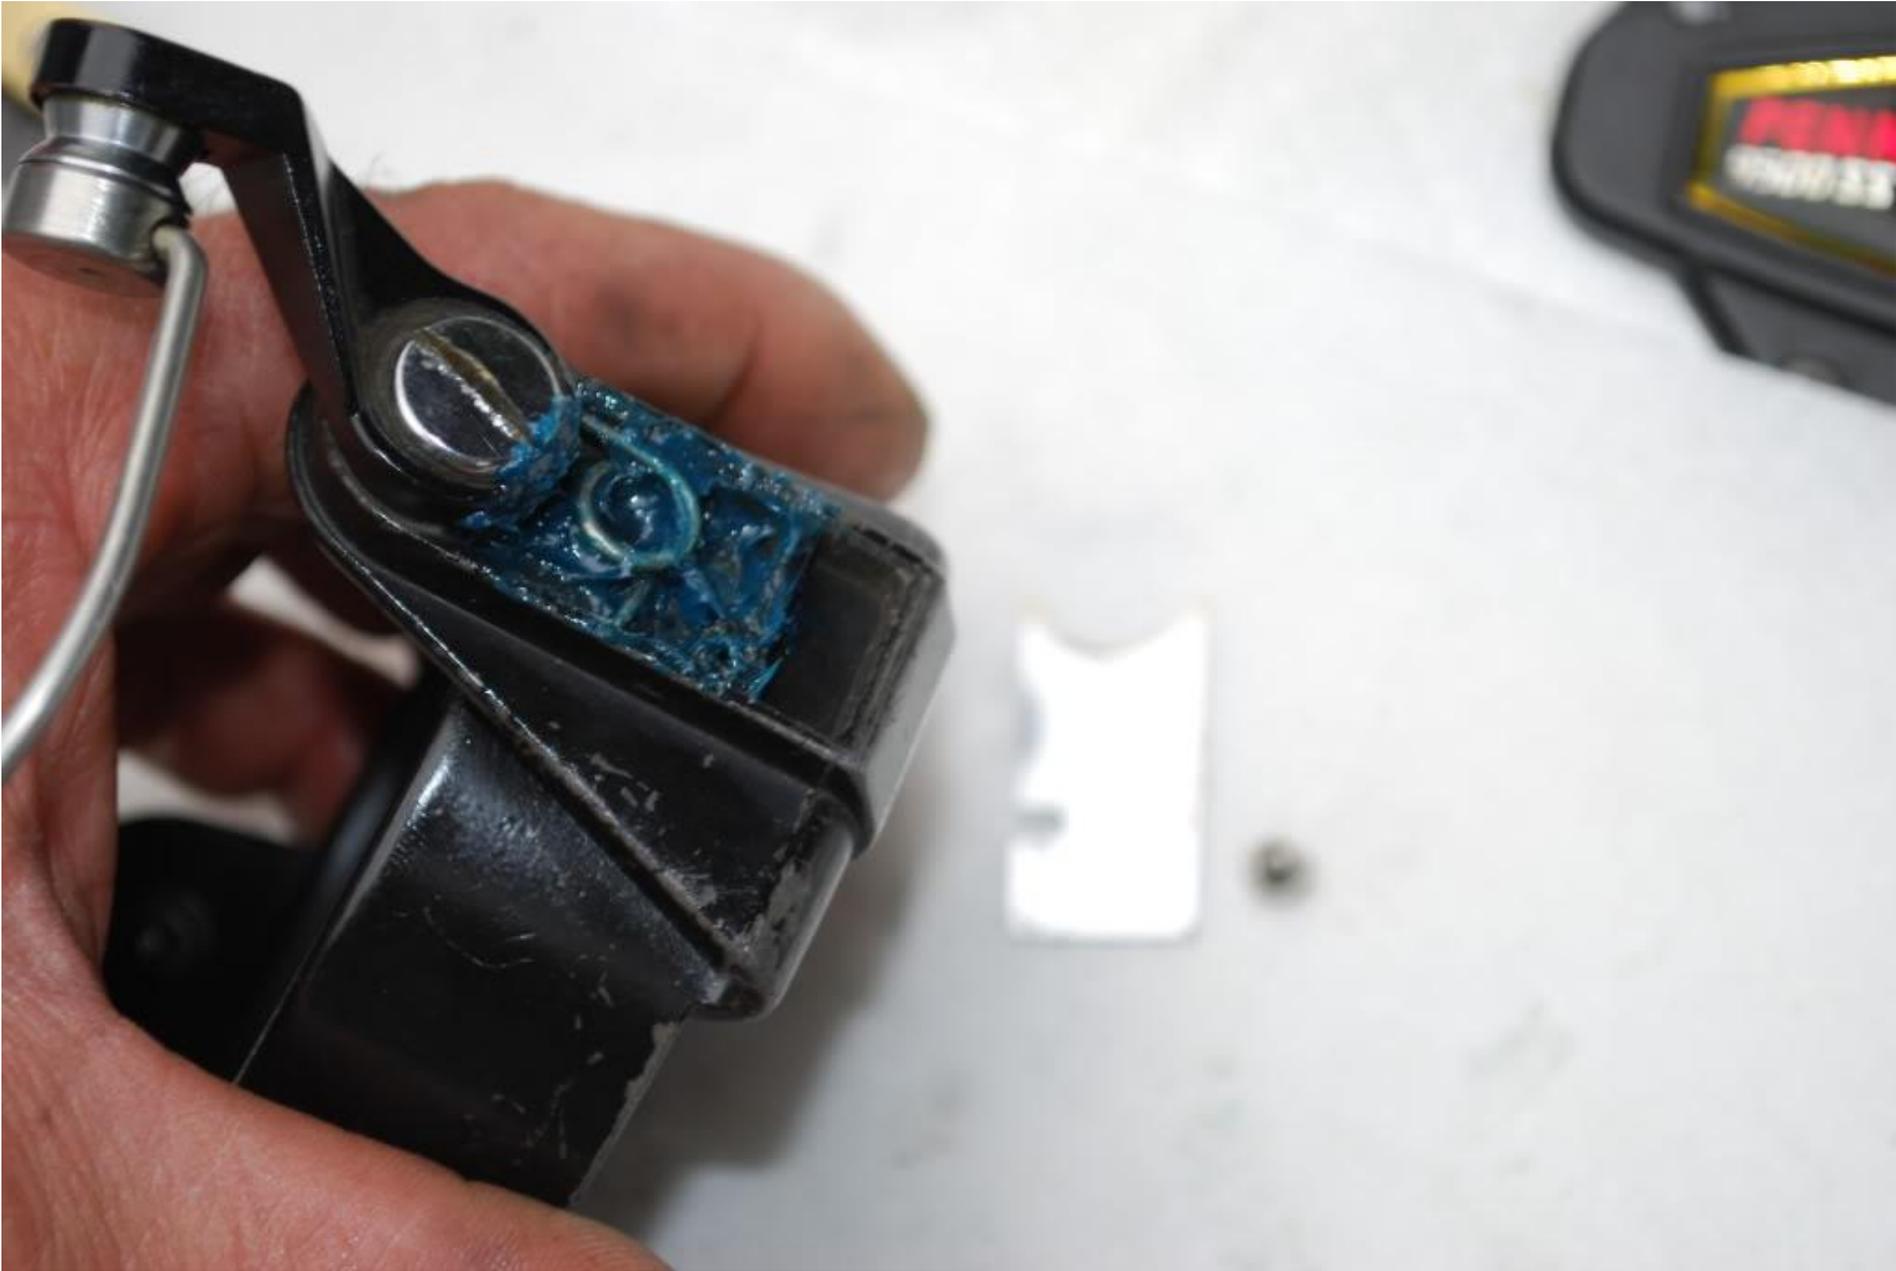
I also removed the bail spring cover, checked the spring, and applied some grease to it.

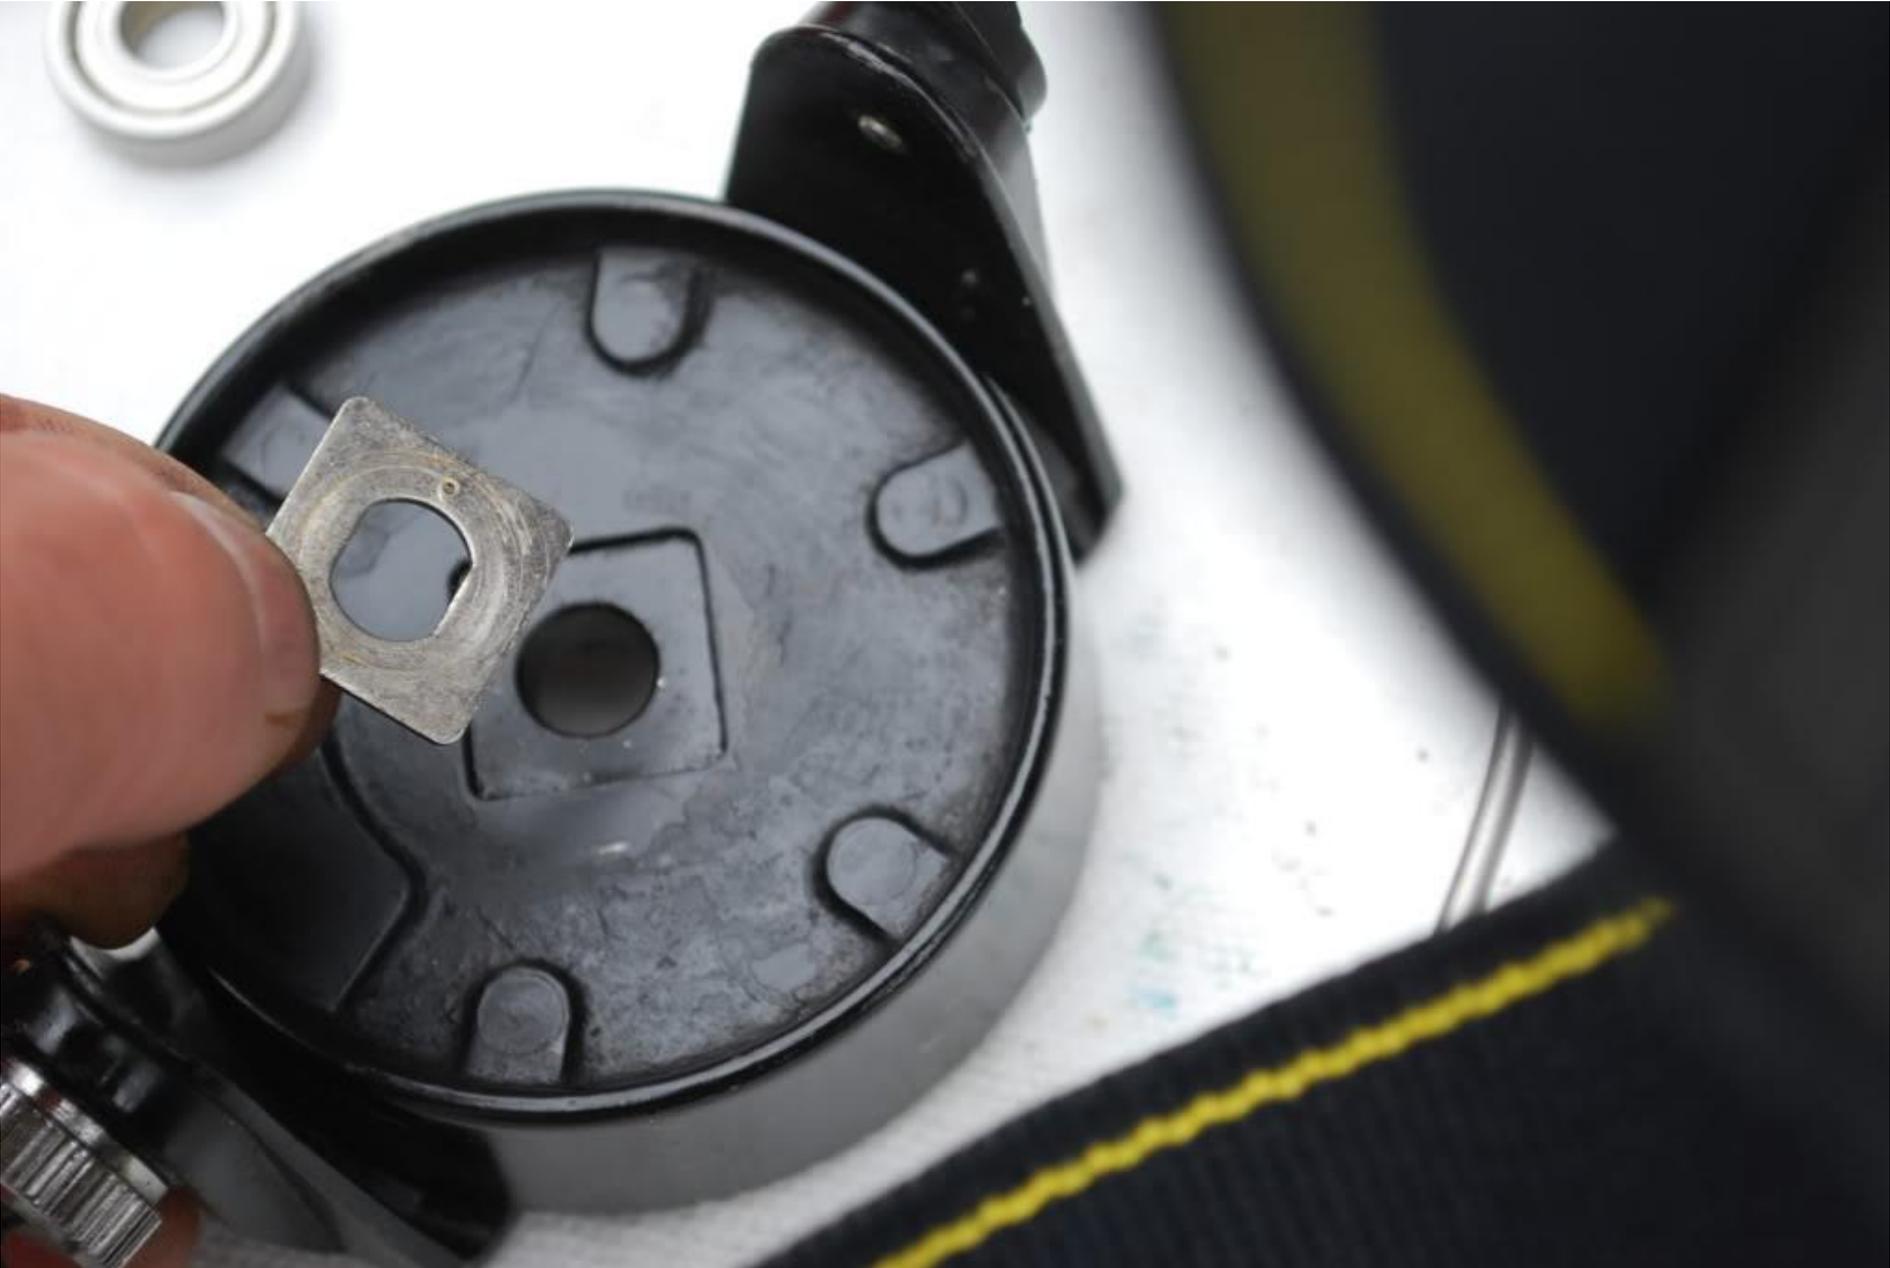
I then installed the rotor (key #27).

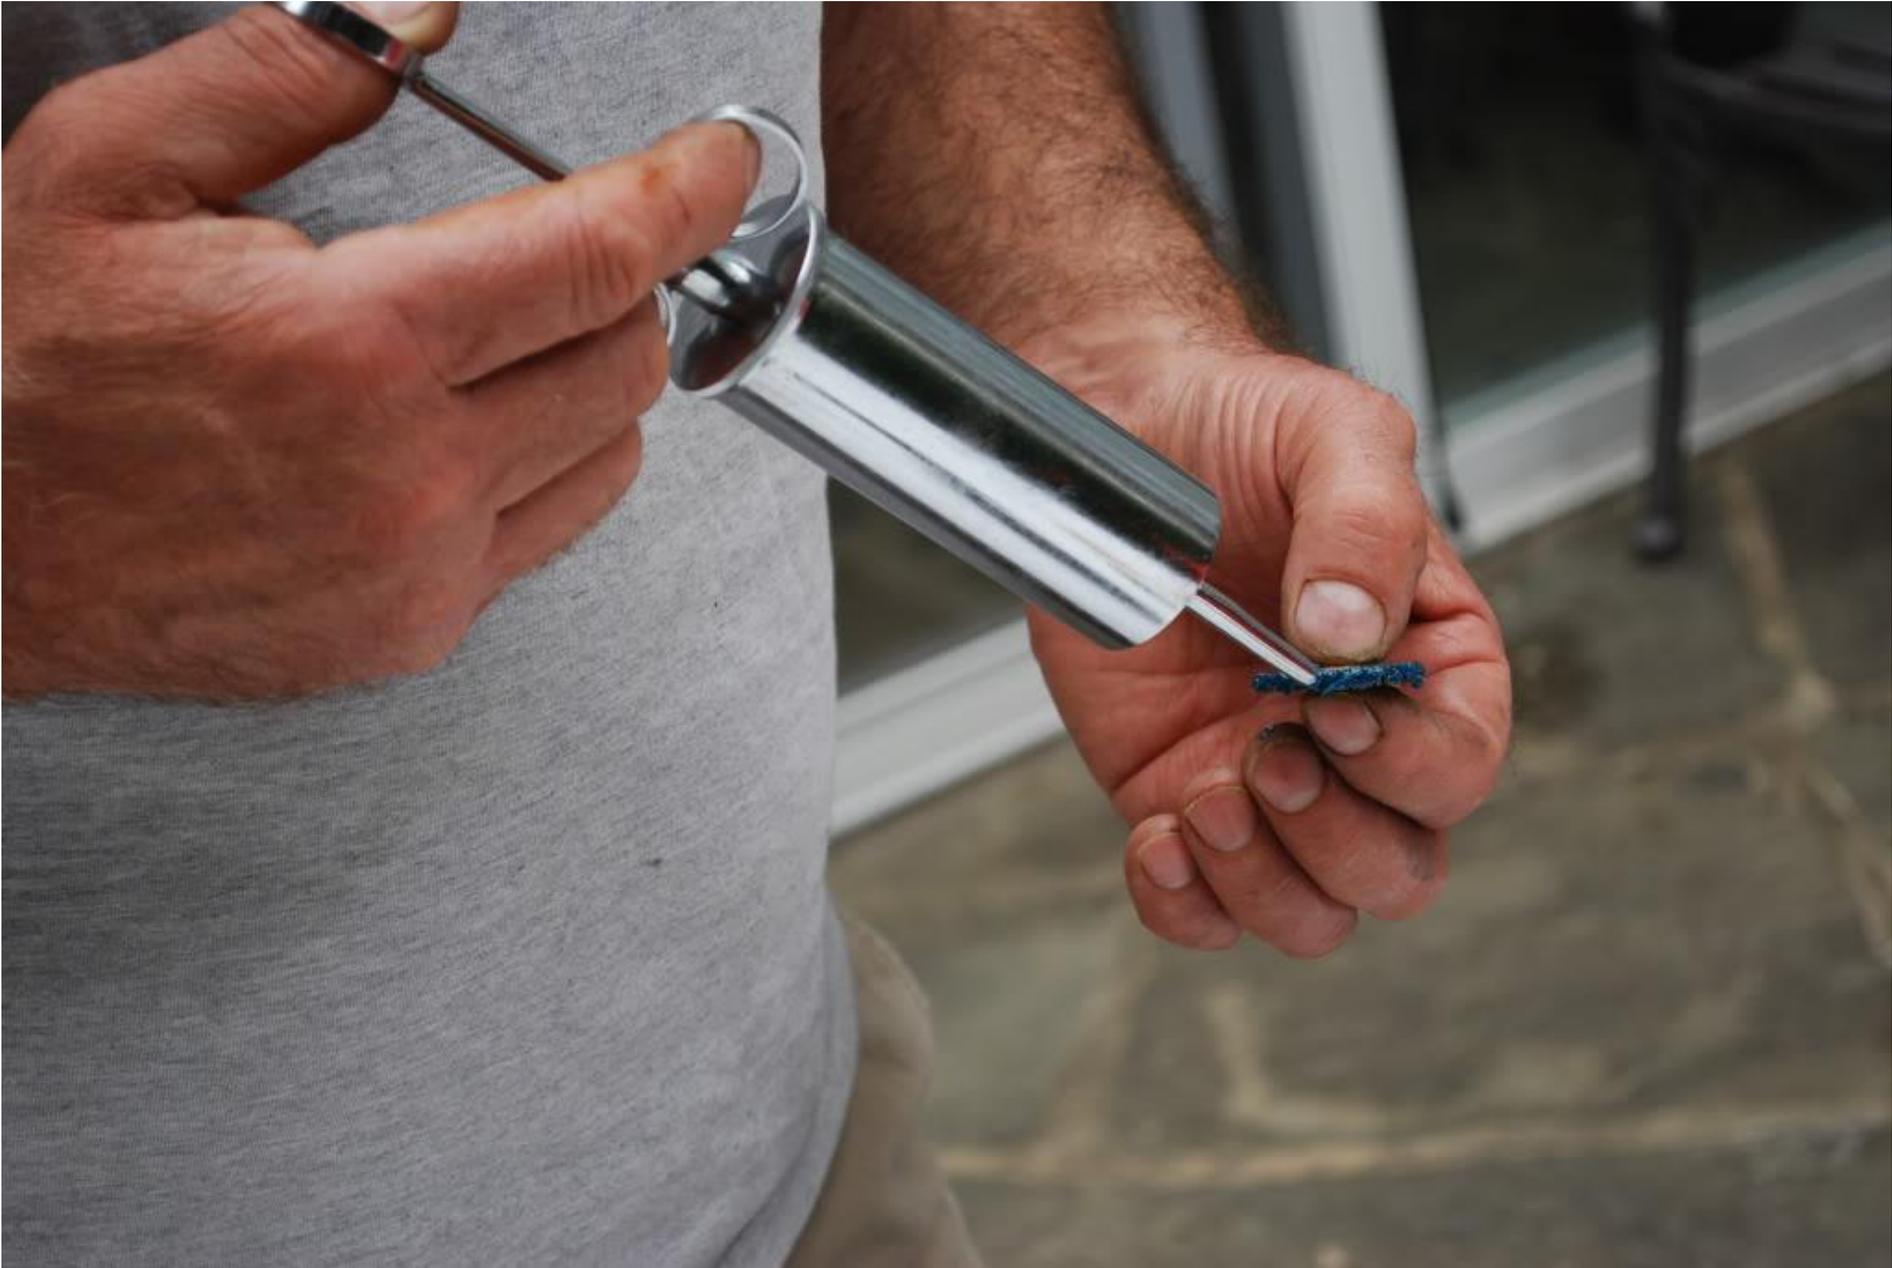
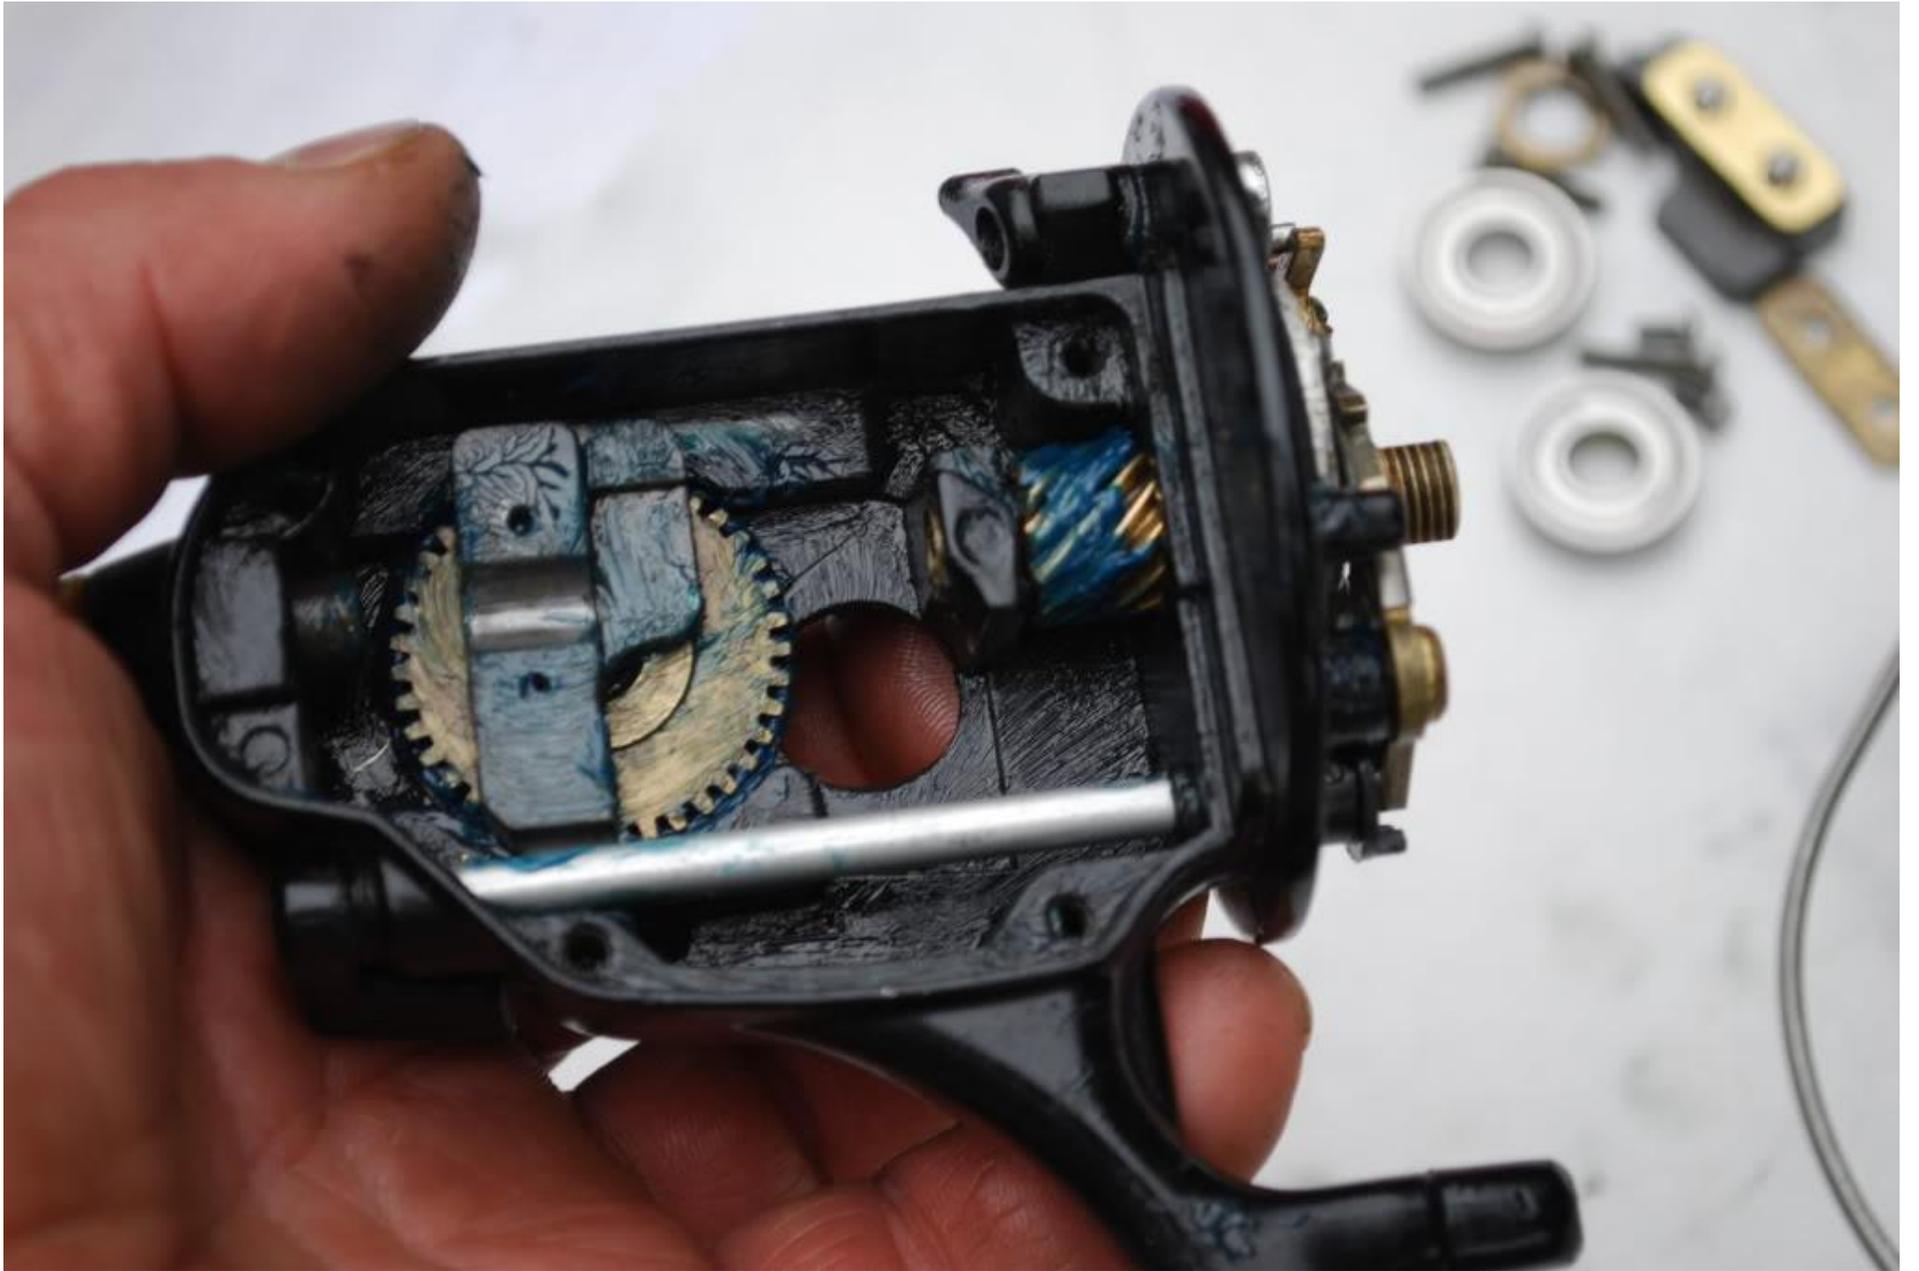
I put the crosswind gear back in place (#231), along with the spool block (#43).
