Servicing a Penn 9500 SS Spinning Reel

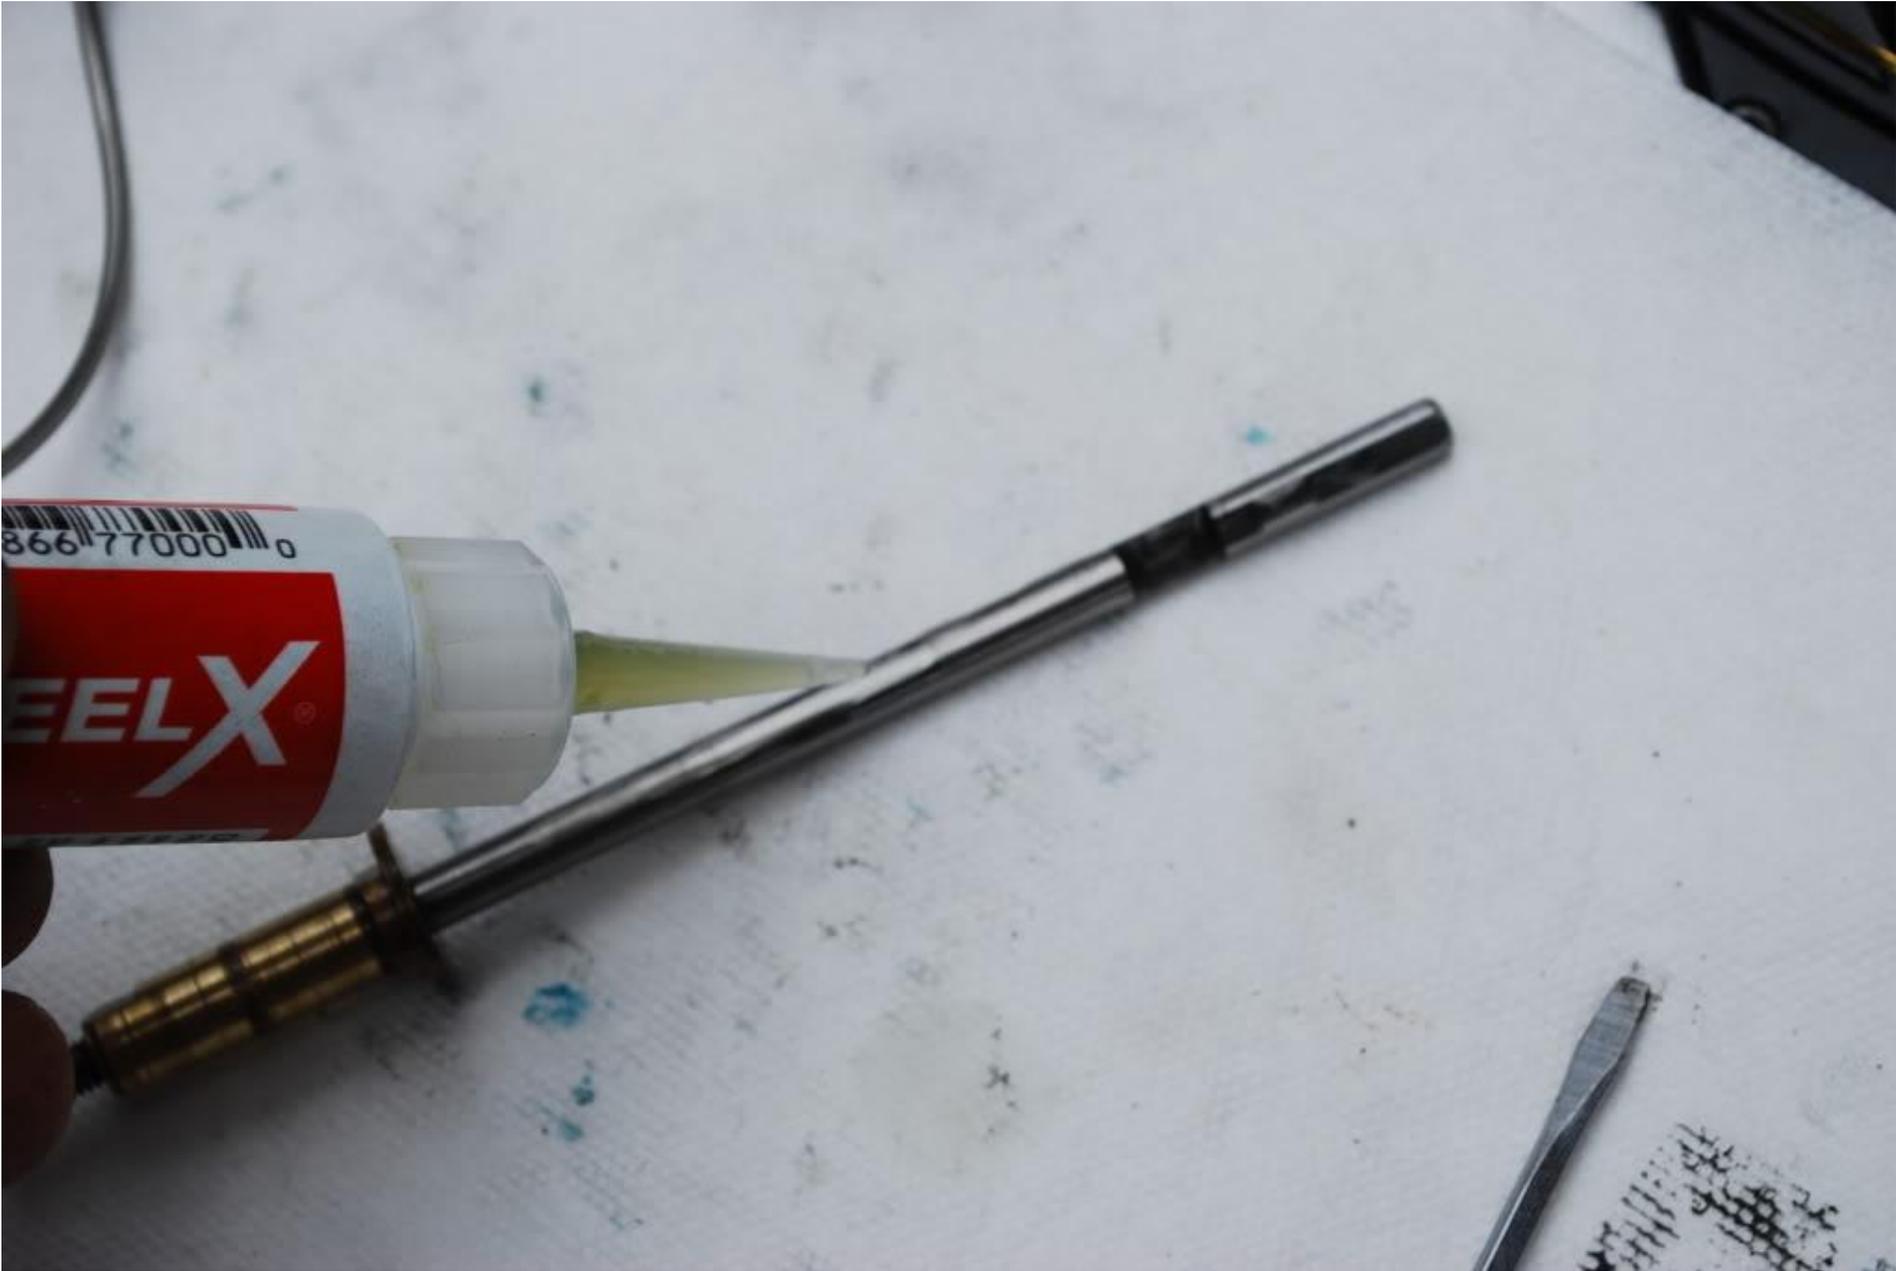
I greased the spool shaft and set it in place, key #39.

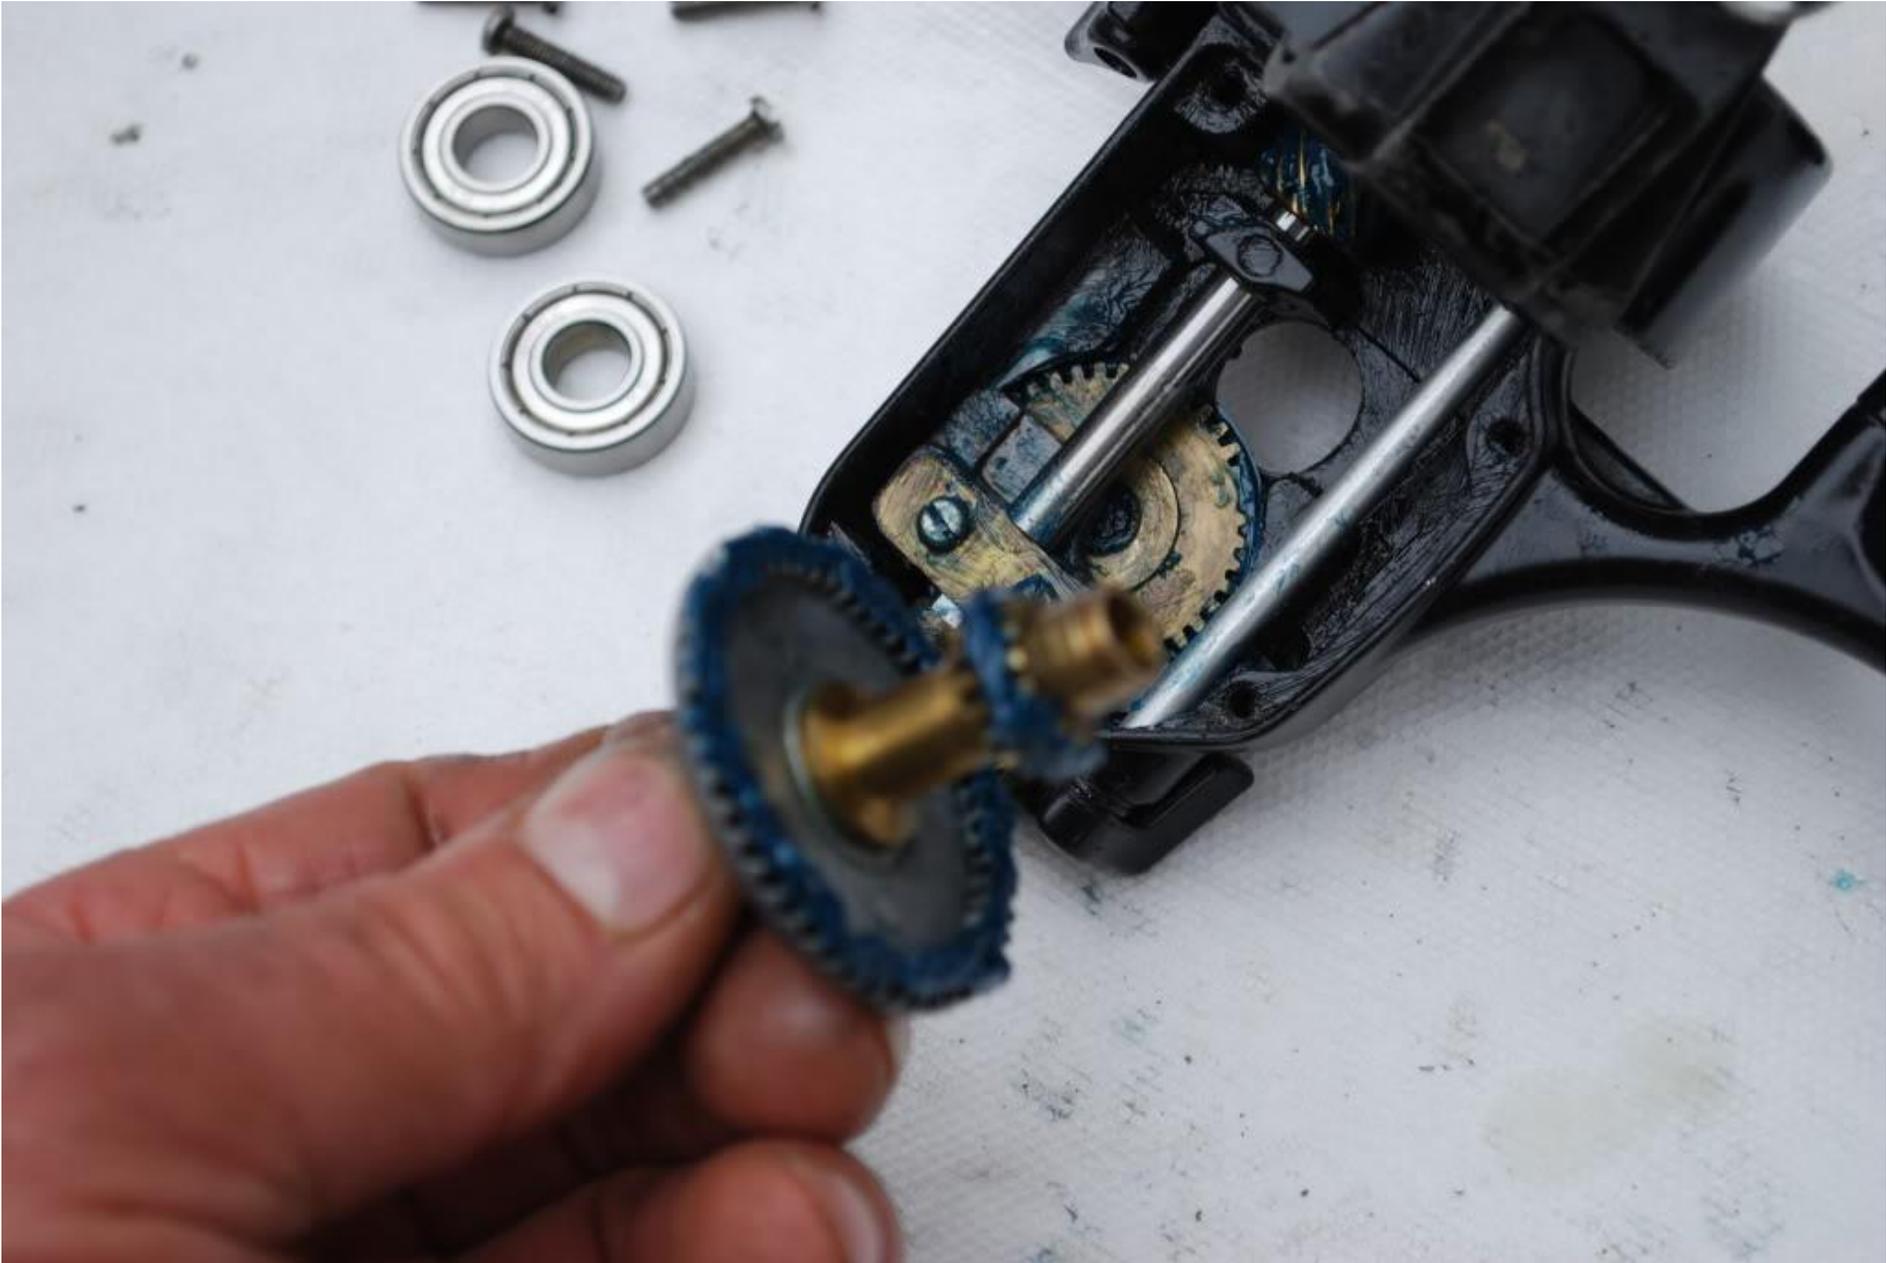
Next, I installed the main gear (key #8).

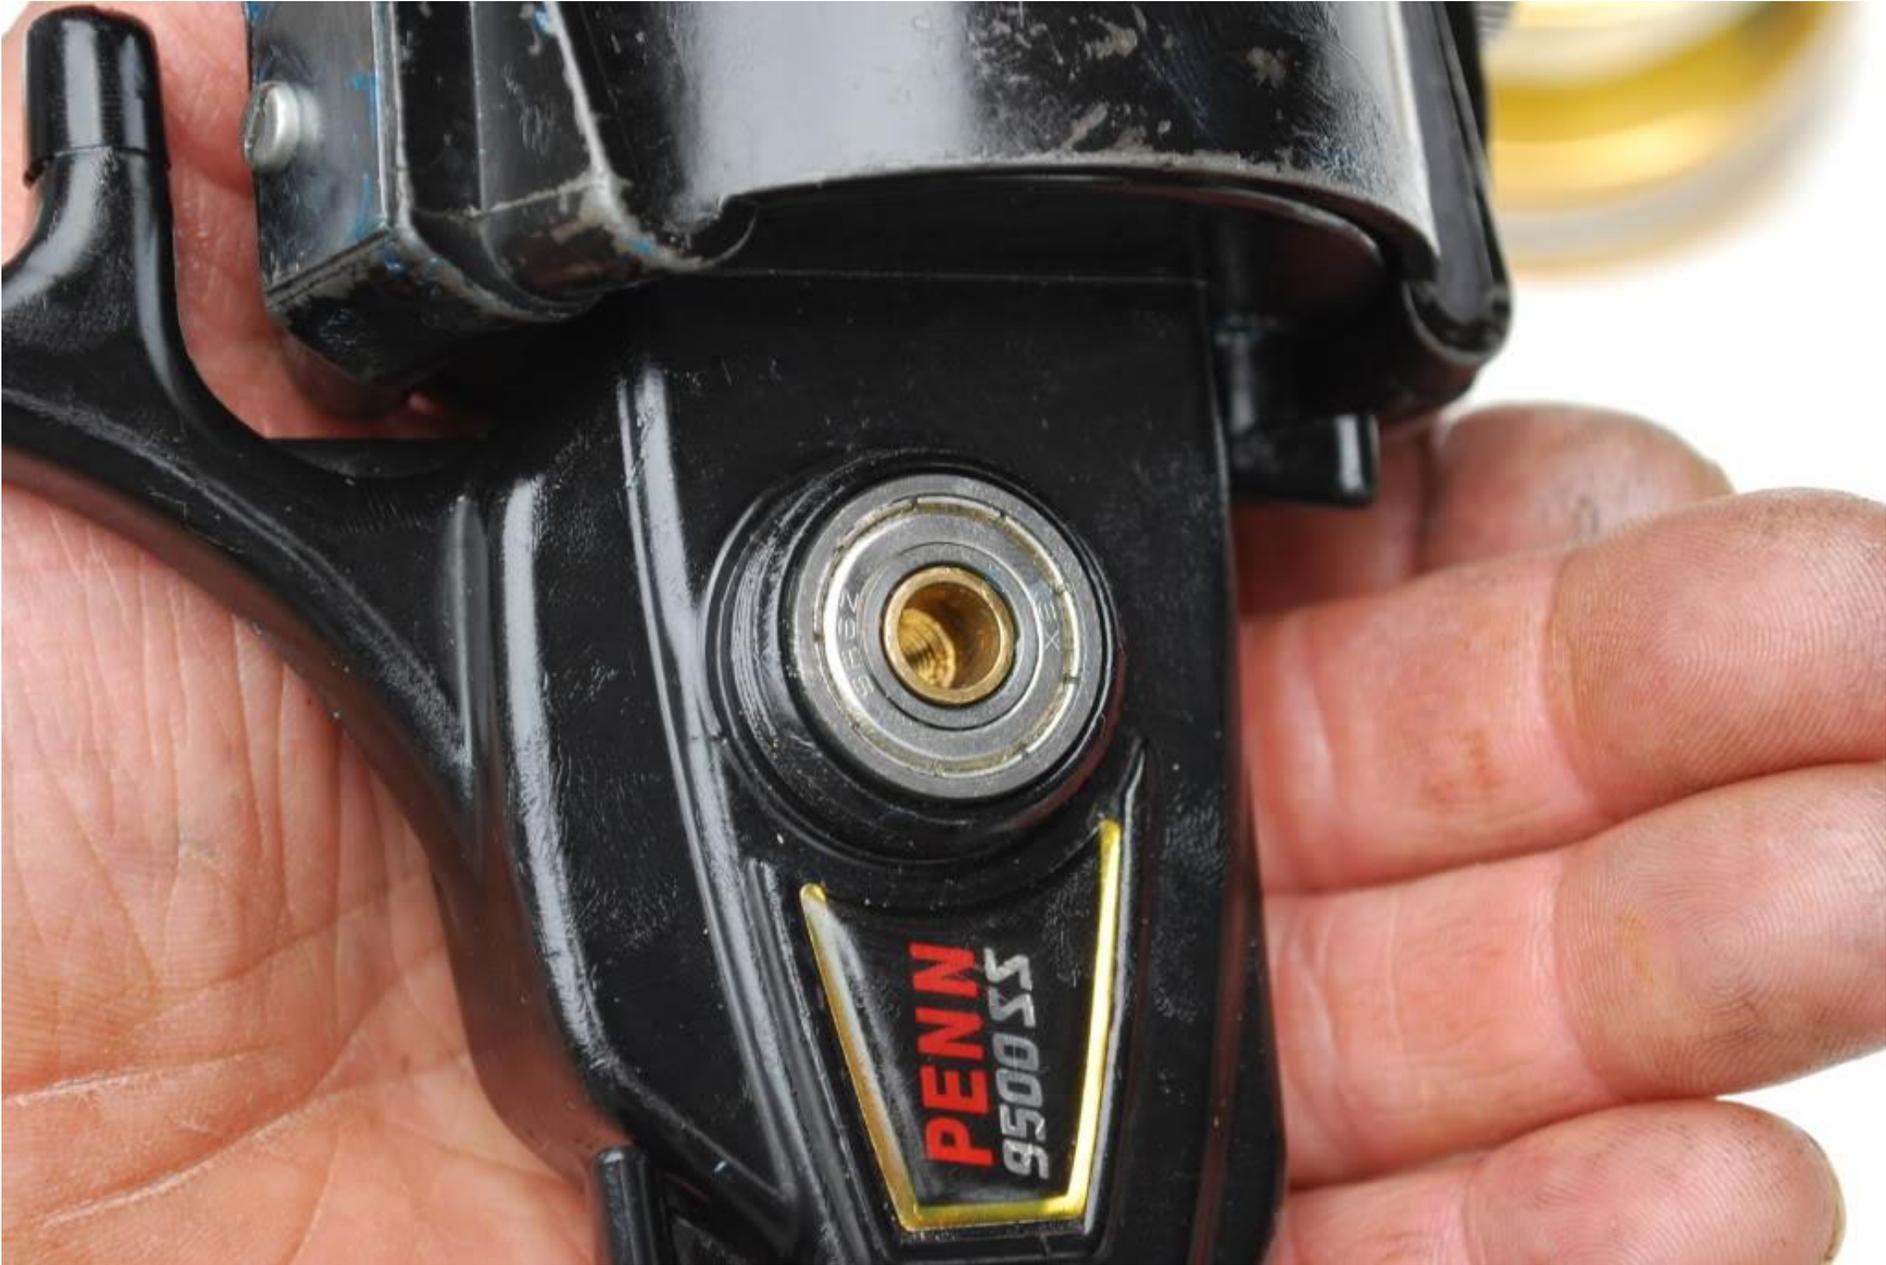
Along with the right side bearing (#20)

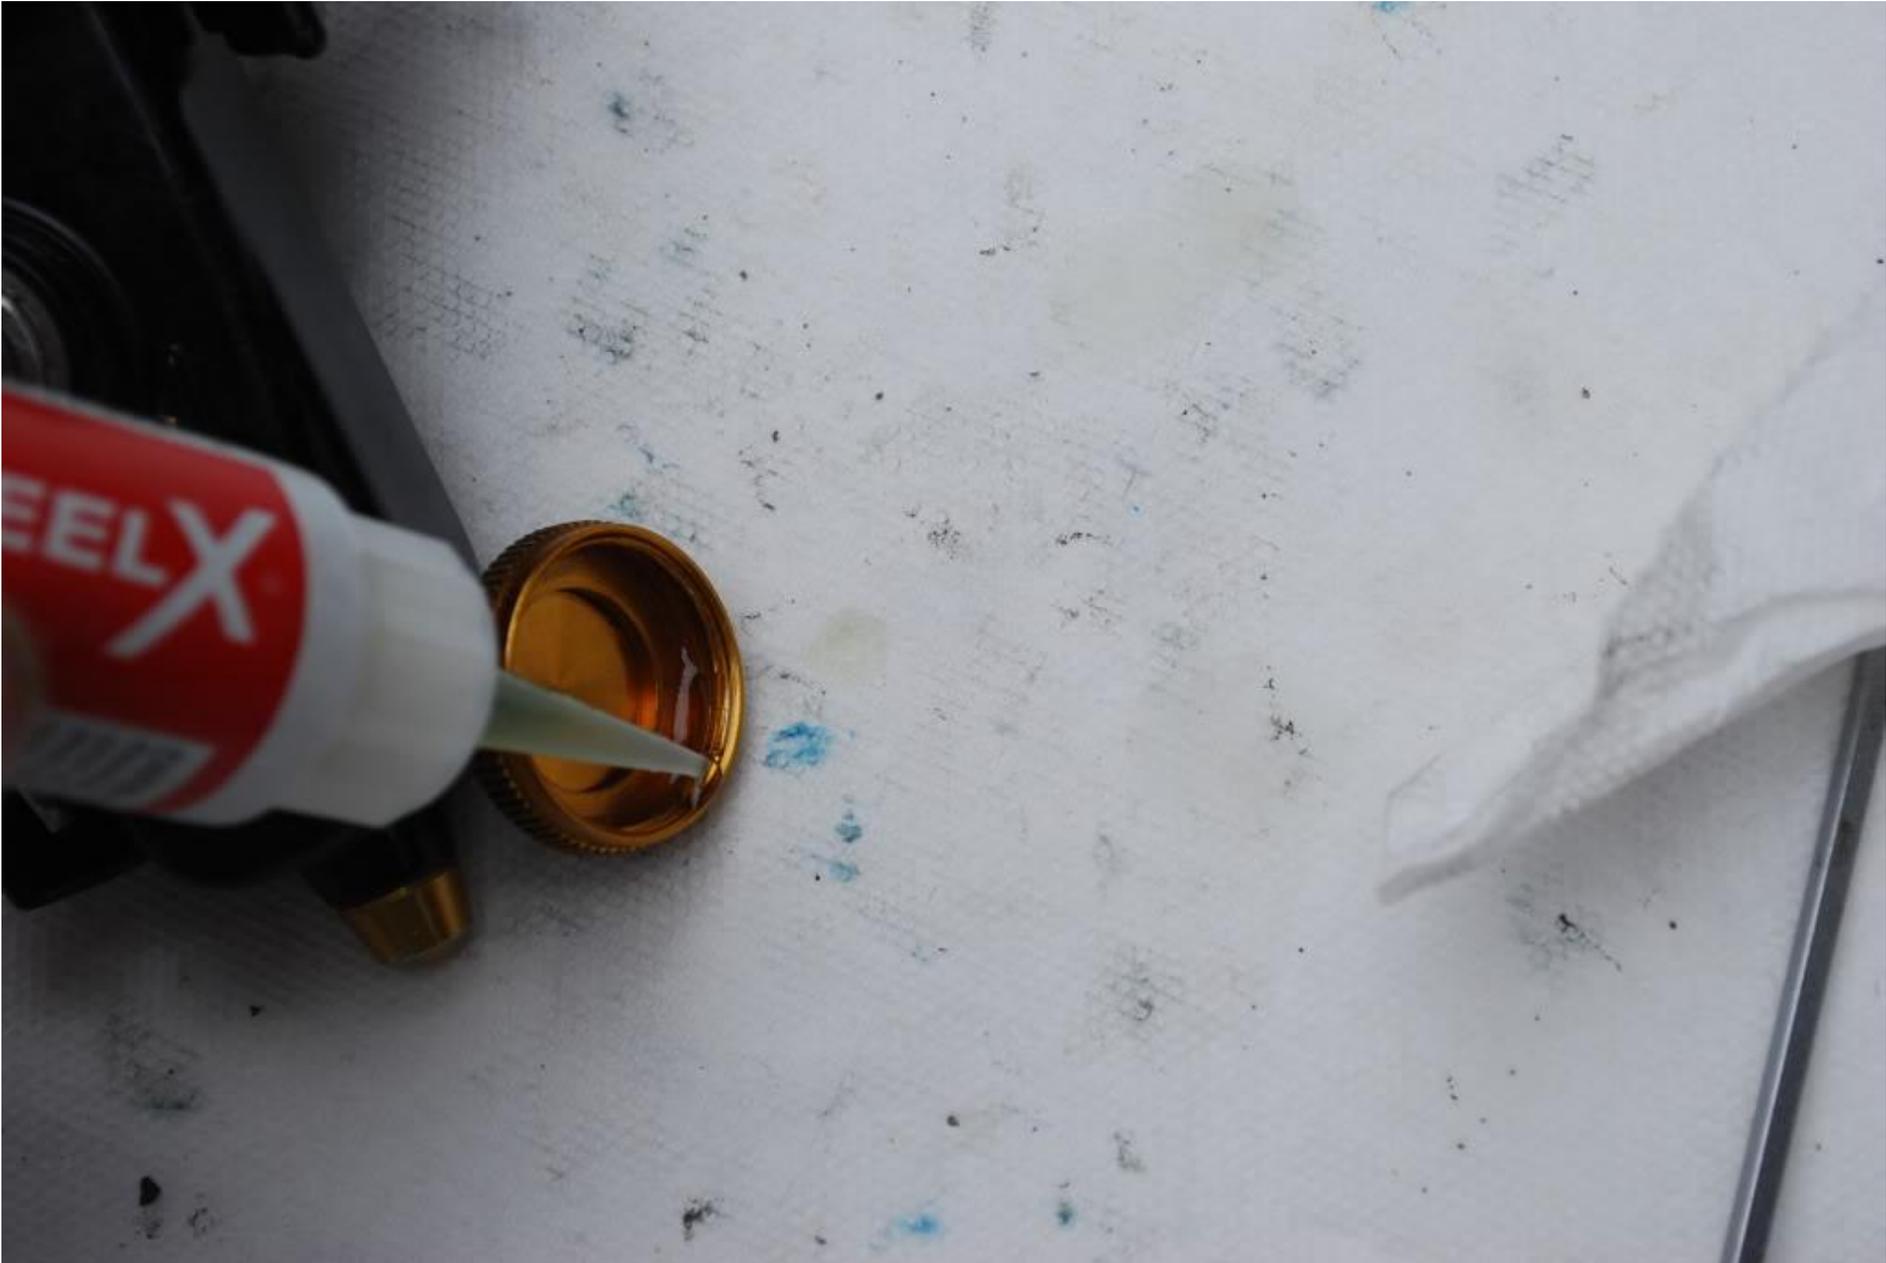
And the bearing cover (223)

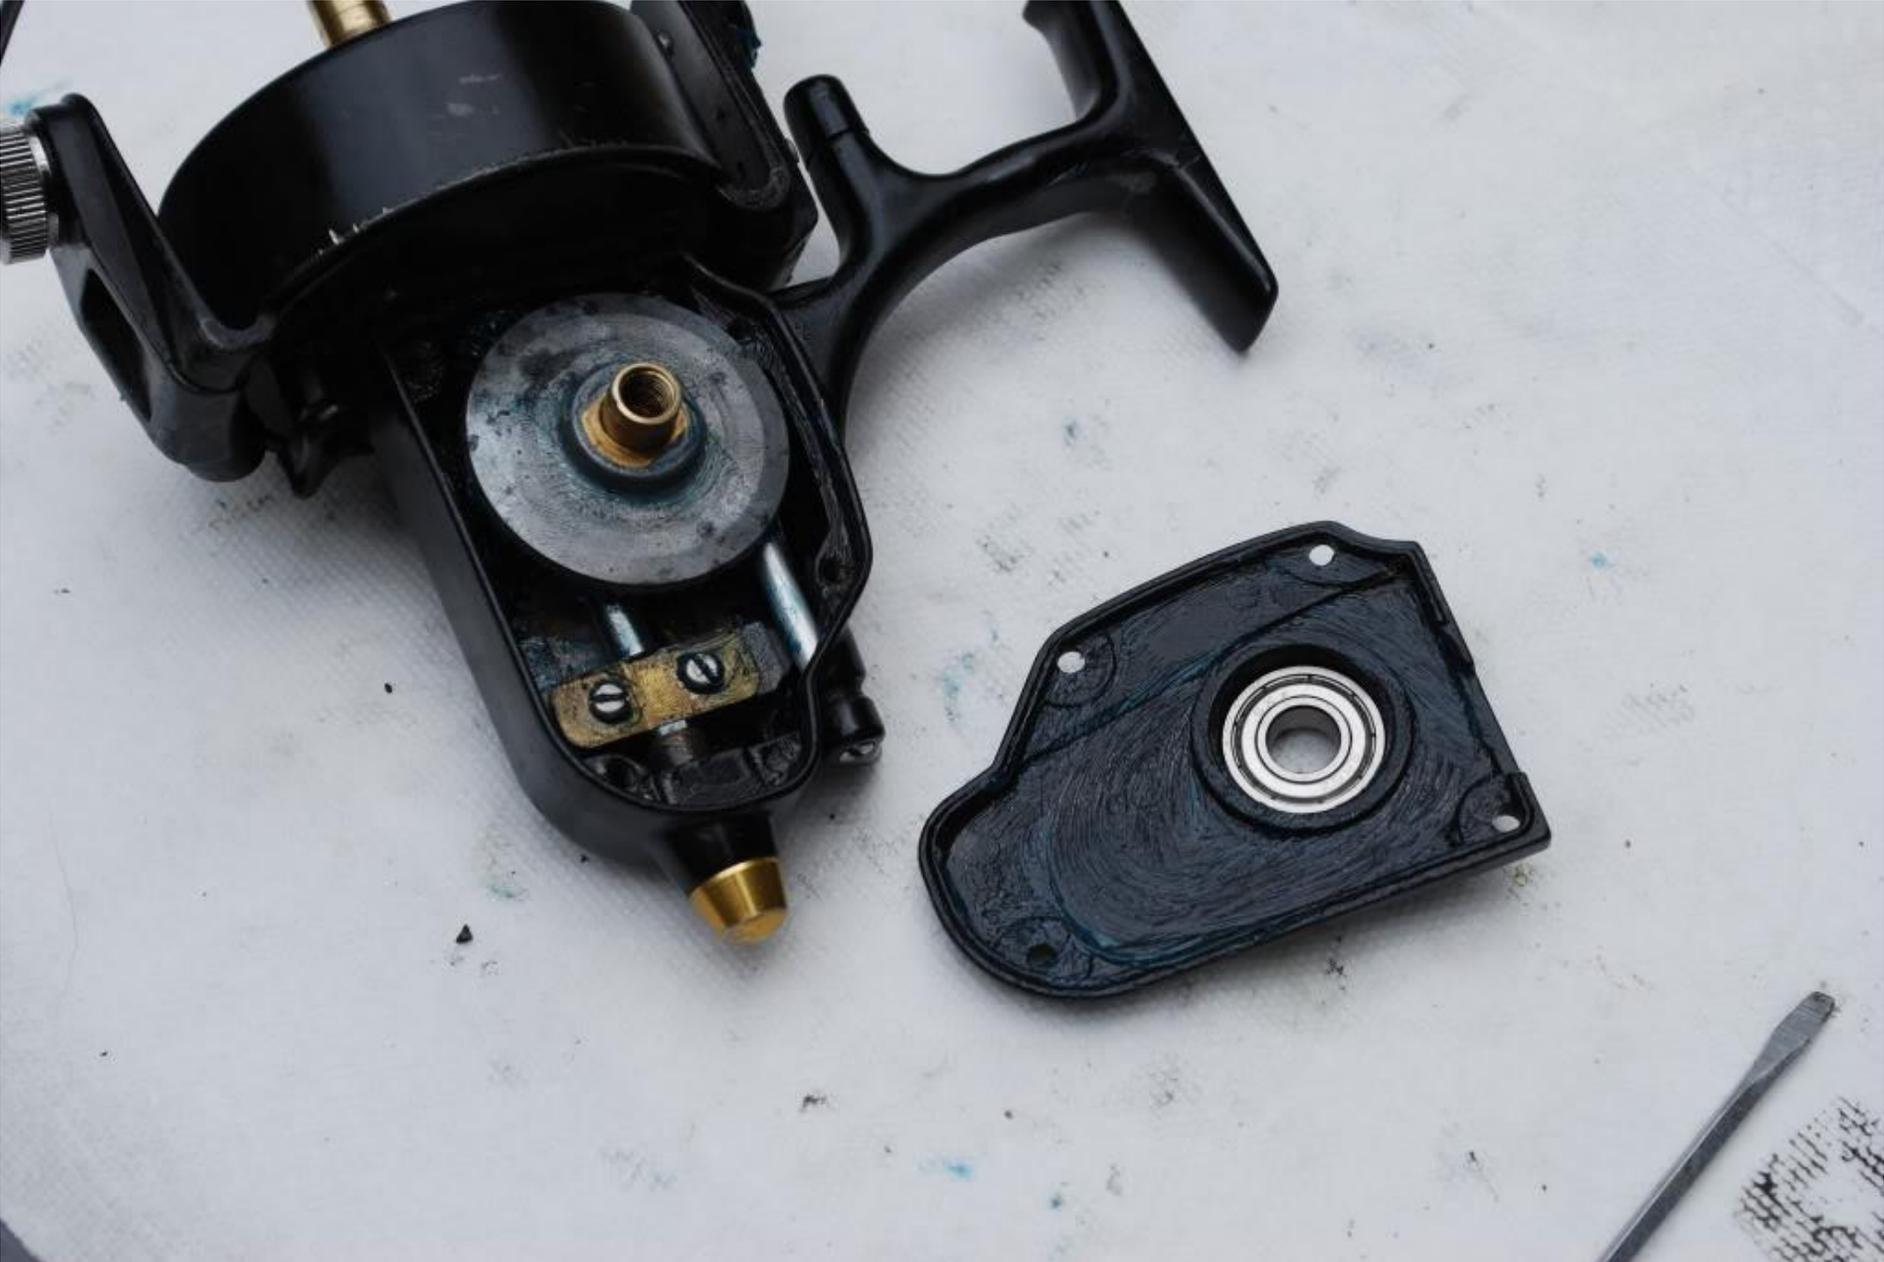
I then installed the housing cover (#45) with the bearing in it.

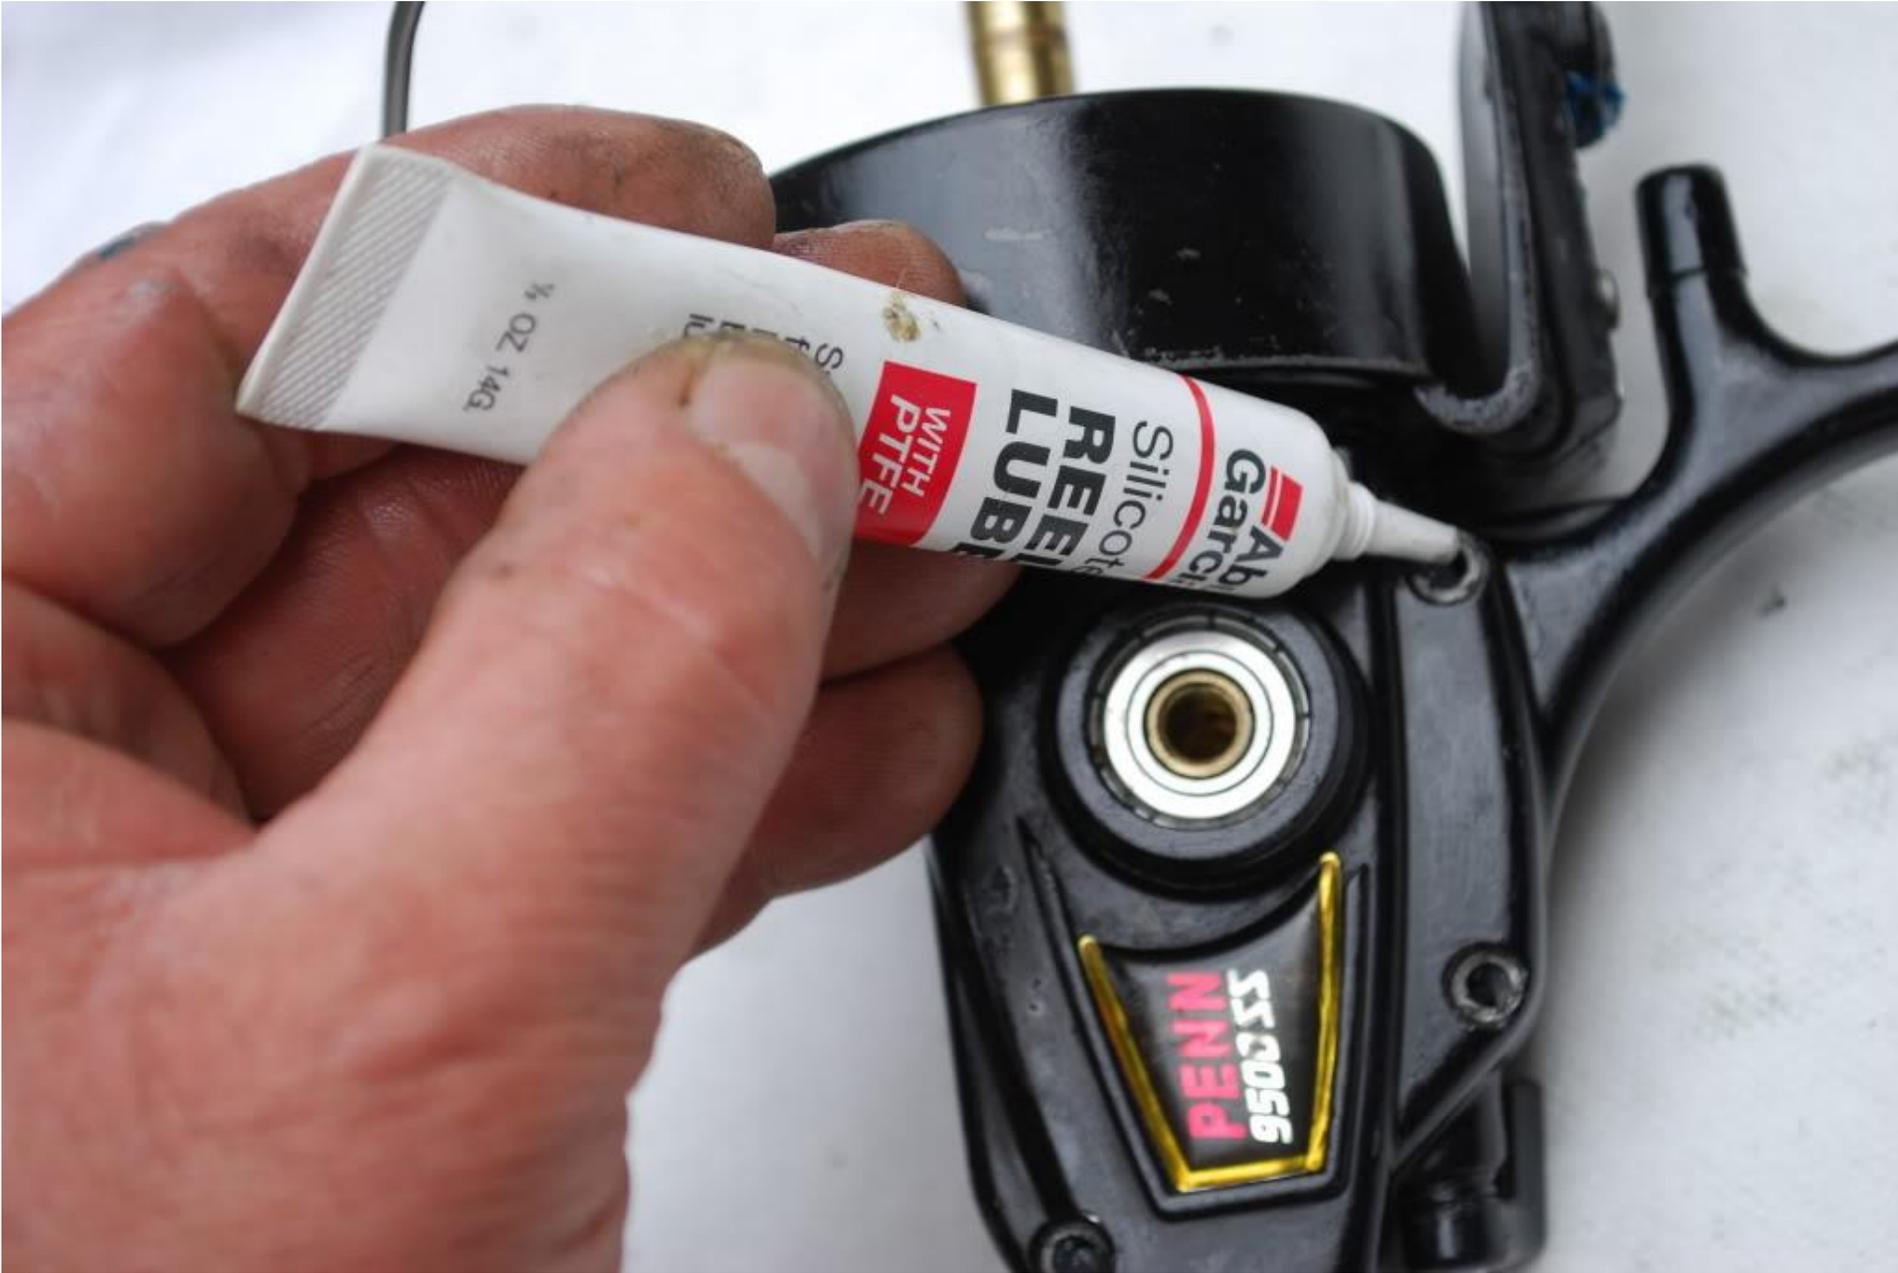
I then greased the screw holes and set the screws in.

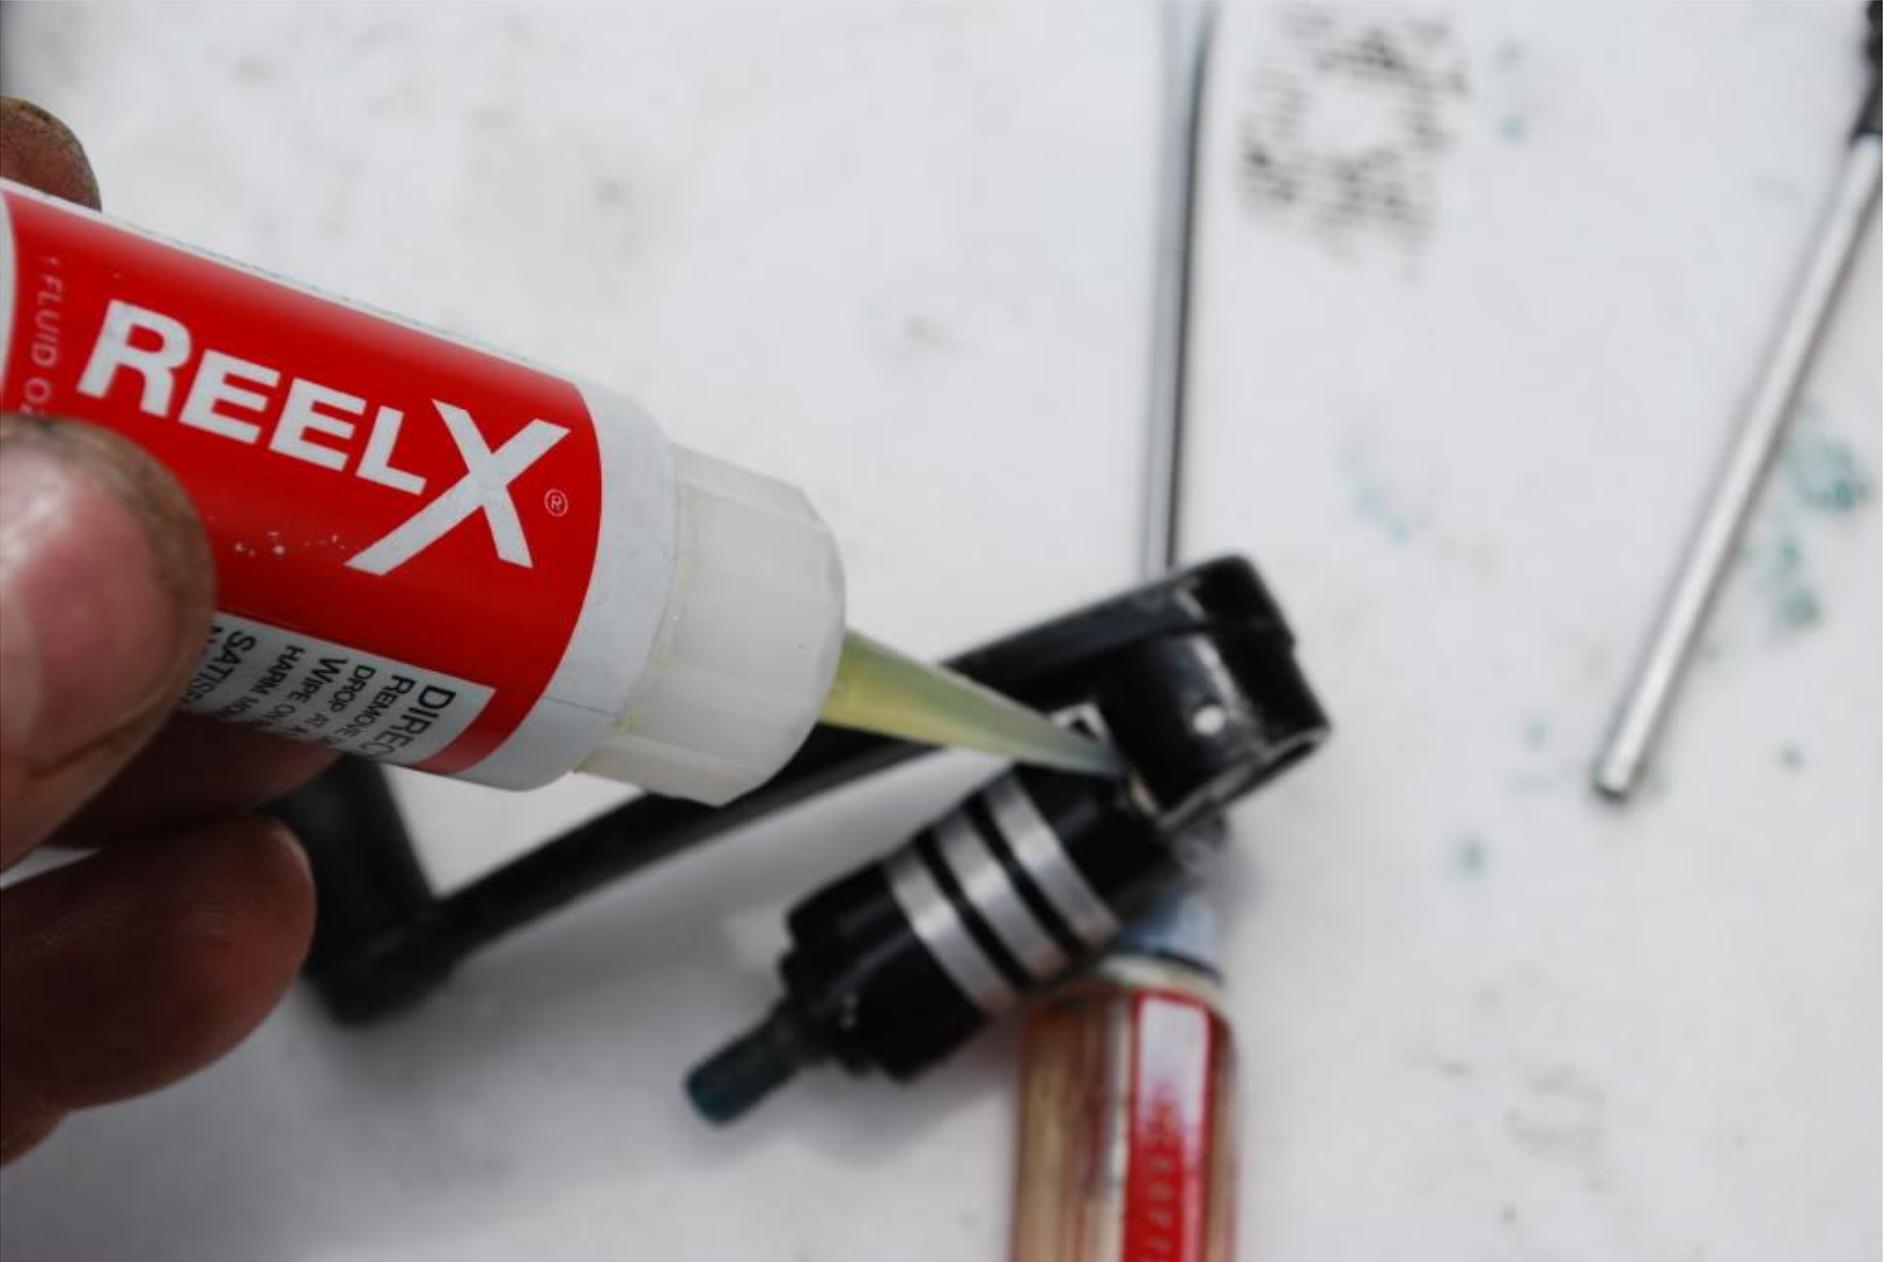
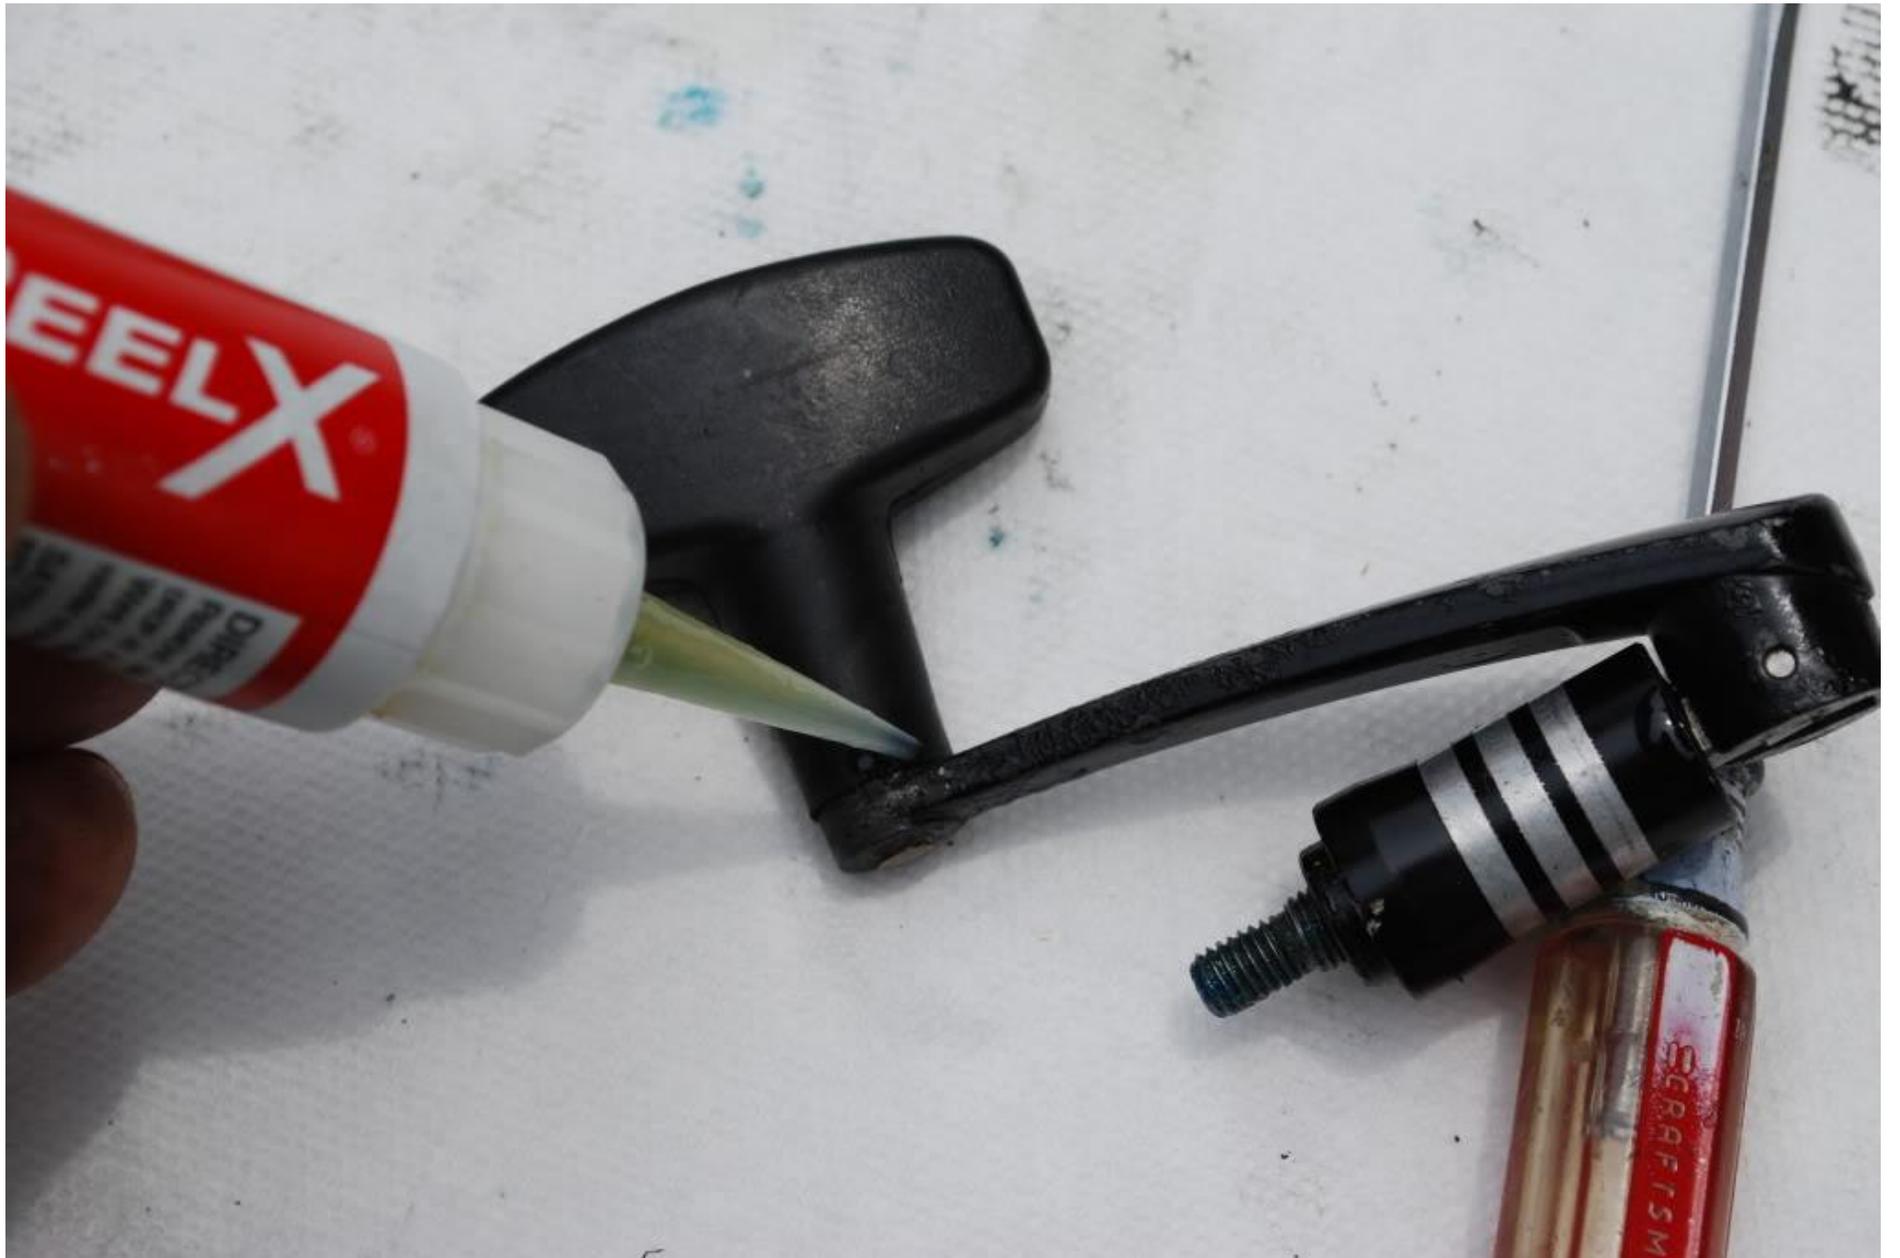
I then put the handle back. I put a drop of oil on the joints and knob (#15).

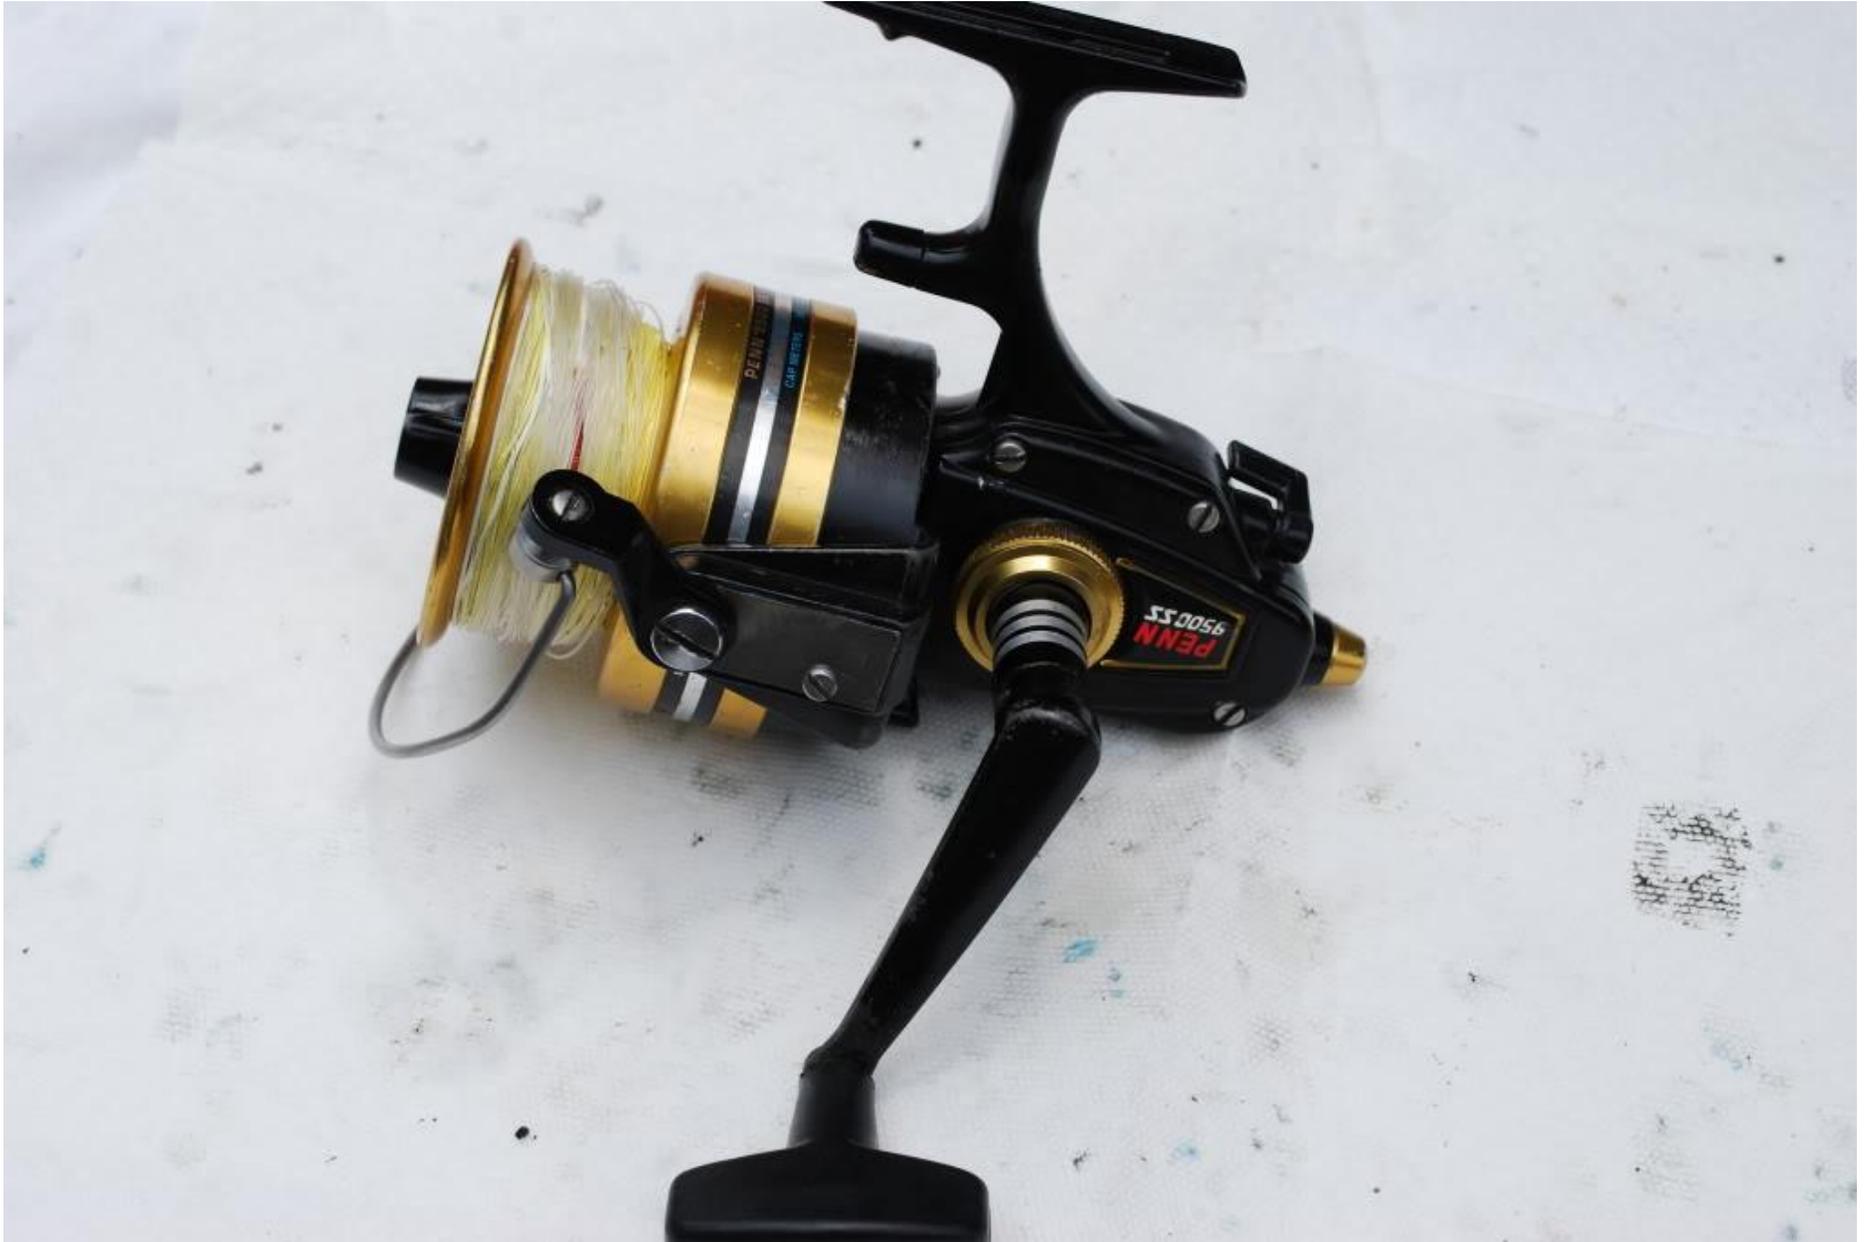
Here is the finished reel, ready for action!

As you can see, this reel was fished hard and the anti-reverse was not functioning properly, so I decided to service it. It is now working as good as it did when it was brand new. I hope you enjoy it for what it's worth.
